RFA DARKDALE SURVEY

SALVAGE AND
MARINE
OPERATIONS

SURVEY REPORT

This document was prepared following the survey of *RFA Darkdale*, at St Helena in 2012 by Salvage and Marine Operations.

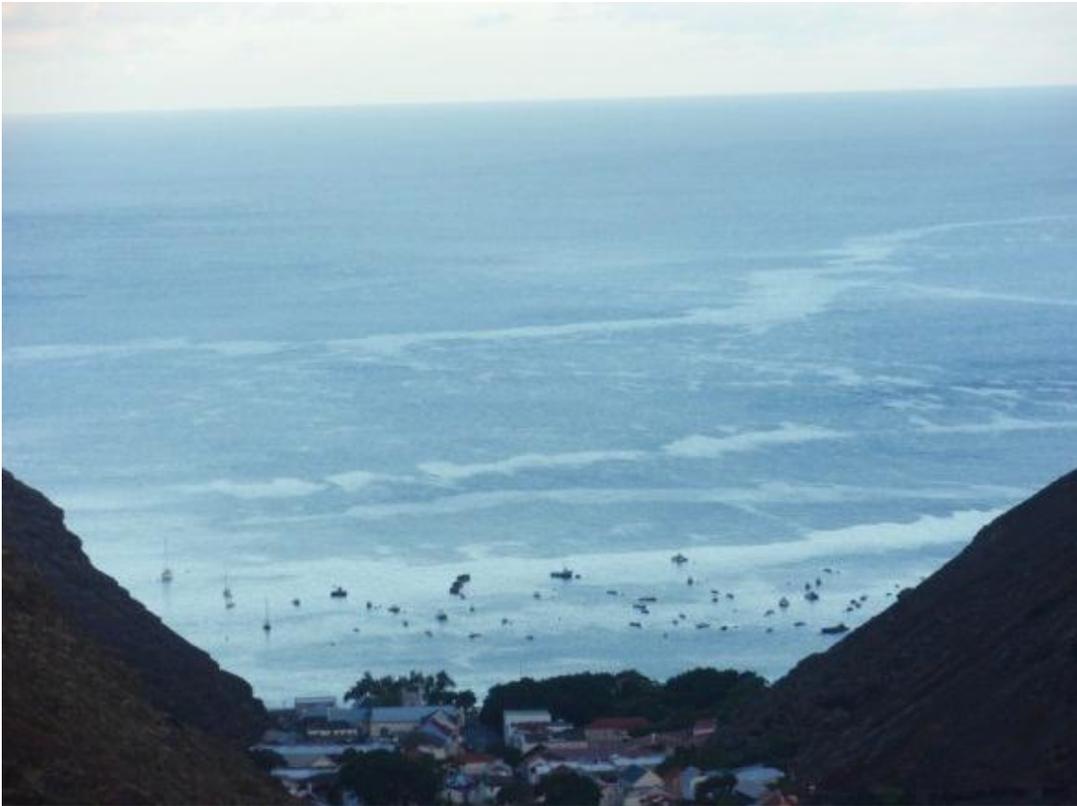
Figure 5 - James Bay, 8th March 2010

75. The Figure 5 shows the extent of the oil spill one week after the storm that caused the release. The oil can be seen to be dispersed in to bands but still covering a significant area including most of the bay.

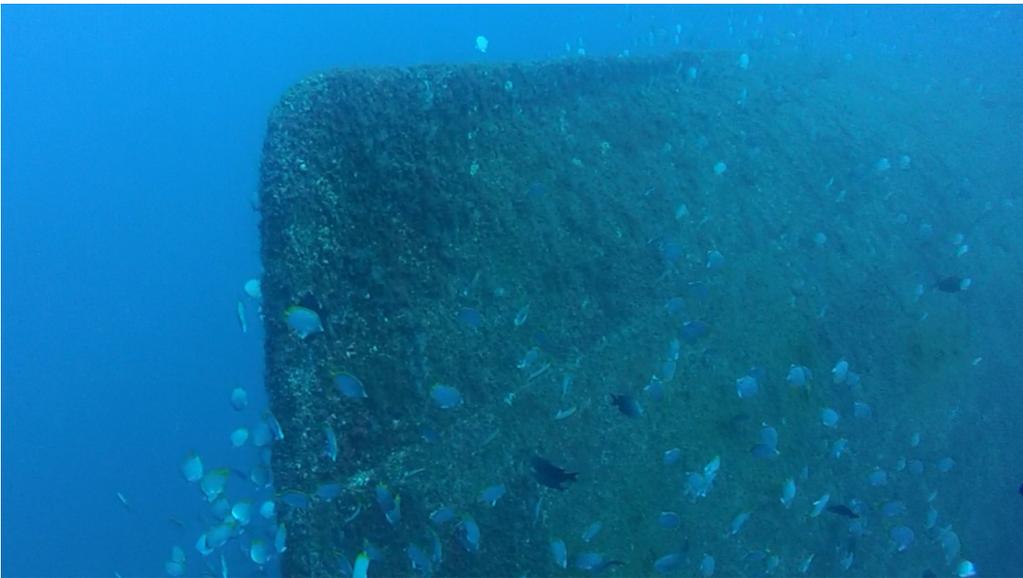
102. The wreck is covered in light concretion and minimal marine growth.

Figure 6 - Bow showing typical degree of marine growth

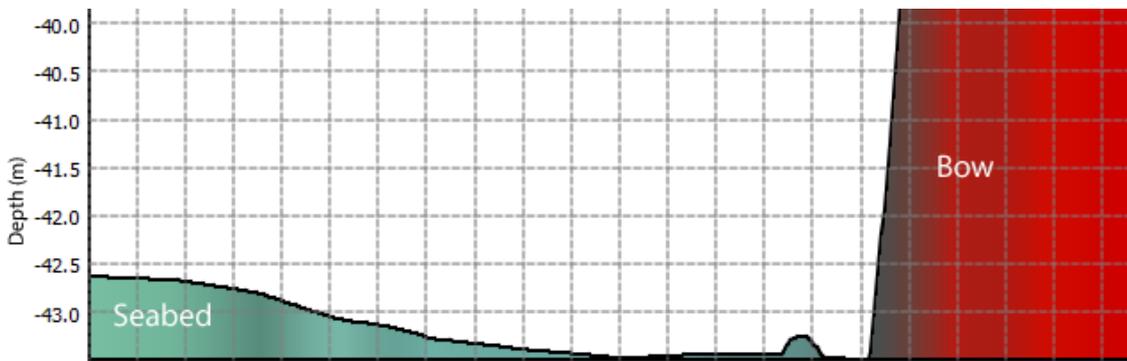
109. There is some scour around the bow of the wreck with the bow sitting in a depression approximately 1 m deep. The area of scour extends in a horse shoe shape around the bow region, stretching back to 10 m aft.

Figure 9 – Longitudinal section through bow area showing scour

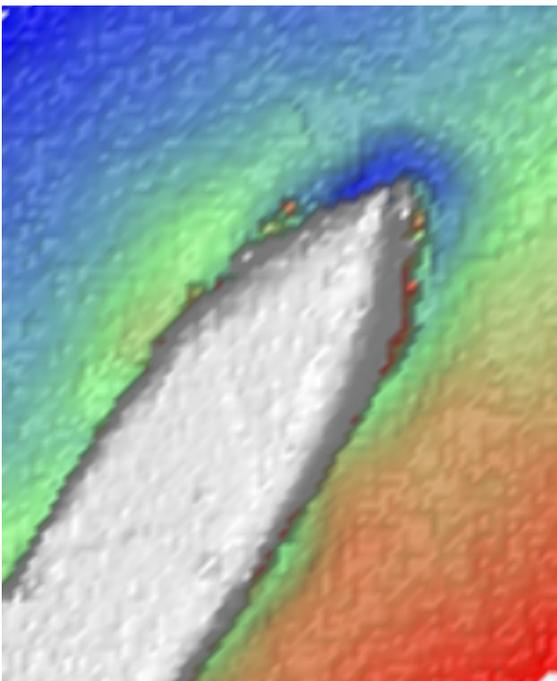
Figure 10 – Multibeam sonar image showing scour in region of the bow

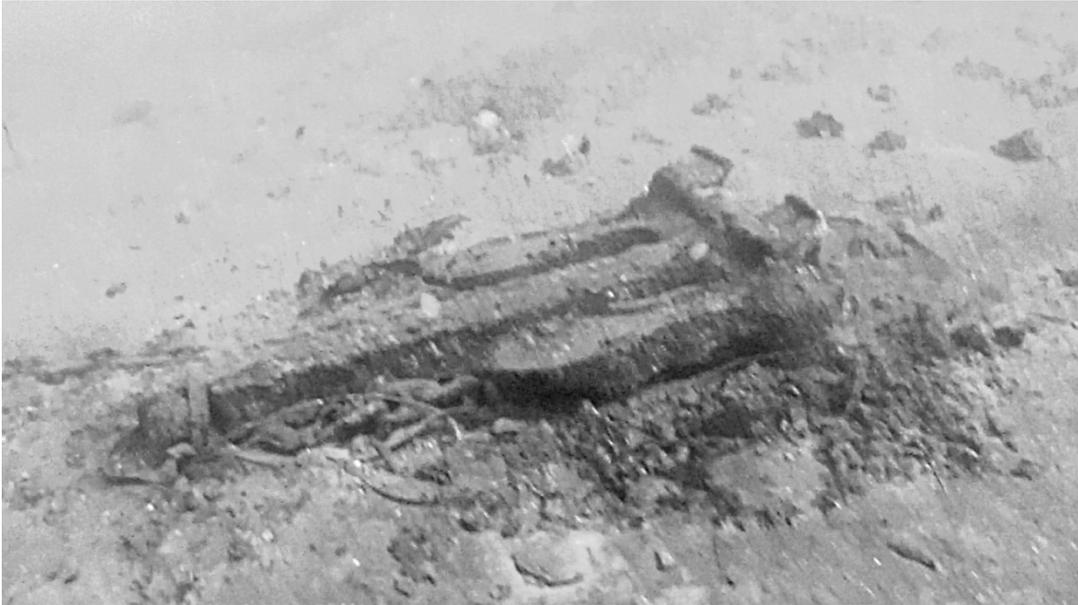
114. The chain runs to the bow of the ship but is no longer connected to the vessel. The hawse pipe lies detached from the wreck, 1m from the portside of the bow. It is unclear what has caused this to become detached.

Figure 11 - Anchor

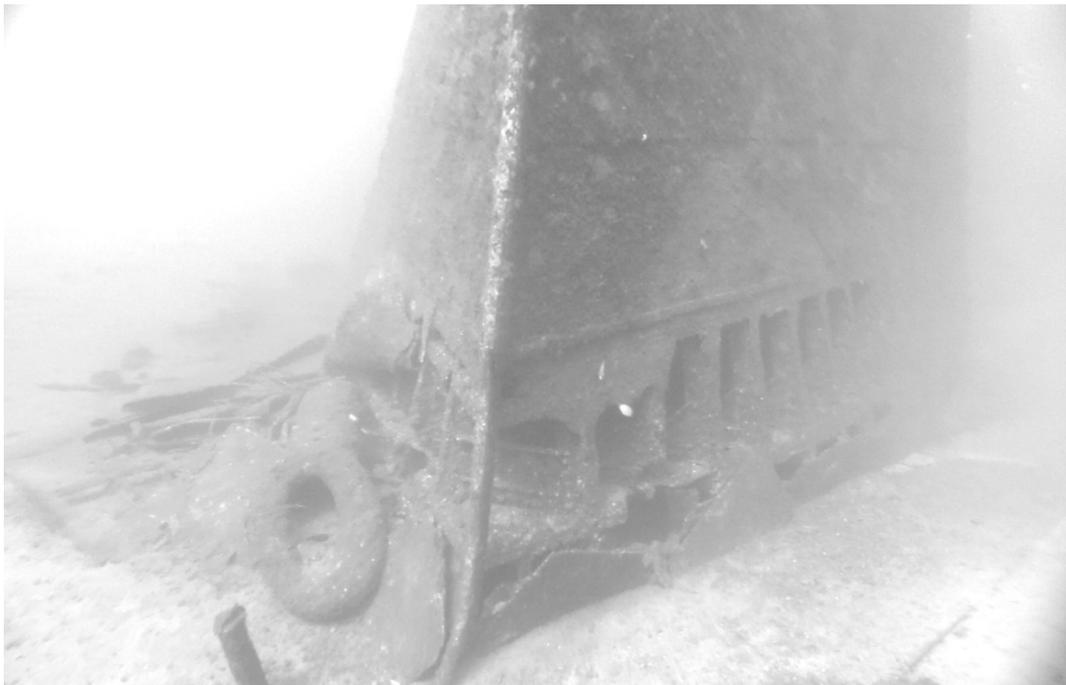
Figure 12 - Bow showing missing plating

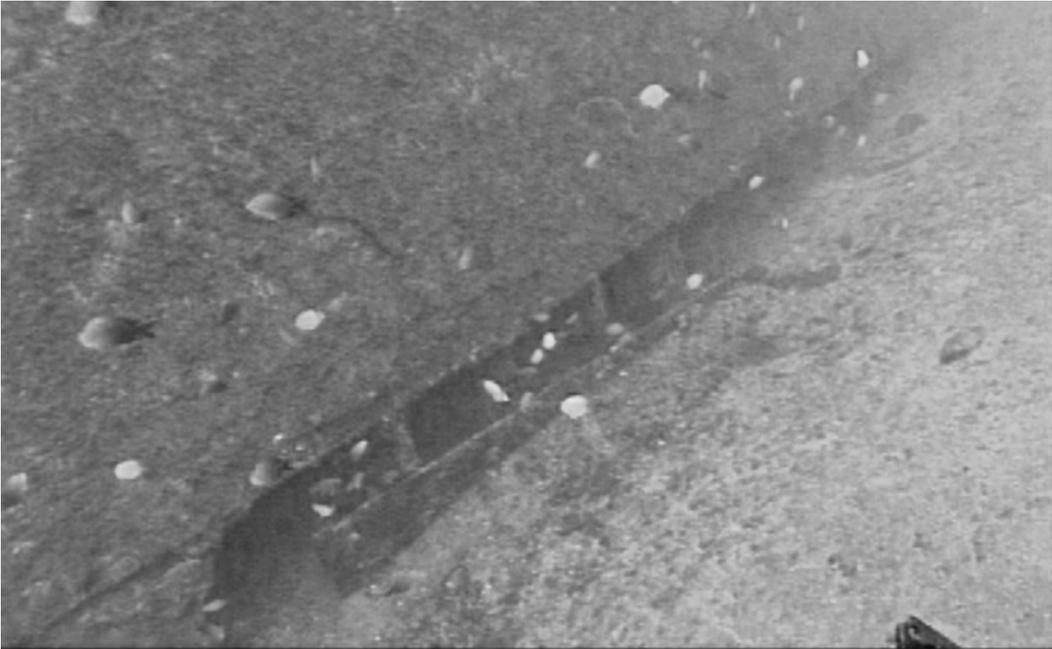
124. Above the unsupported area, there is some laminar corrosion, though no cracking was evident.

Figure 13 - Unsupported area, No.9 tank

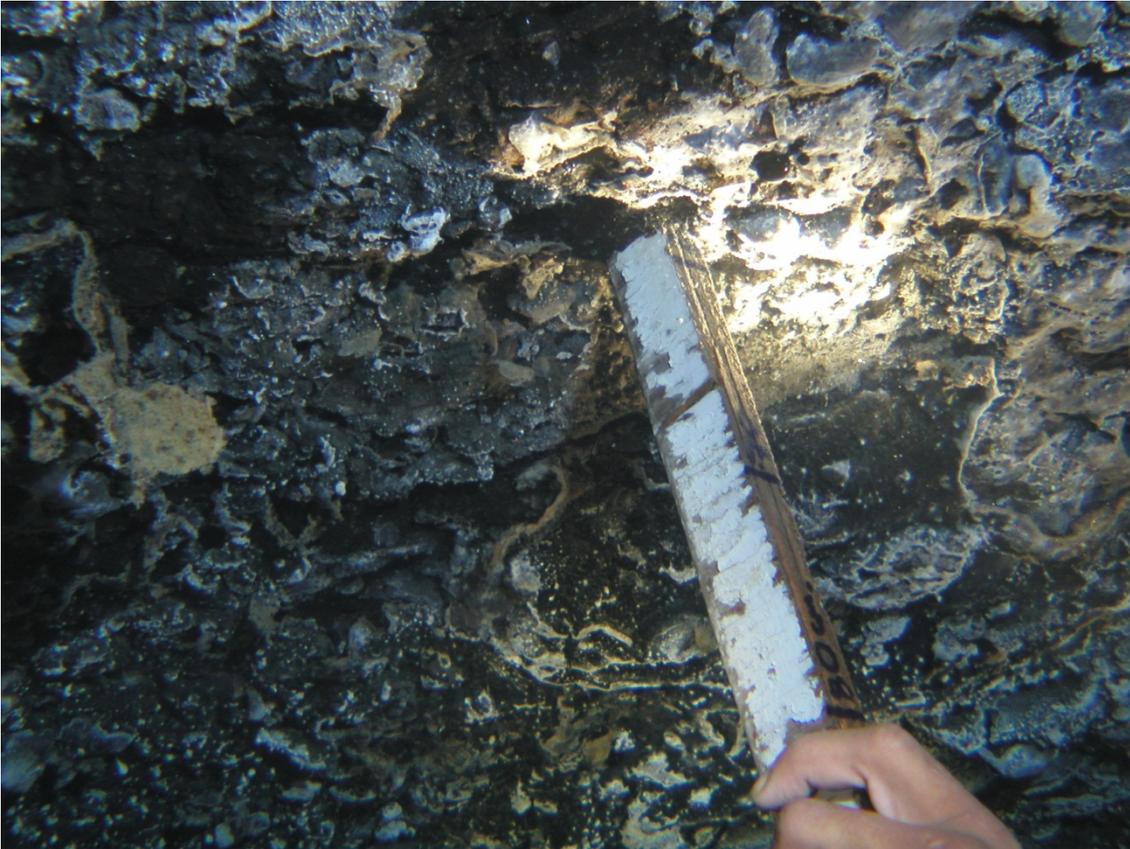
140. If oil is trapped in the port tank, it is probable that oil will also be trapped in the centre and starboard tanks. Combined there could be 100 m³ of oil within this space.

Figure 14 – Divers picture of oil inside No. 4 tank

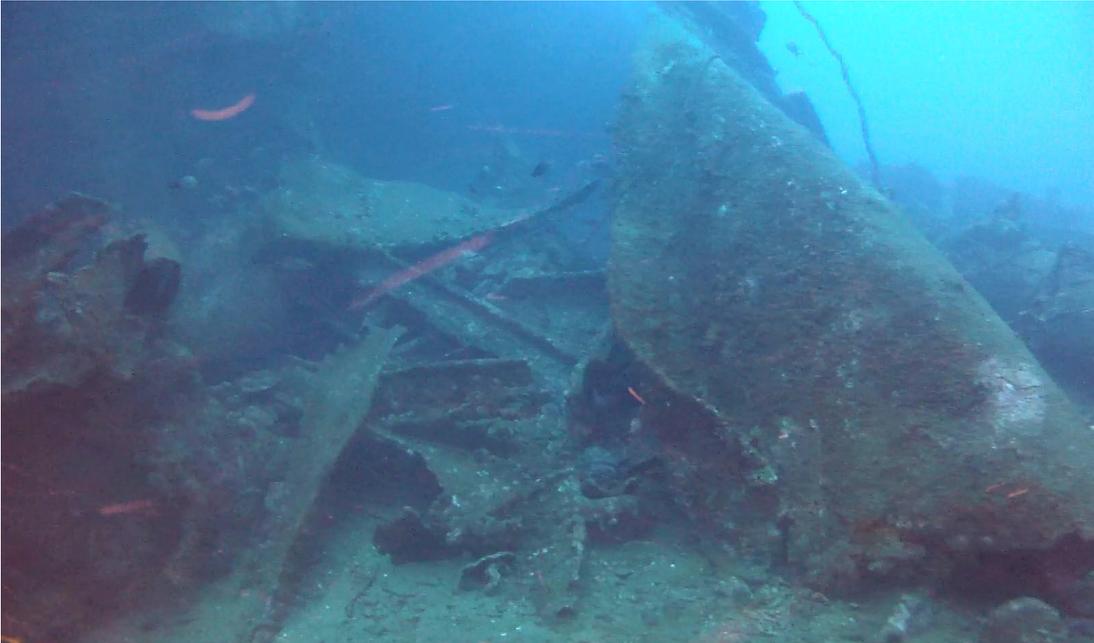
171. As the forward end of this tank is open to the sea, no significant oil remains within the space. It is possible that small amounts of residue remain within the tank, trapped behind the remaining structure but none was sighted by the ROV.

Figure 16 – Shell plating from Aft Pump Room on the seabed

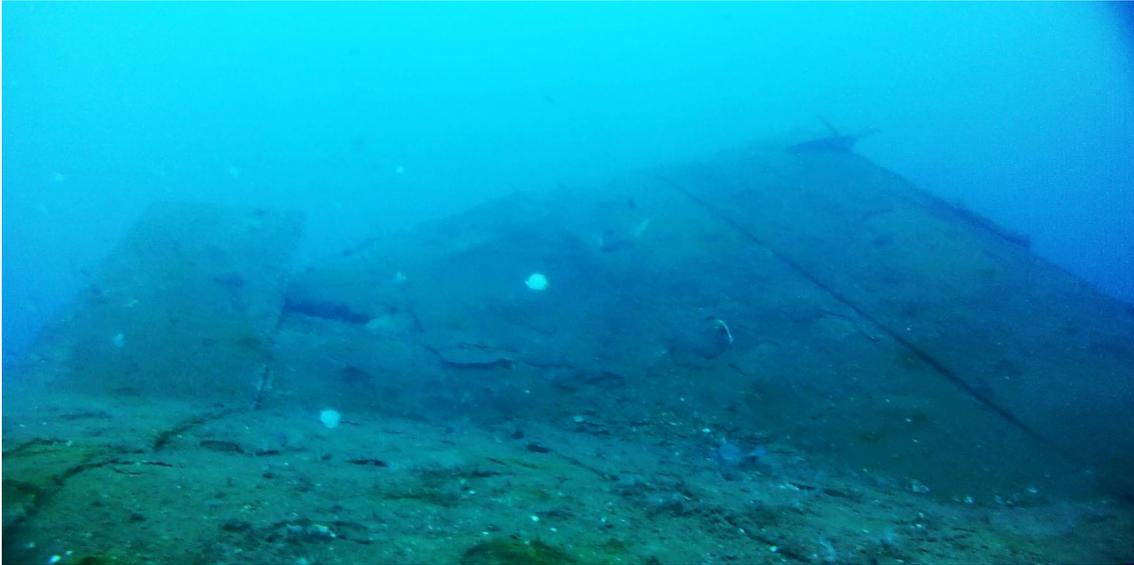
178. The starboard shell plate is perforated in the region of frame 41A, 3 m from the keel with a piece of shell plate detached on 3 sides and bent away from the frames at frame 44A.

Figure 17 - Damage to No. 1 tank – plating bent away from the frames.

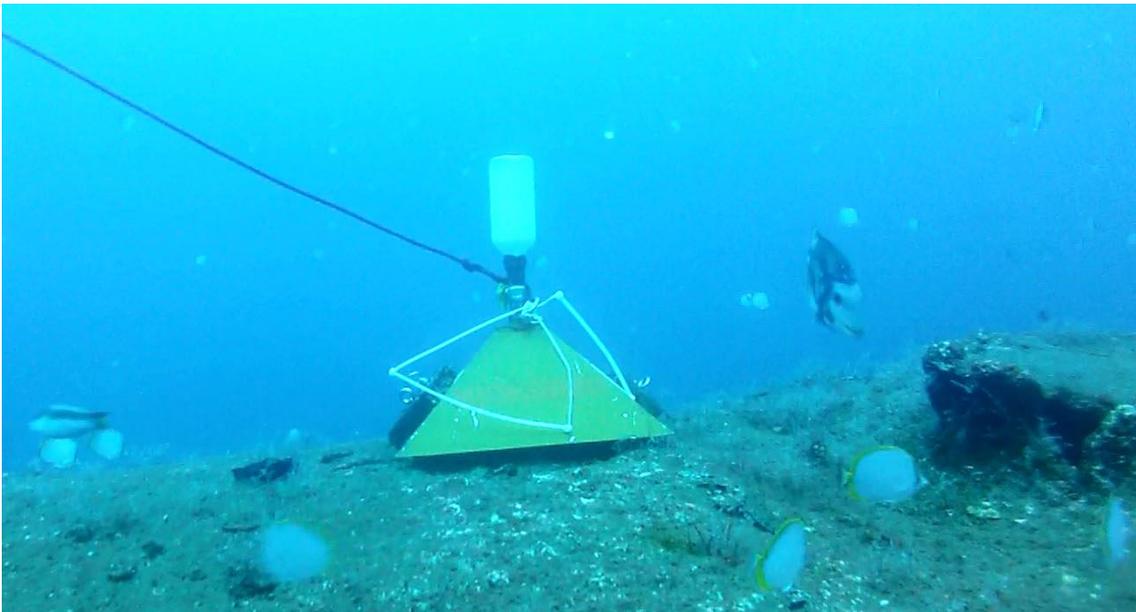
182. The leakage rate from this sampling method was recorded as 900 ml/day but it is known from local reports that the extent of the sheen does vary. However this rate is believed to be typical of the average rate of leakage.

Figure 18 – Top hat oil sample collector

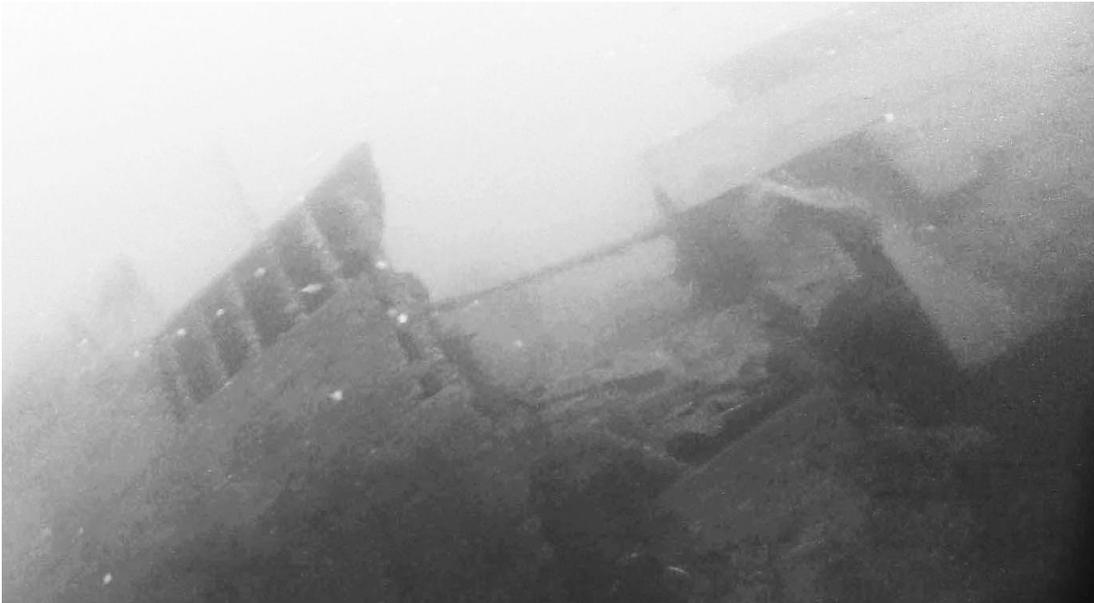
190. Above and aft of the Main Engine Room is the Boiler Flat. The shell plating in this area is missing and the supporting structure has collapsed, exposing the boilers contained within. The boilers and exhausts are still in place on their mountings and appear to be in good condition.

Figure 19 - Starboard side of Boiler Flat

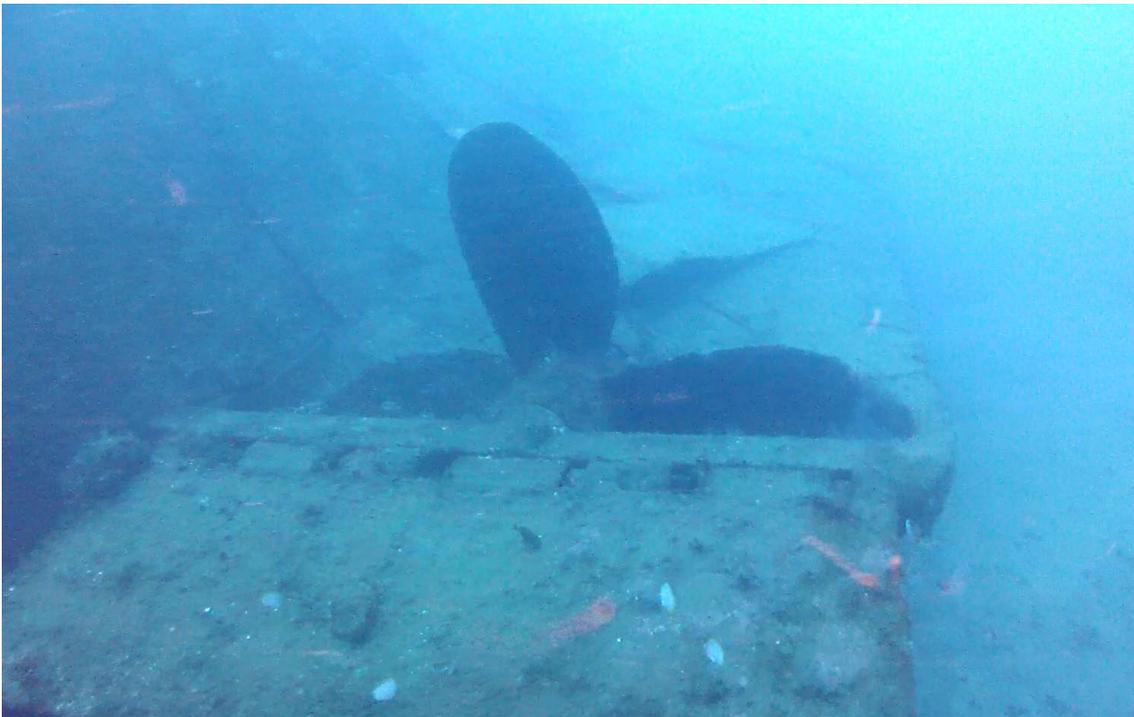
192. The shaft area extending back to the propeller and rudder are undamaged. The rudder is in the amidships position and the four blade propeller is in place. Just forward of the propeller are two pieces of shell plate that have fallen, most probably from the boiler flat above.

Figure 20 - Rudder and propeller

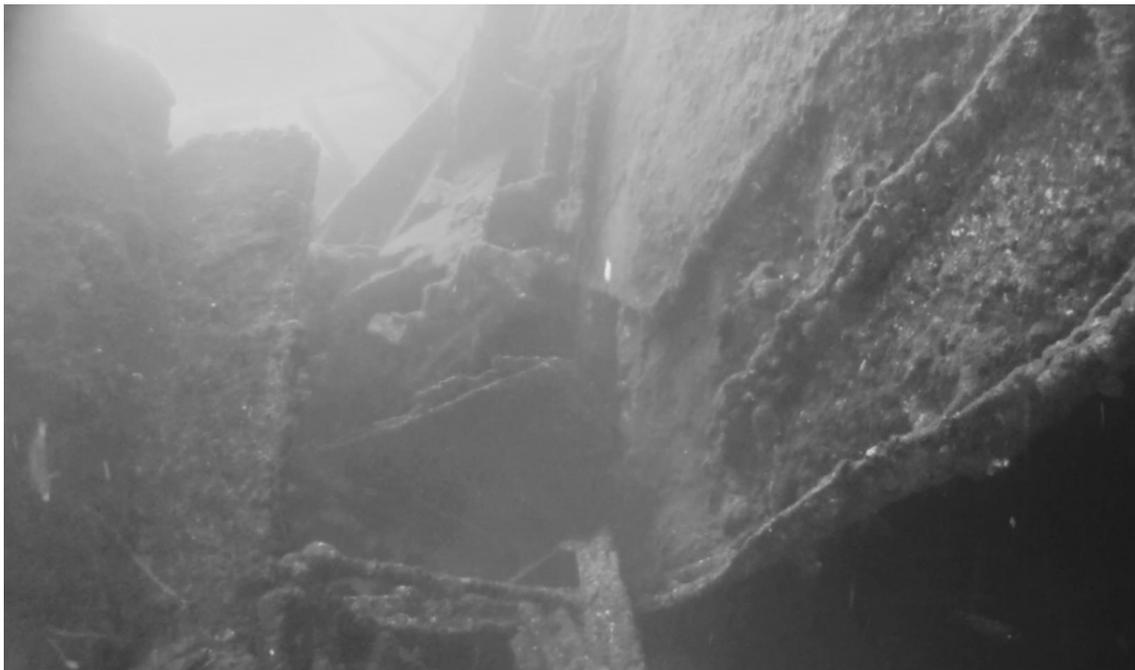
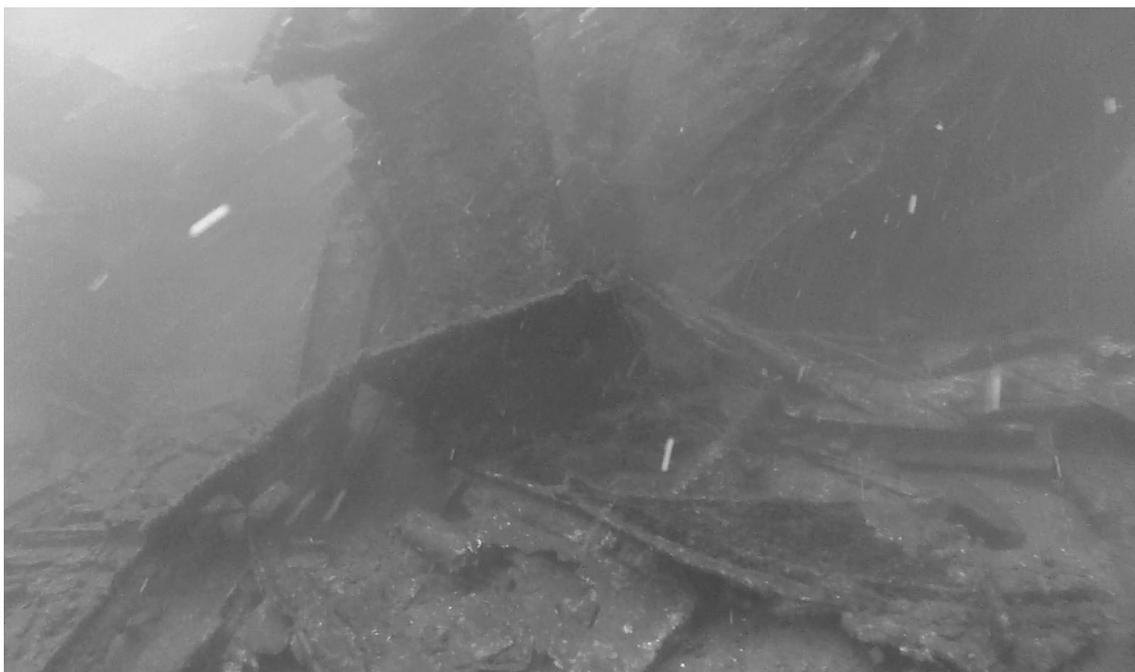
Figure 21 – Collapsed crew accommodation

Figure 22 - Collapsed crew accommodation

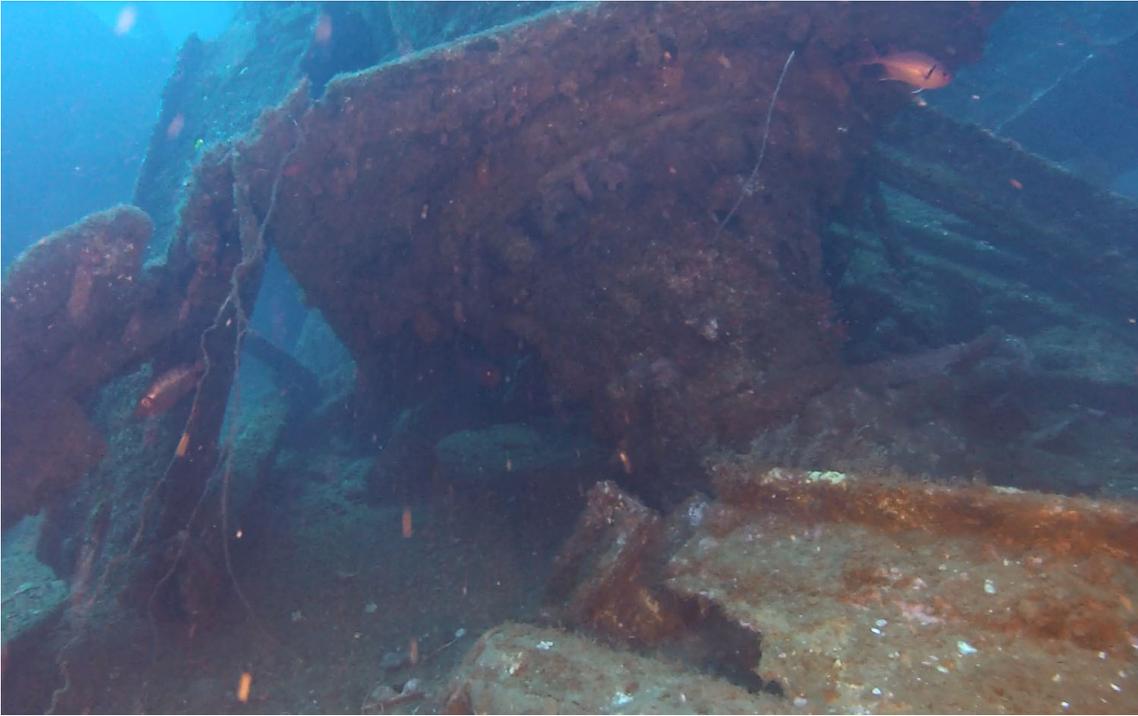
Figure 23 – Gun mount, detached and inverted

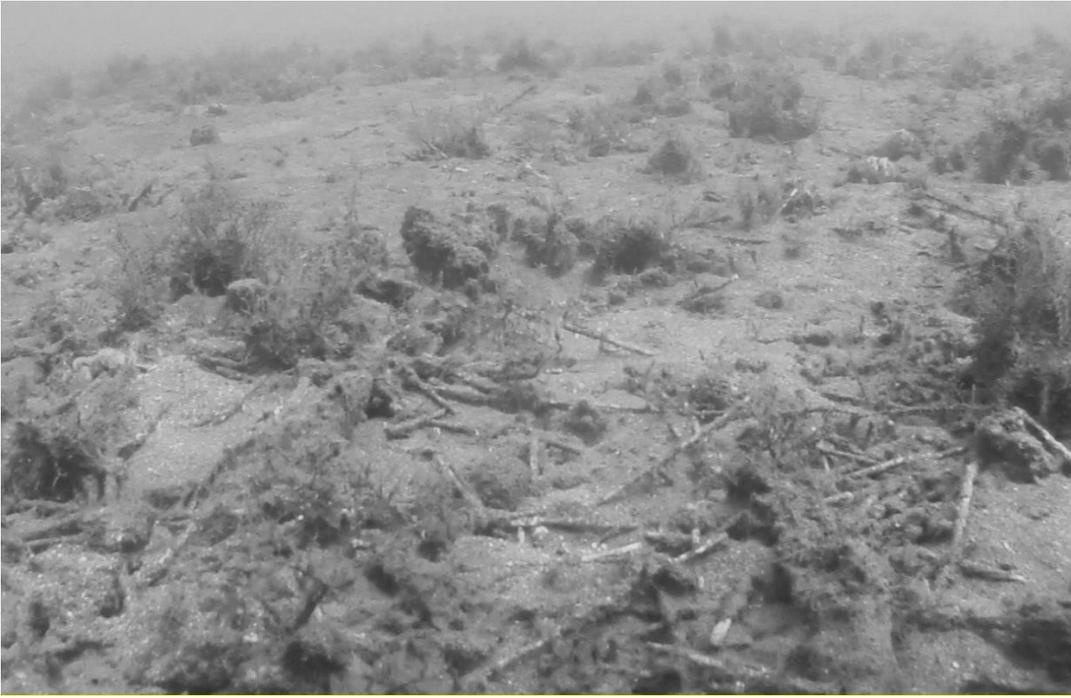
205. In the area immediately surrounding the bow, lengths of Cordite can be found lying on the seabed. The cordite will have been stored in the forward magazine as a firing charge for the 4.7 inch gun. Originally it would have been contained in silk bags but the bags are no longer apparent allowing the cordite to scatter on the seabed.

Figure 27 - Cordite strands on seabed

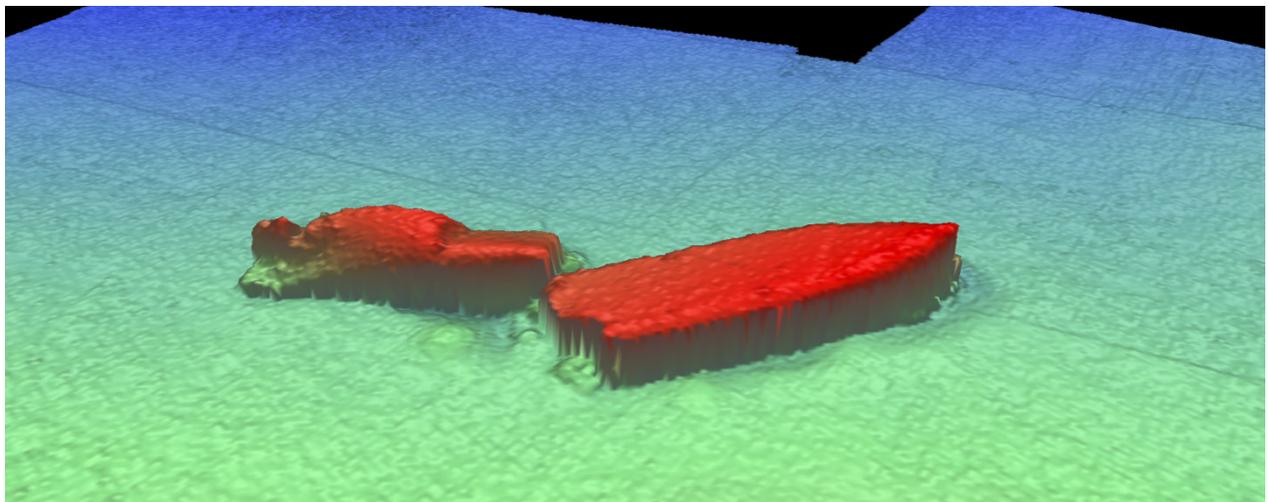
Figure 6 – Multibeam image of the wreck site looking north west, note the partial slumping of the starboard side of the aft section discussed below, the near absence of a debris field on this side of the wreck and the virtually flat seabed

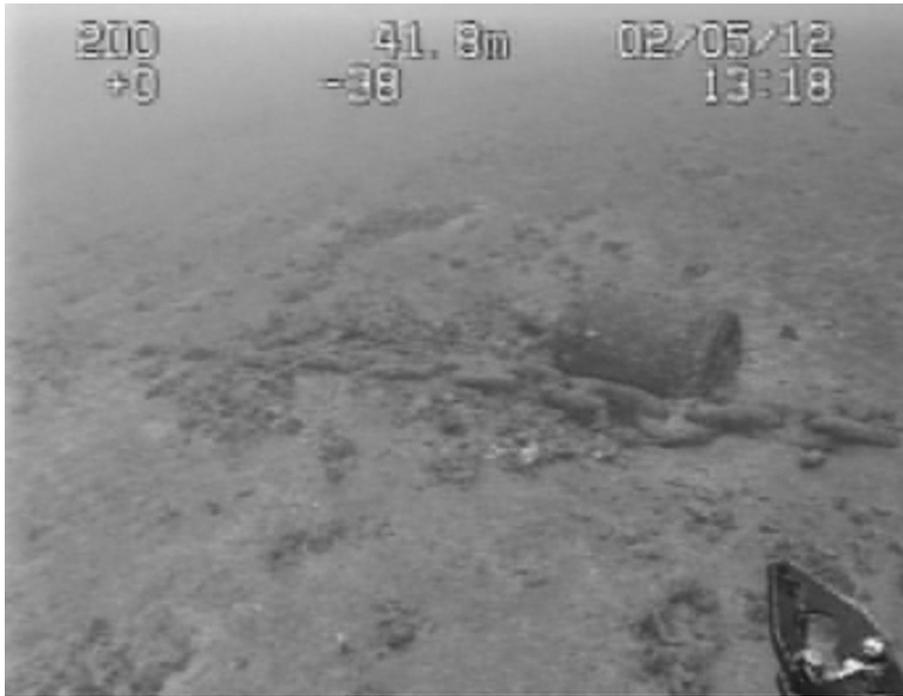
Figure 10 – Damaged barrel lying alongside the anchor chain – one of four lying close by and believed to have been part of the cargo of lubricating oil carried in barrels on the deck of the *Darkdale*

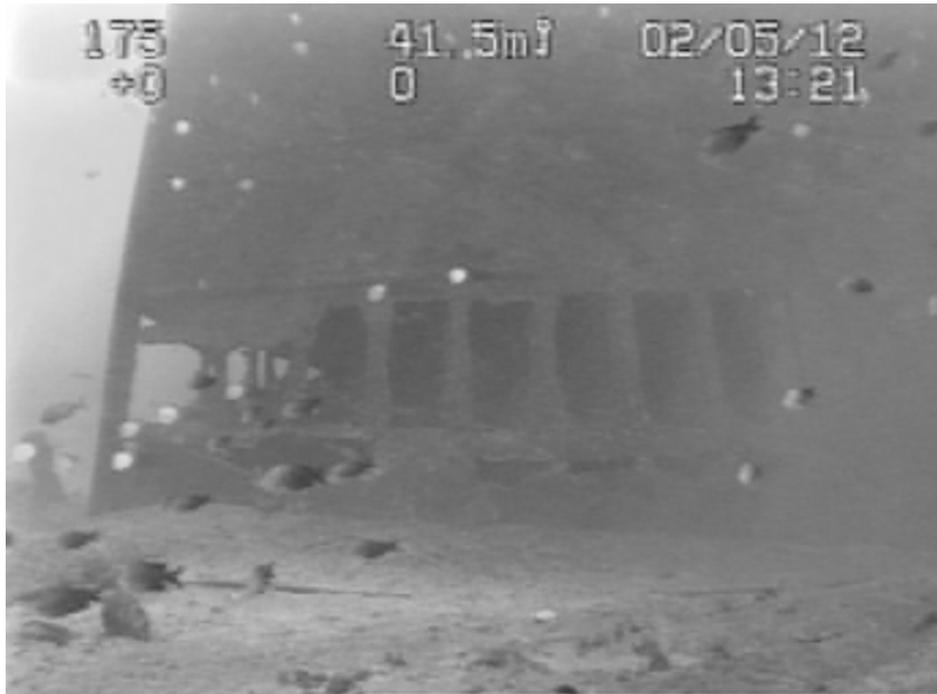
Figure 12 – The starboard side of the ship's stem showing the missing plates in the vicinity of the forward paint locker

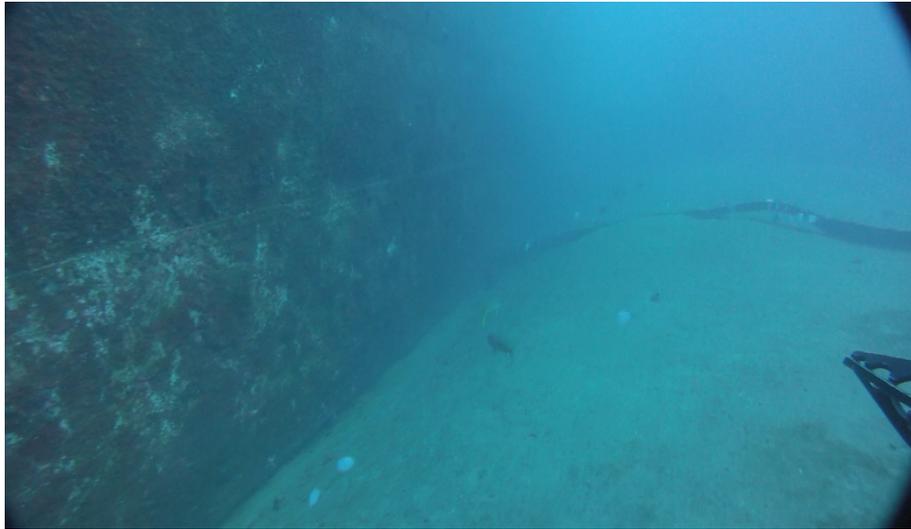
Figure 13 – Bow section, starboard side with a detached section of bilge keel on the seabed

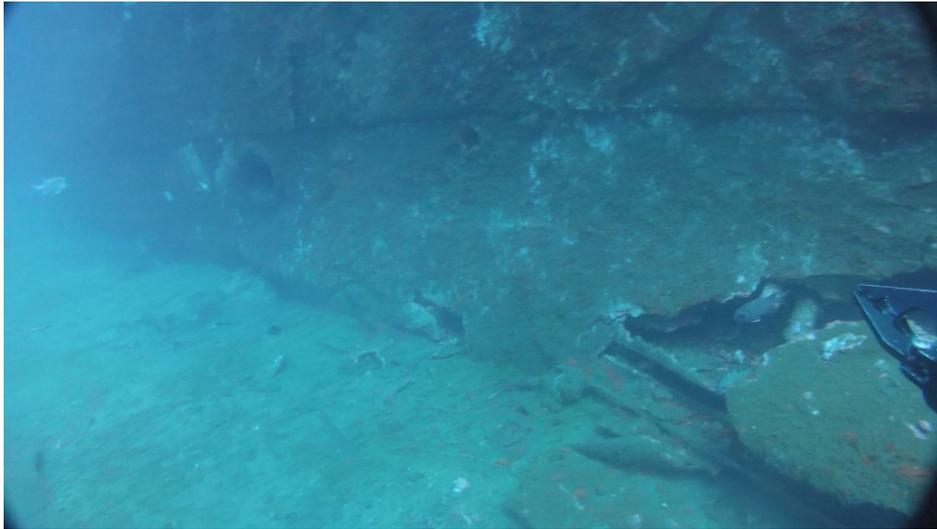
Figure 14 – Bow section, port side showing damage to the bulwark in the vicinity of the now vanished bridge

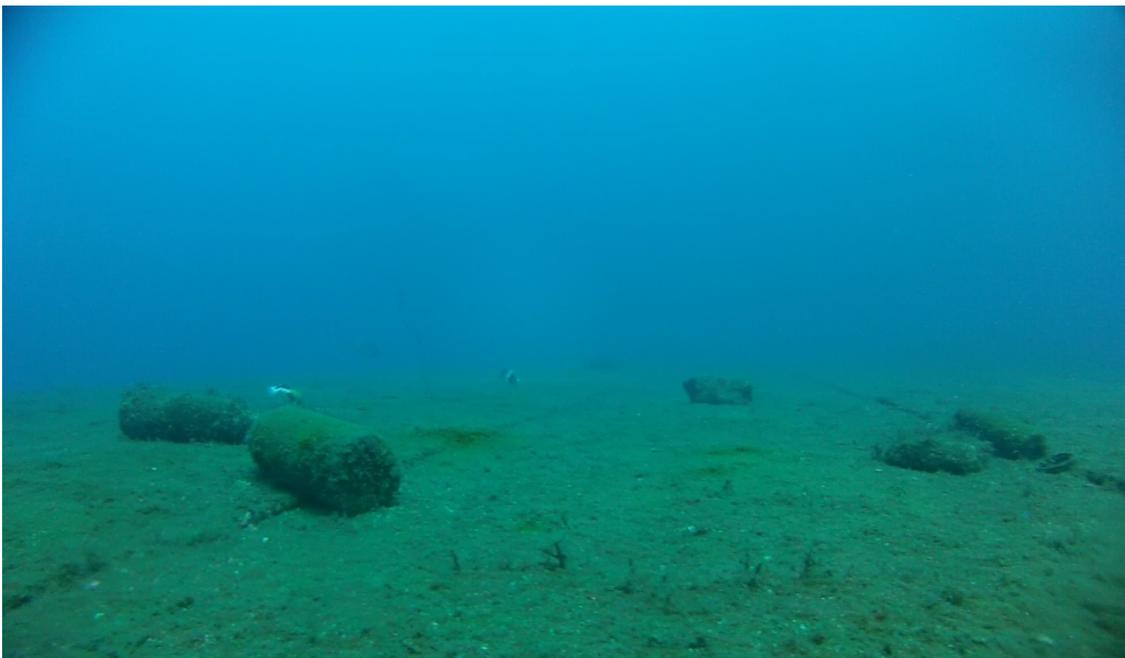
Figure 15 – Shells lying on the upturned bow section

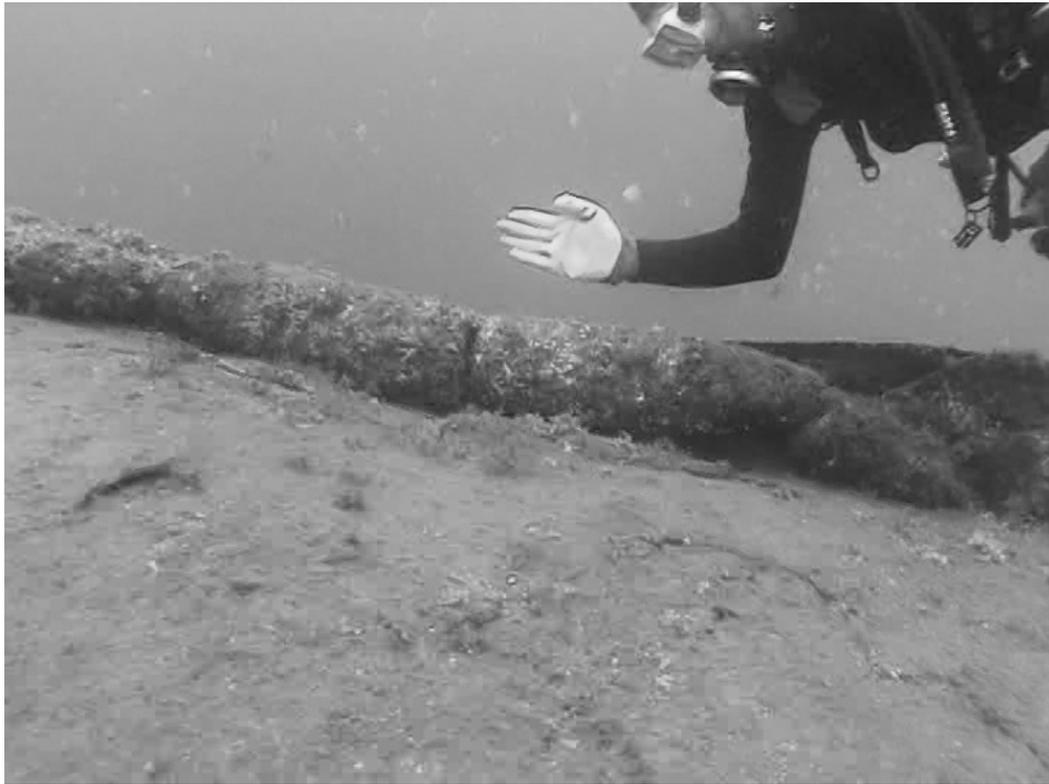
Figure 16 – Shells lined up along the bilge keel on the upturned bow section

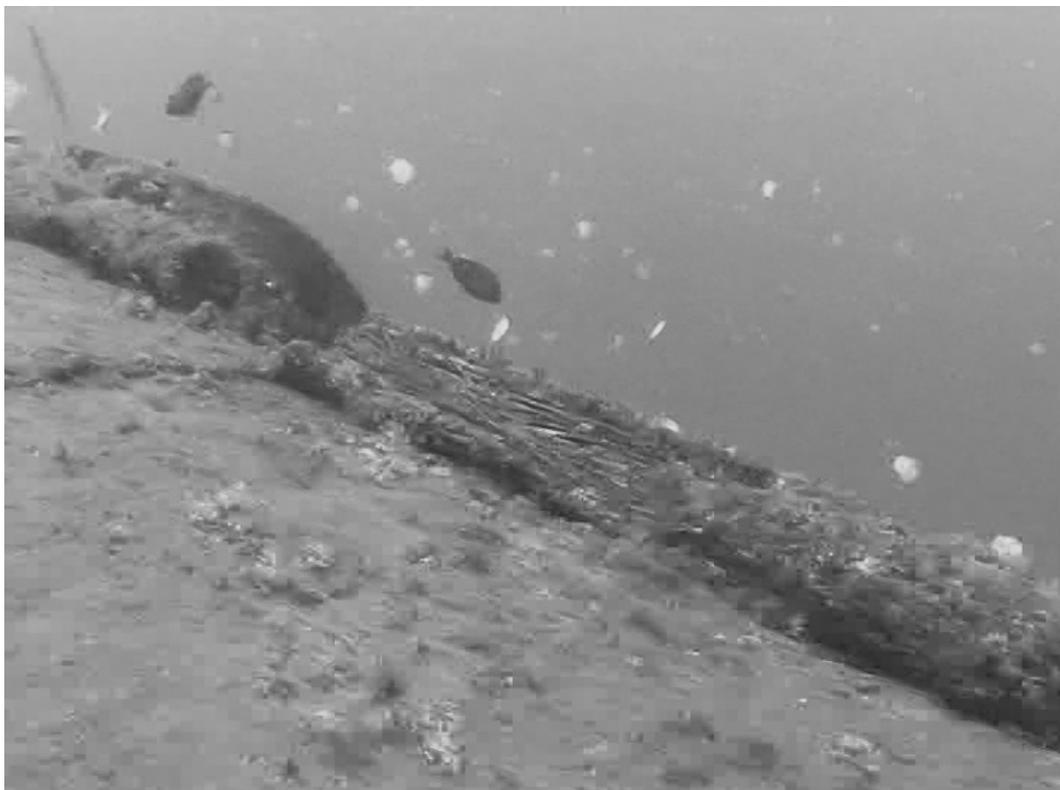
Figure 17– Bundles of cordite rods amongst the shells lining the bilge keel – believed to be the remains of cartridges

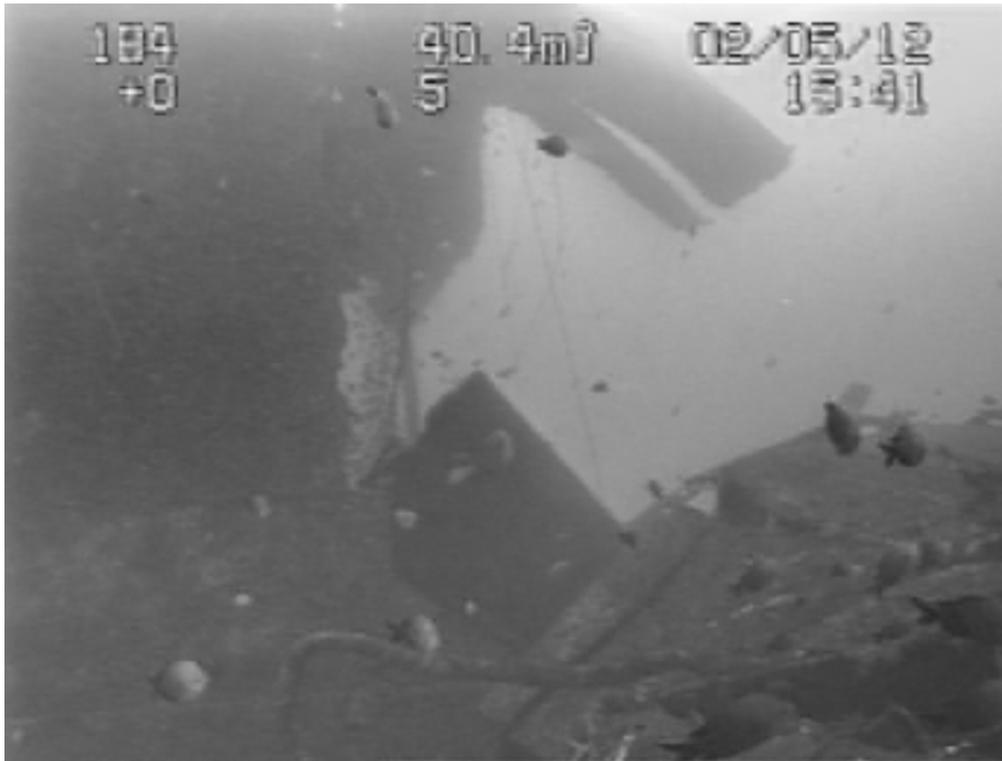
Figure 18 – View of the starboard side of the bow at its aft end with the plates of the ship's bottom overhanging the break zone

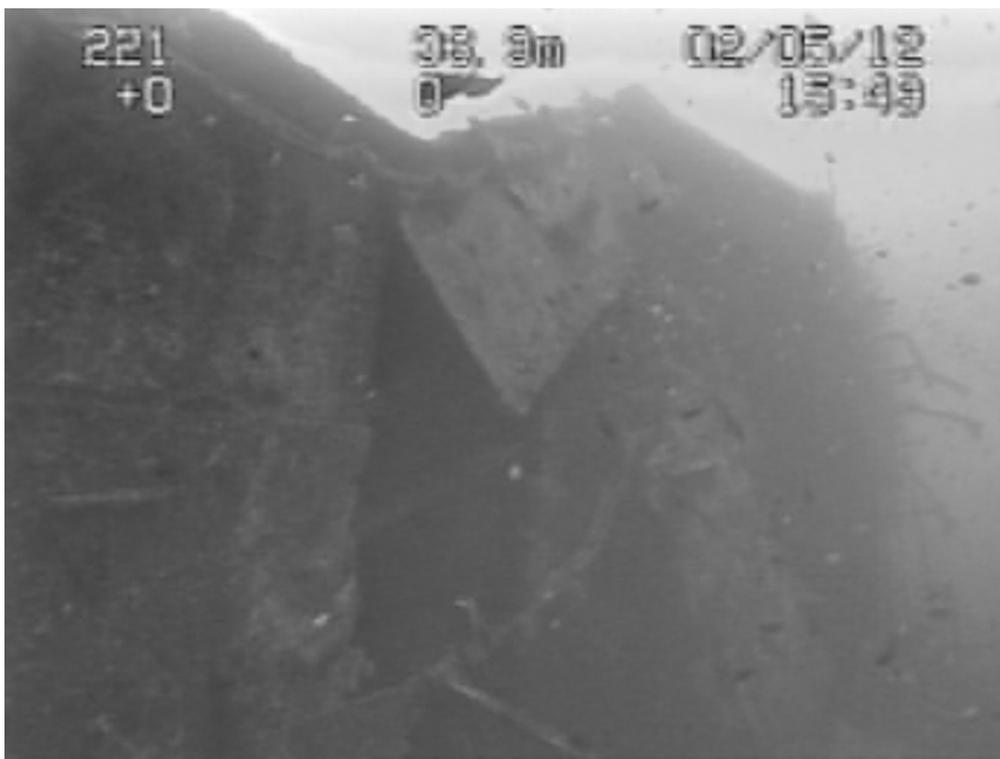
Figure 19 – View of the vertically orientated stern section of the wreck taken during the 2012 survey looking aft towards the remains of the poop deck – note the hole over no.1 cargo tank and the distortion in the alignment of the starboard side

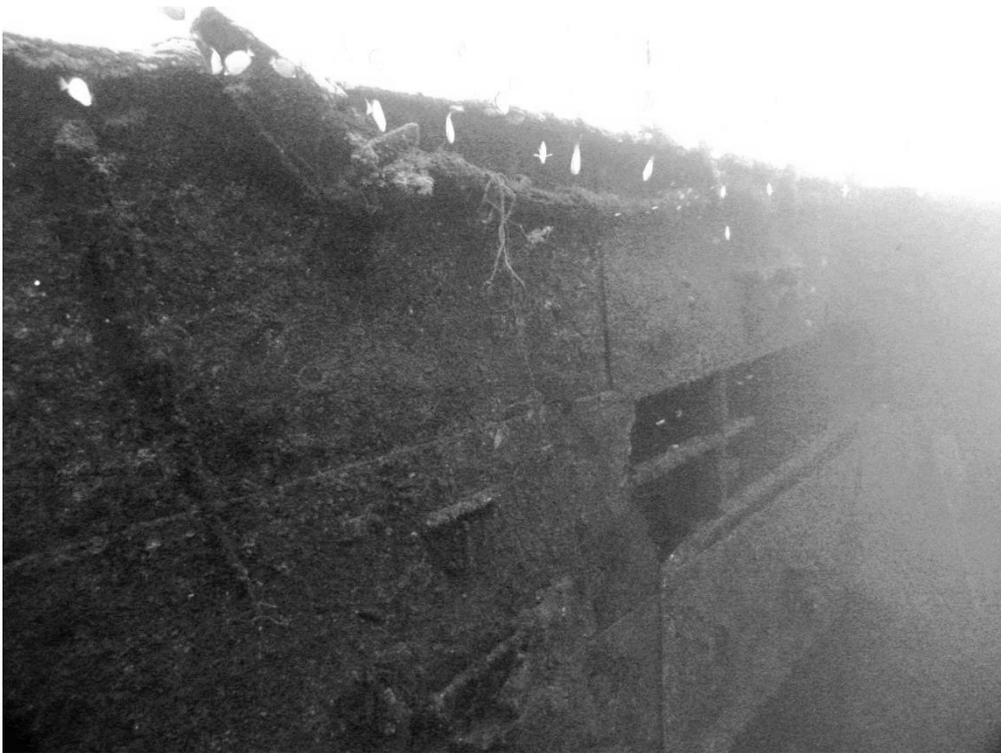
Figure 20– View of approximately the same area as in figure 19 taken during the 2002 visit to the wreck by the RAF Dive Club. Note the lack of distortion to the hole over no.1 cargo tank and the starboard side of the vessel in its correct alignment

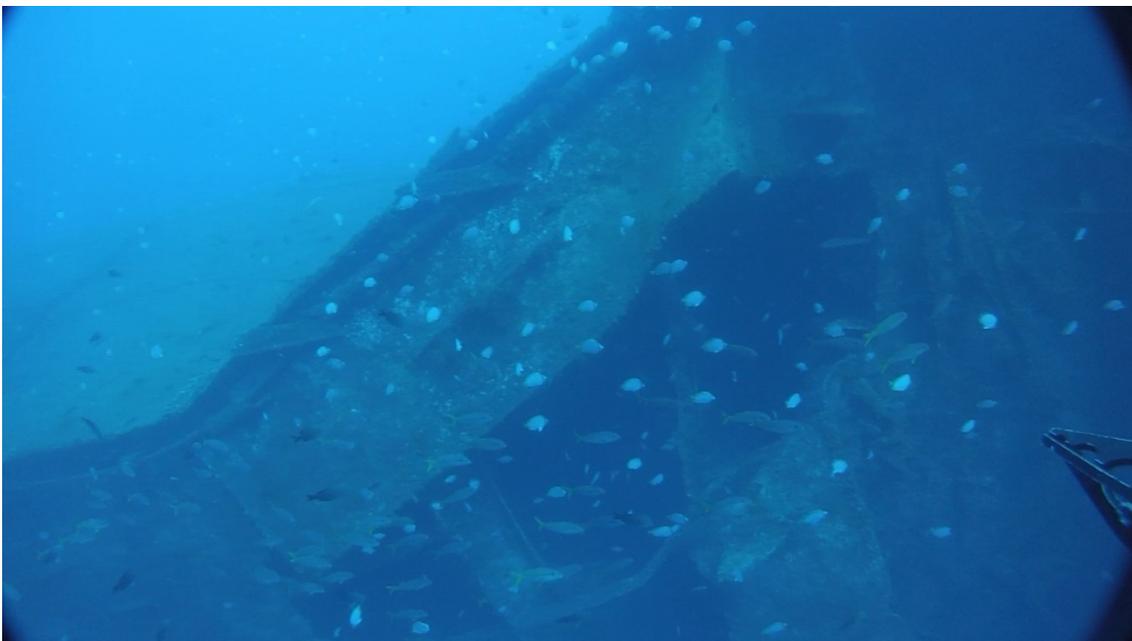
Figure 21 – View from the poop deck taken during the 2012 survey looking forward– note the obvious distortion to the starboard side that has occurred in the 10 years since the visit of the RAF Dive Club

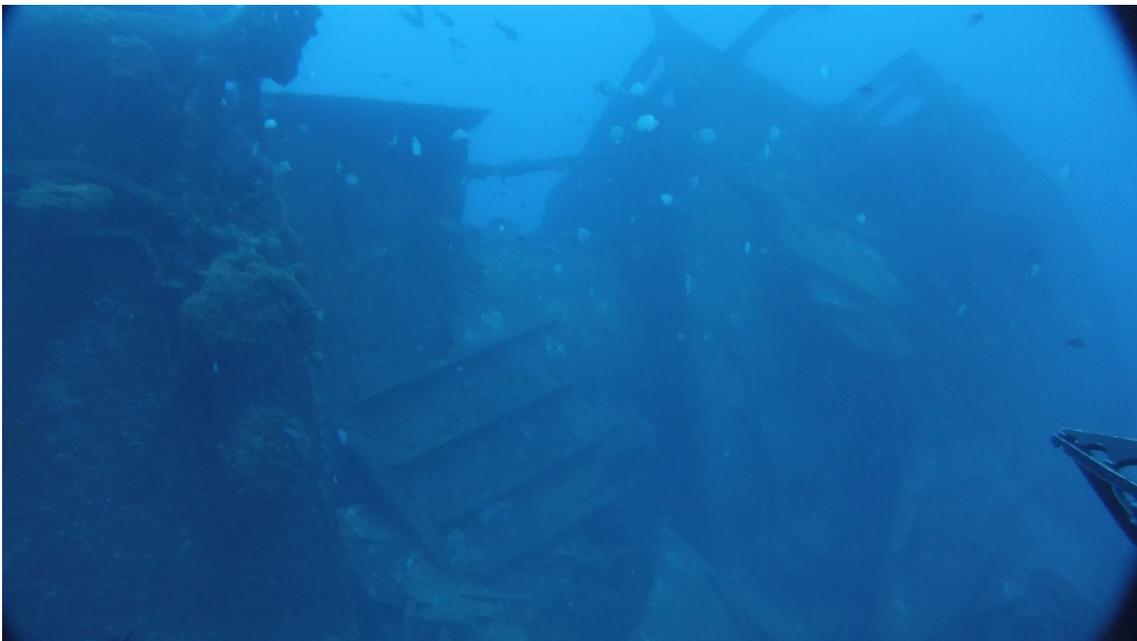
Figure 22 – View of the triangular split tapering from its widest point on the starboard gunwale down the vertical deck of the stern

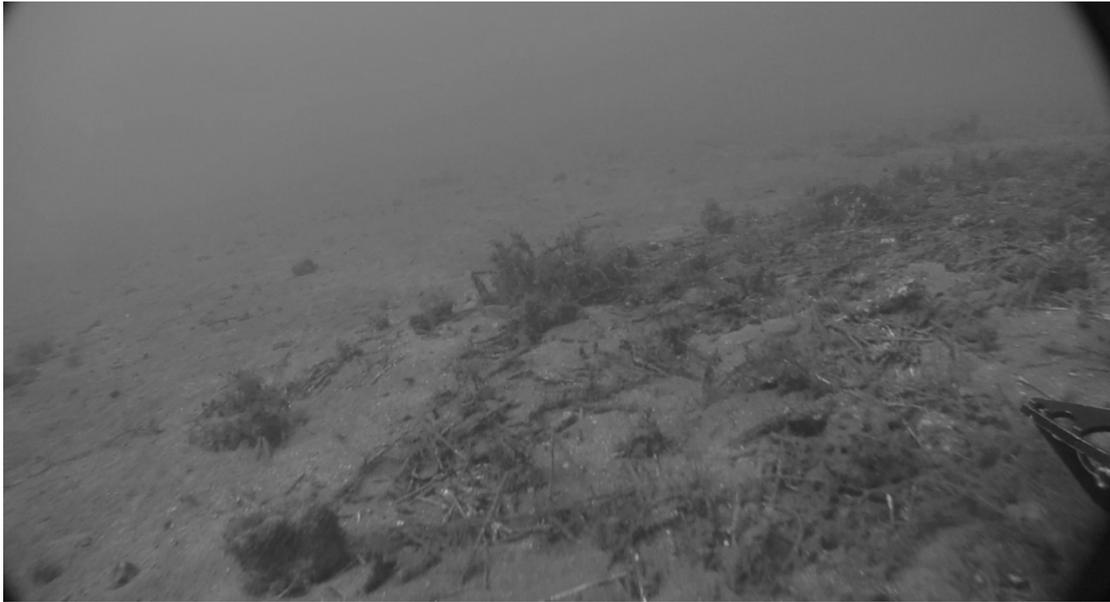
Figure 23 – Cordite rods on the north side of the stern
