RFA DARKDALE SURVEY

SALVAGE AND
MARINE
OPERATIONS

SURVEY REPORT

This document was prepared following the survey of *RFA Darkdale*, at St Helena in 2012 by Salvage and Marine Operations.

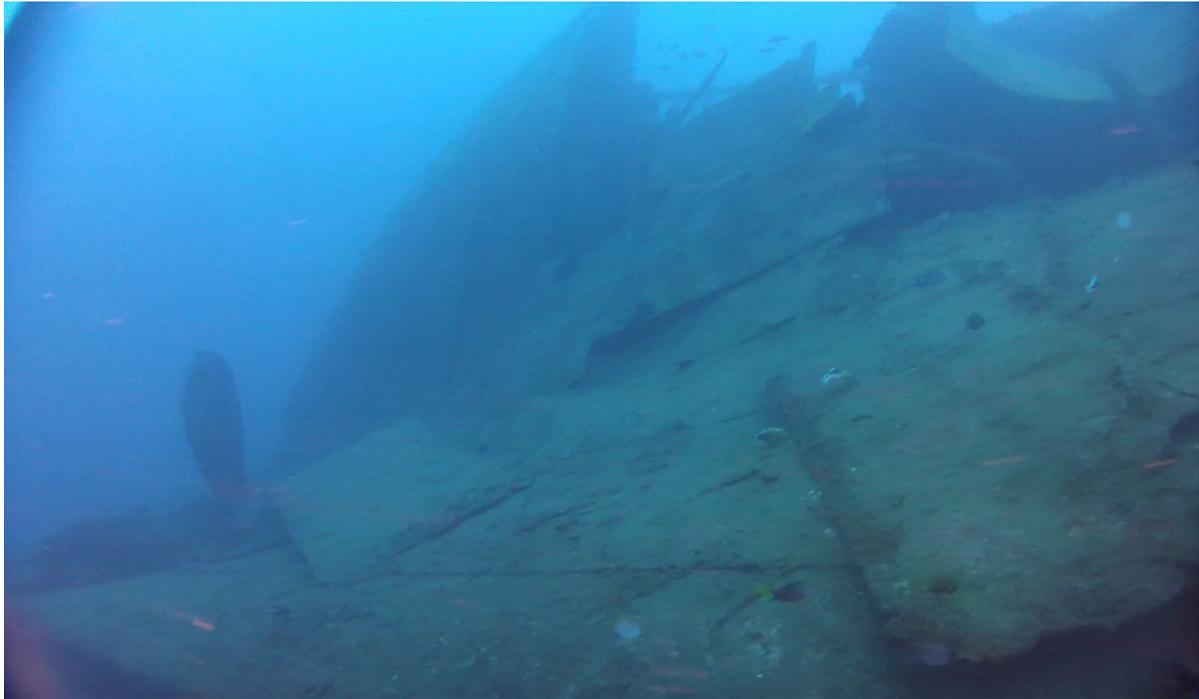
Figure 24 – Damage to the starboard side in the vicinity of frame 80 – this adjoins the triangular split running down the deck shown in figure 22
