**ST HELENA AIRPORT PROJECT  
ANNUAL ENVIRONMENTAL REPORT 2015-16**

**January, 2017**

**Prepared by  
Bryony Walmsley  
CEMPC**

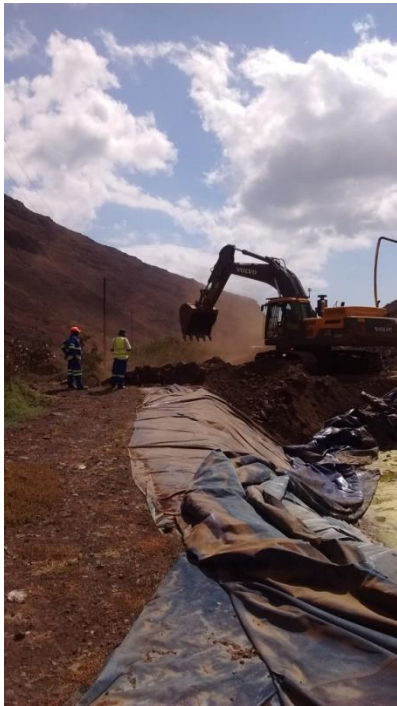
**Plate 5: Scattered human bones were found during removal of the temporary reservoir in Rupert's Valley. Work stopped immediately as per CEMP**

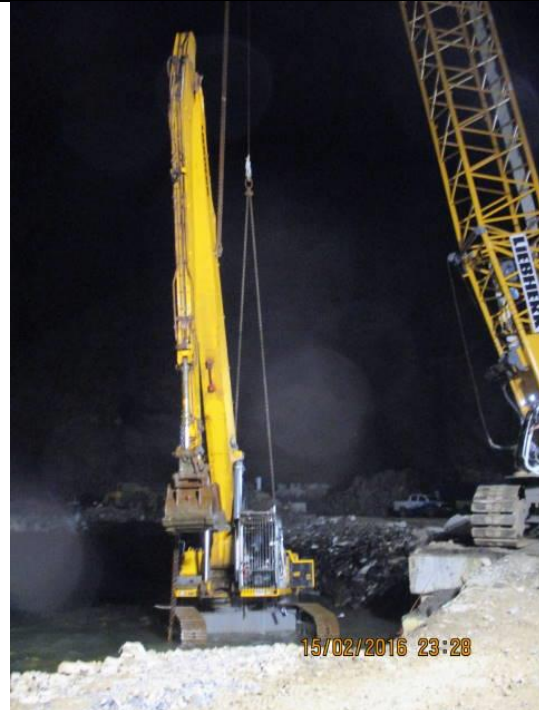
**Plate 6: An excavator fell into the sea at the permanent wharf. Oil spill protection was deployed immediately as per CEMP**

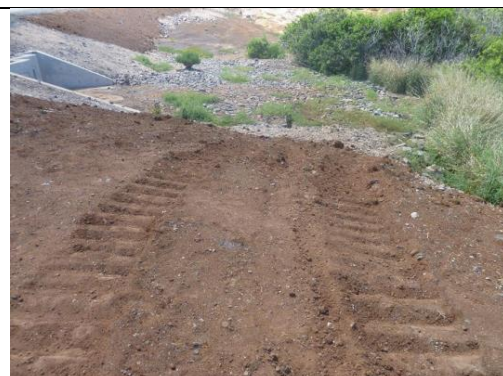
Non-conformance Notice being issued by PMU when a tracked vehicle travelled off road from the Southern Plateau of Prosperous Bay Plain near Tank 6 to Bradley's Workshop to avoid the newly laid Cape Seal road surface without permission. The vehicle travelled off road along the Southern Plateau through the rehabilitation plot on Tungi Flats, down the slope along the above-ground power line into Fisher's Valley, across the airport access road and over another rehabilitation plot in Fisher's Valley watercourse (Plate 8), and then up the slope to Bradley's Workshop.

**Plate 8: Tracks of the excavator driving illegally through a rehabilitation plot in Fisher's Valley**

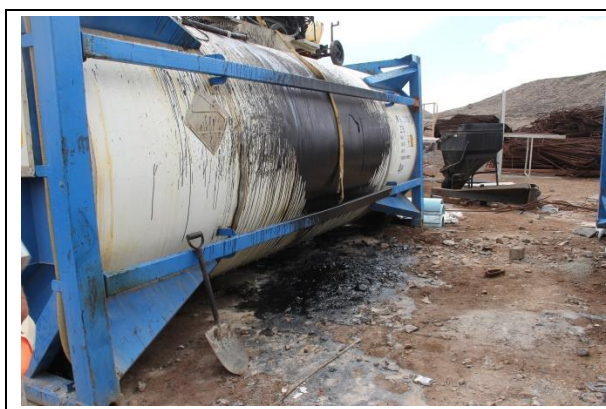
Disappointingly there was a significant increase in the number of major findings observed during the February 2016 audit – from 5 in the September 2015 audit to 18, reversing the improving trend since September 2013 (Figure 7). Eight of the major findings concerned bitumen management and related waste disposal by sub-contractors, underlying the need for greater environmental management oversight of all sub-contractors working on the project (Plate 9).

**Plate 9: Poor bitumen management was observed in several places during the February 2016 audit**

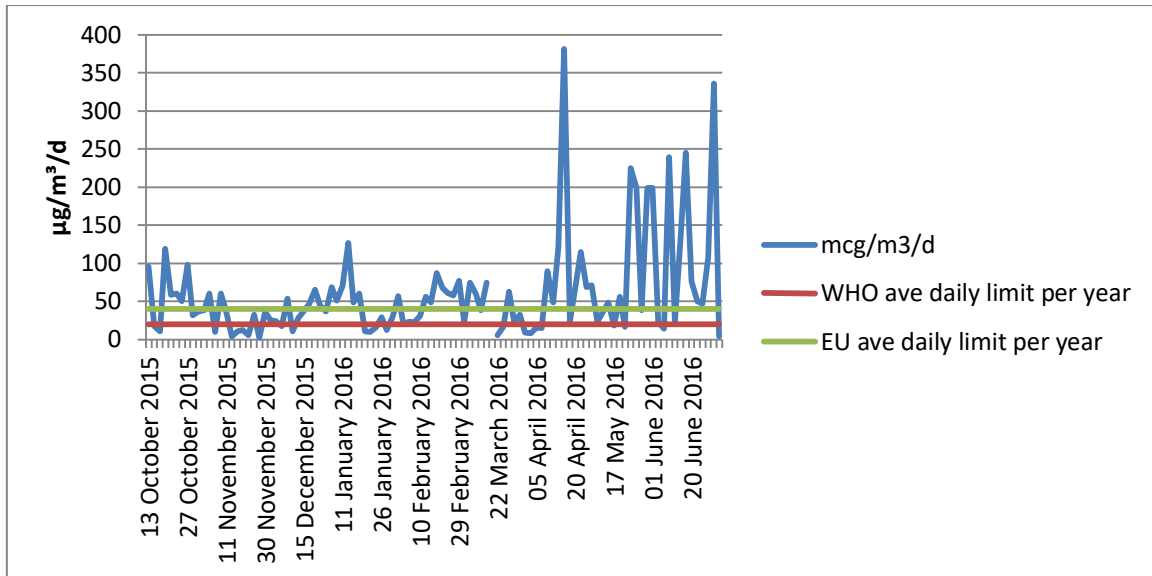
Figure 12: PM10 readings from Rupert's Valley

From Figure 12 it can be seen that respirable dust levels in Rupert's Valley have been consistently over both guideline limits during the past year. The high level of dust was raised as a major finding in both the September 2015 and February 2016 audits and increased efforts were made to reduce dust concentrations on the public road through the valley (e.g. speed reduction, increased use of water bowsers, road repairs, etc.), but high construction traffic volumes, drought conditions and other construction works in close proximity to the residential area, have continued to cause high respirable dust levels.

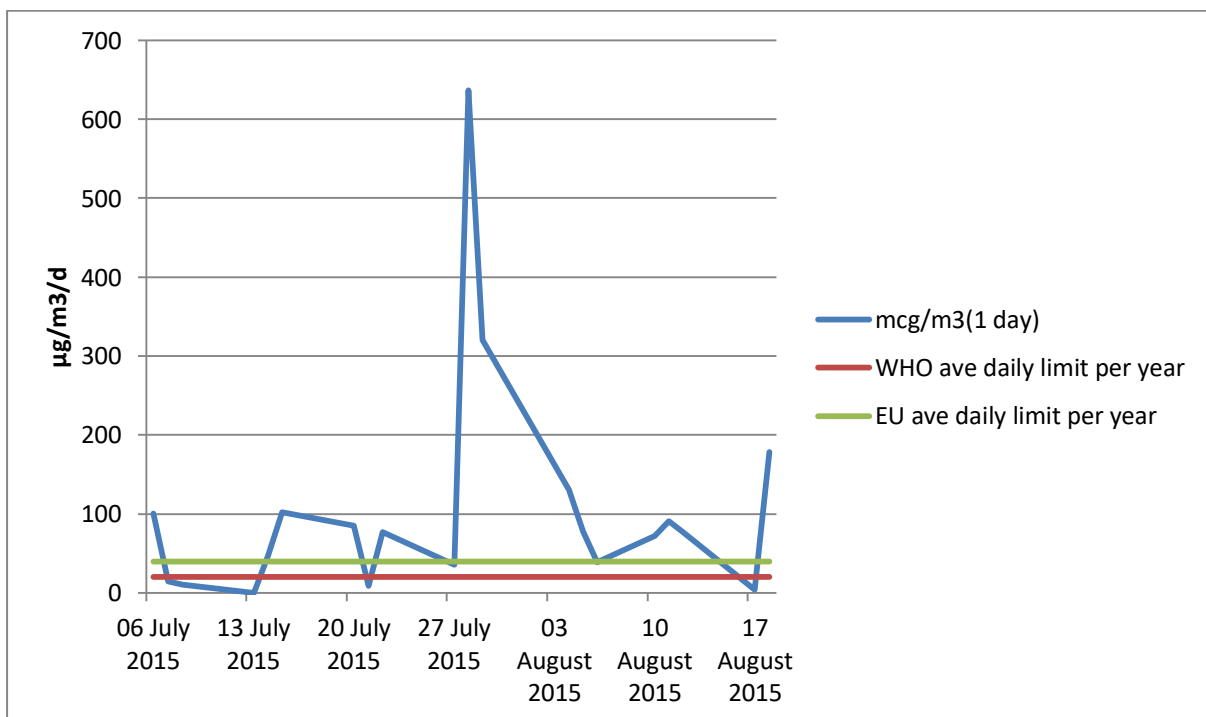
Figure 13: PM10 in Central Basin during runway grooving

Figure 13 shows that significant amounts of fine dust were generated during the runway grooving exercise, but there are no human receptors in Central Basin for there to have been any adverse health effects. Fortunately, the grooving operations only lasted for 6 weeks and the impact on fauna and flora was minimal (pers. comm. SHNT).

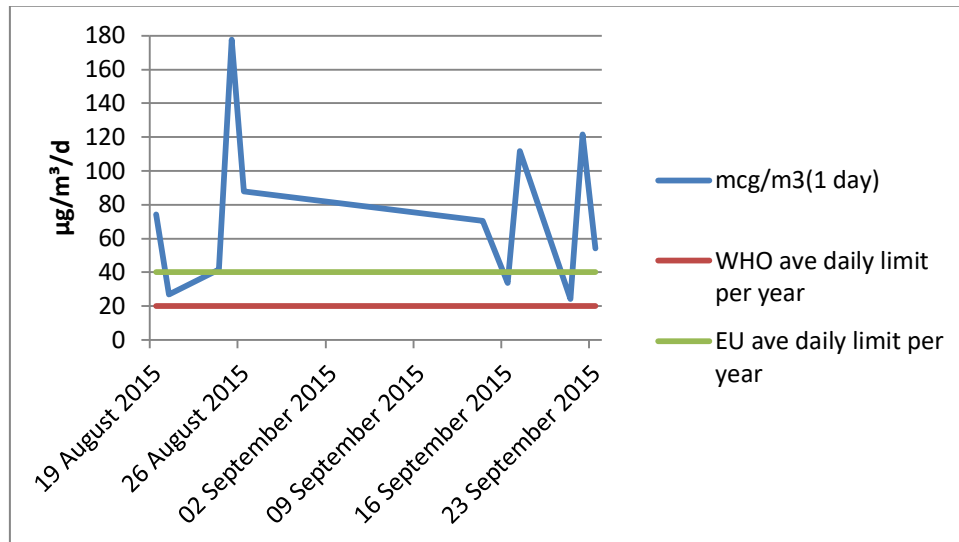
Figure 14: PM10 dust levels at the Met Station during incinerator commissioning

The incinerator at Horse Point landfill was commissioned during the period 11<sup>th</sup> August to 5<sup>th</sup> September with intermittent burning throughout this period and going forward. No correlation between incinerator operation and PM10 levels at the Met station could be drawn - the August spike in PM10, shown in Figure 14 above, occurred prior to the first burn and the first September spike occurred on a day when the incinerator was not operating, while the second spike does coincide with operations (Figure 14). However there are other days when it was burning and PM10 levels were less than 40 µg/m<sup>3</sup>/d. The dust is more likely to be from crushing operations at Horse Point quarry than the incinerator.

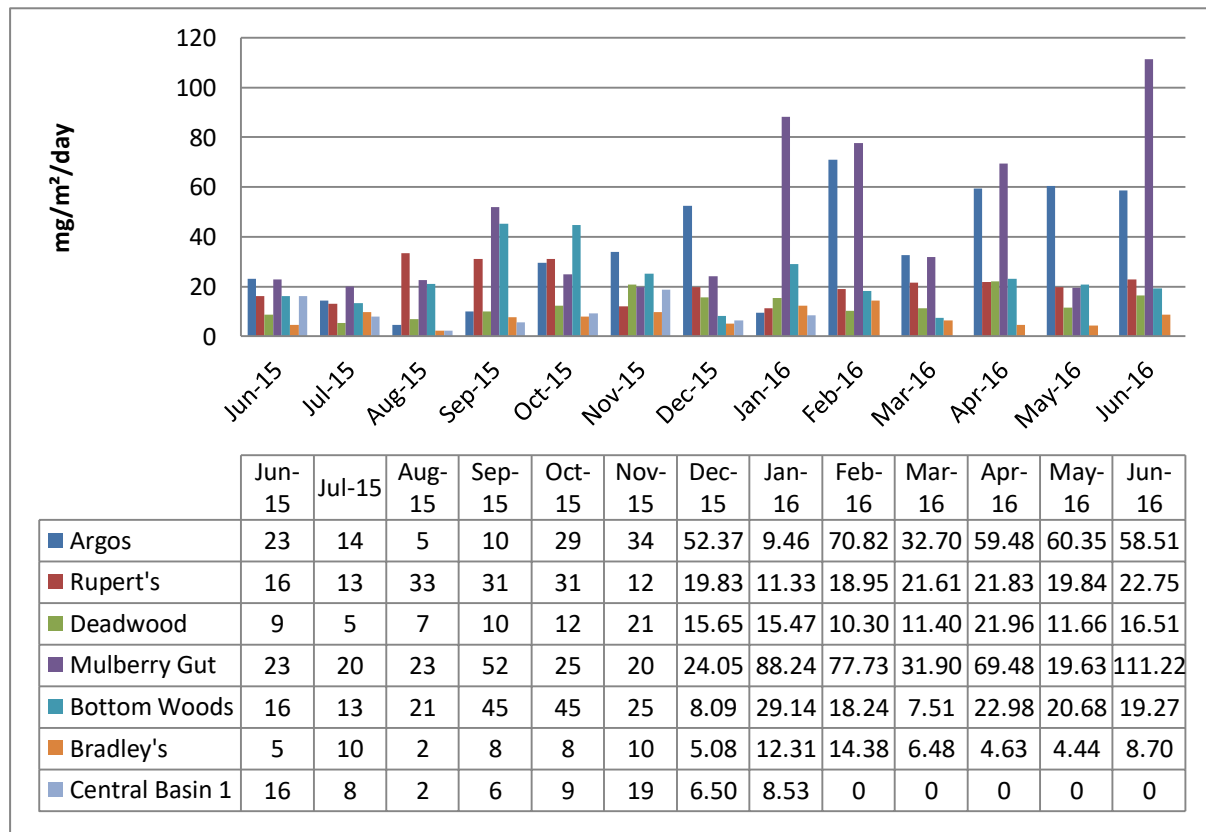
Figure 16: Total suspended particulates

Total suspended particulate (TSP) dust levels were however, well within the UK limit of 200 mg/m<sup>2</sup>/day at all locations as shown in Figure 16 below. The various locations experienced dust peaks at different times reflecting areas where construction activities were occurring e.g. in Mulberry Gut. The high PM10 readings in Rupert's Valley in the first 6 months of 2016 are also reflected in the peak TSP recorded for that period at Argos.

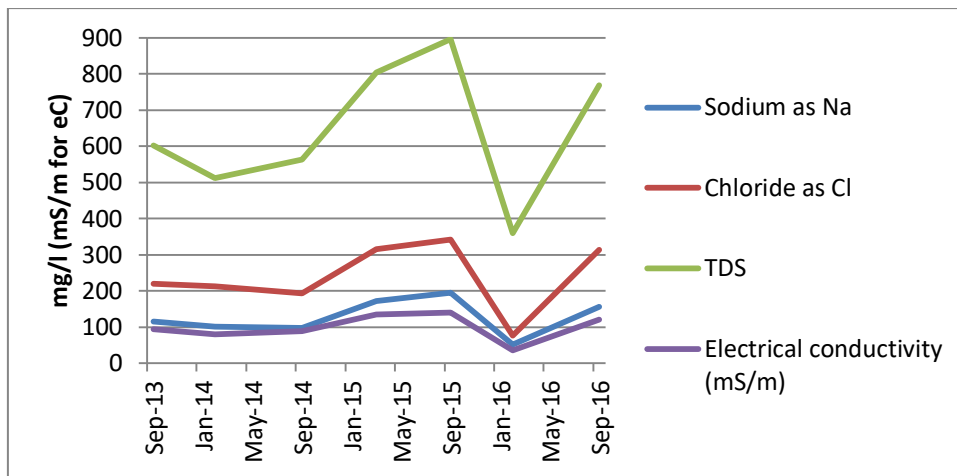
Figure 18: Salinity indicators, Borehole 5

The main water quality issue is its corrosivity, caused by the high chloride to sulphate ratio and low alkalinity. This does not affect the potability of the water, but if left untreated, can cause corrosion in steel pipes, tanks, pumps and fittings if used over a long period of time. There are a number of simple treatment options which are being considered by BR.

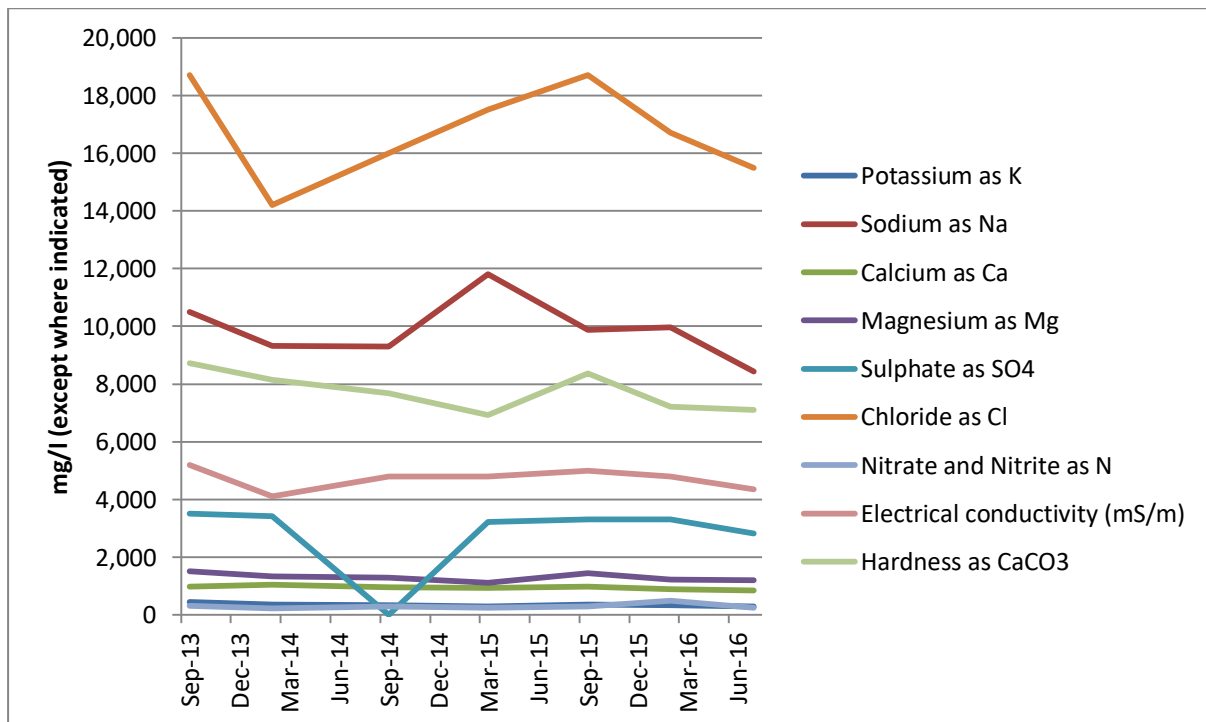
Figure 19: Water quality trends at Champagne Pools

No significant changes were noted in the sample taken from Champagne Pools; the water continues to be highly saline and all parameters were within the range measured over the past 3 years (Figure 19). Nitrate levels are still high which may reflect the presence of blasting residues on the surfaces of rocks used for the Dry Gut fill.
