Rupert's Pollution Incident

Ref: ERM-TN-2015-001-rev1

Site Investigation

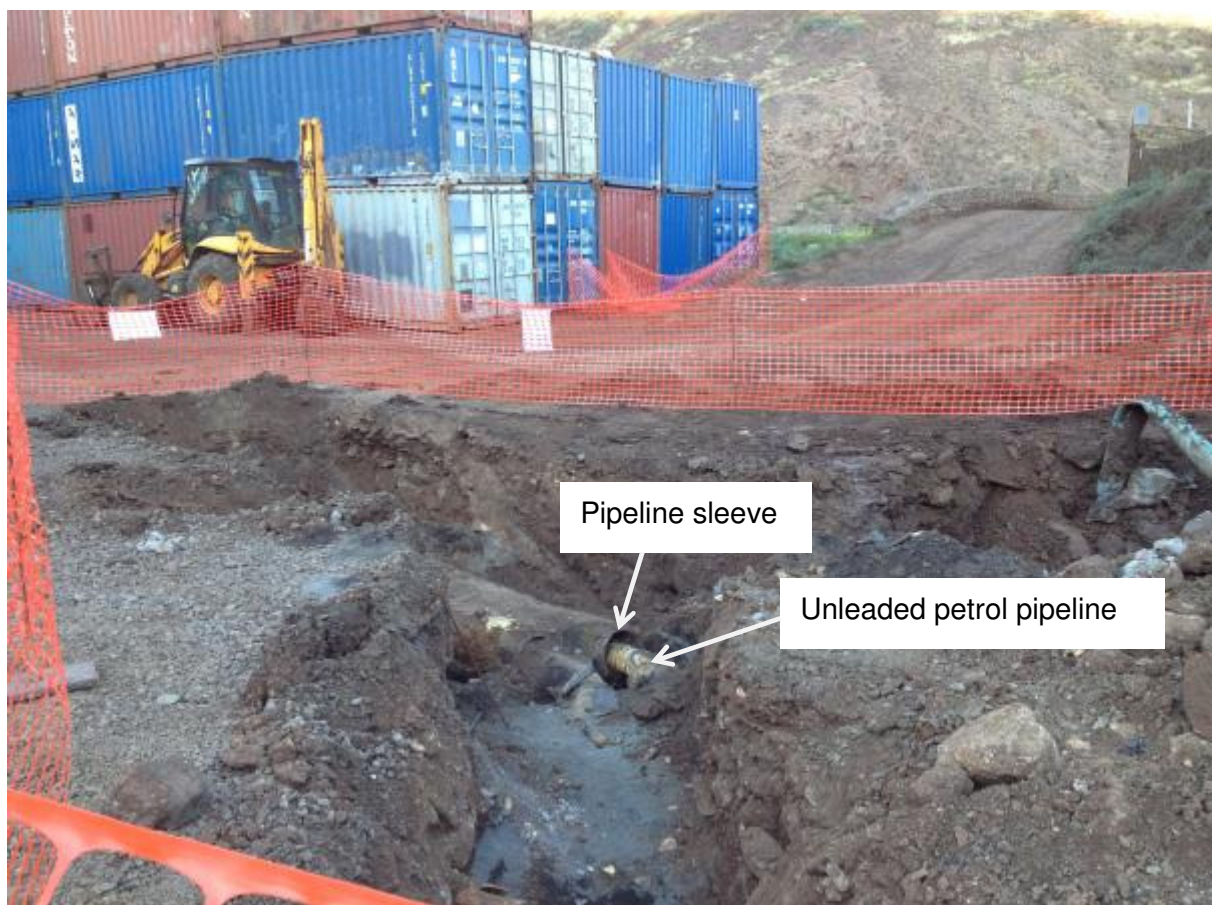
At the time of EMD attending the incident at 16:30 on 20th August 2014, Solomon's contractor had already excavated an area of pipeline where the principal concentration of hydrocarbon vapours had been reported. The exposed pipeline, sleeve and excavation are presented in Plate 1.

Plate 1: Exposed pipe, sleeve and excavation

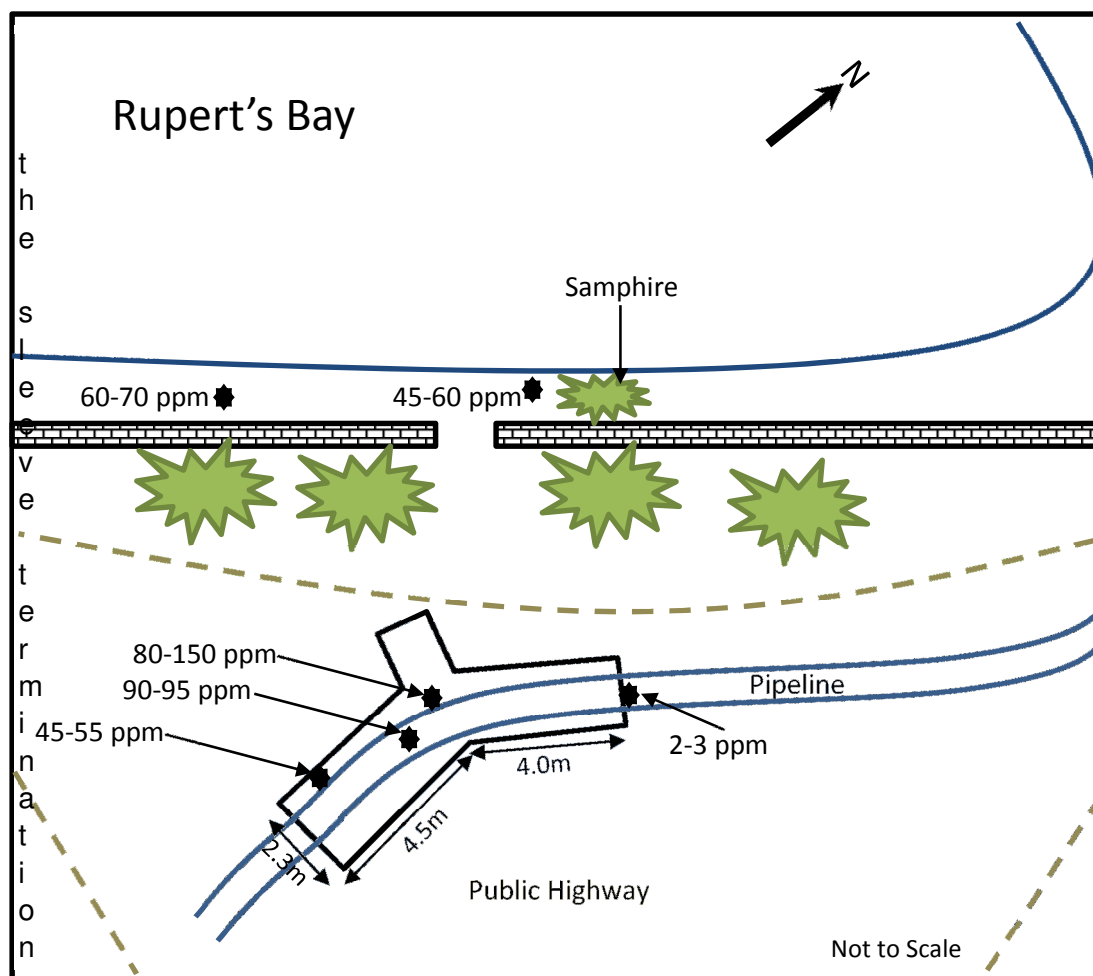
Figure 1 provides a summary of VOC readings taken by Basil Read on 21st August 2014 at 07:30.

Figure 1: VOC Concentrations at Pollution Incident

Concentrations of VOC were seen to exceed the identified threshold within the excavation ("Y" shape) and in ambient air sampled adjacent to Rupert's Bay on the

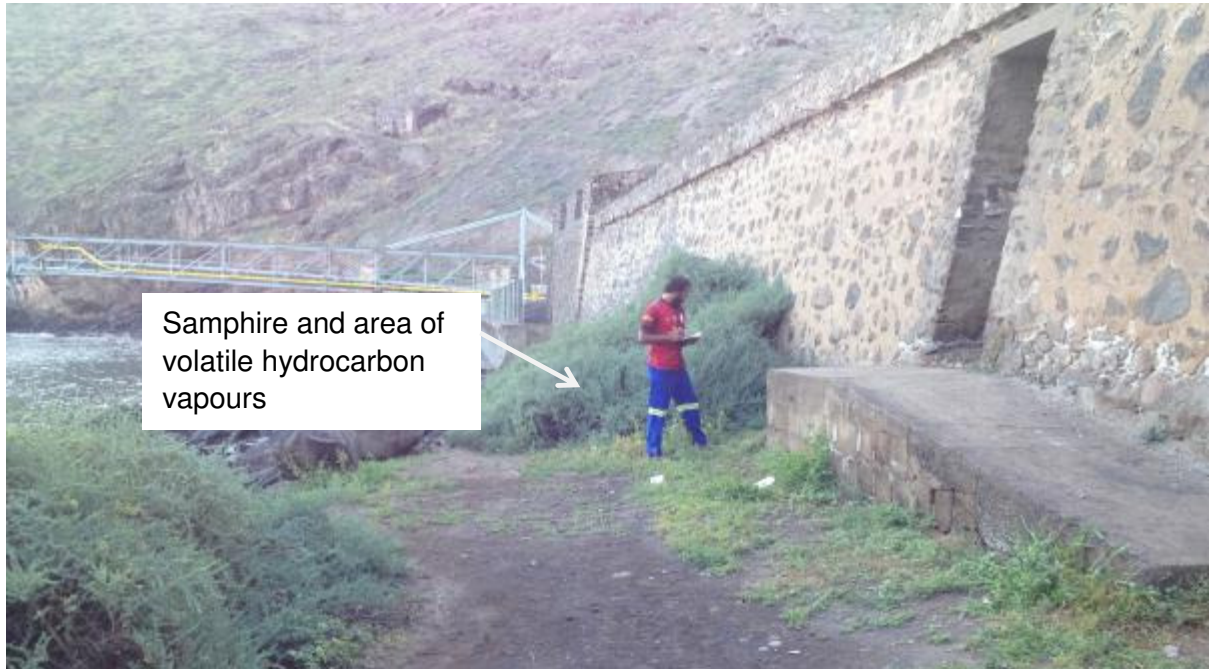
opposite side of the old sea wall. Plate 2 shows an area of samphire behind the old sea wall, where VOC readings exceeded the identified threshold.

Plate 2: Samphire and area of contaminated soil behind old sea wall

The site assessment on the 21st August evaluated the potential for the coastal water of Rupert's Bay to be impacted by the leak; however there was no observed oily sheen on the water or on the sand and rocks above the high tide mark. Volatile organic hydrocarbons were detected on the seaward side of the old sea wall which separates the bay and shoreline from Rupert's valley. The volatile organic hydrocarbons were confirmed as beneath a large patch of samphire between the wall and the coast, adjacent to the archway in the wall. The data suggests that the leaked fuel has migrated down gradient of the pipe sleeve termination and into soil on the seaward side of the wall (see Plate 2).

In order to ensure that the risk of polluting Rupert's Bay was reduced as quickly as possible, it was decided that the excavation would be enlarged in order to remove as much of the contaminated soil as possible. Approximately 49m³ of contaminated soil was removed around and down gradient of the pipe sleeve termination to a depth no greater than that of the exposed pipeline (approximately 1.2m below ground level) during the evening of the 21st August 2014. No contaminated soil beneath the pipeline was removed for safety reasons. No groundwater was encountered in the excavation beneath the pipeline.

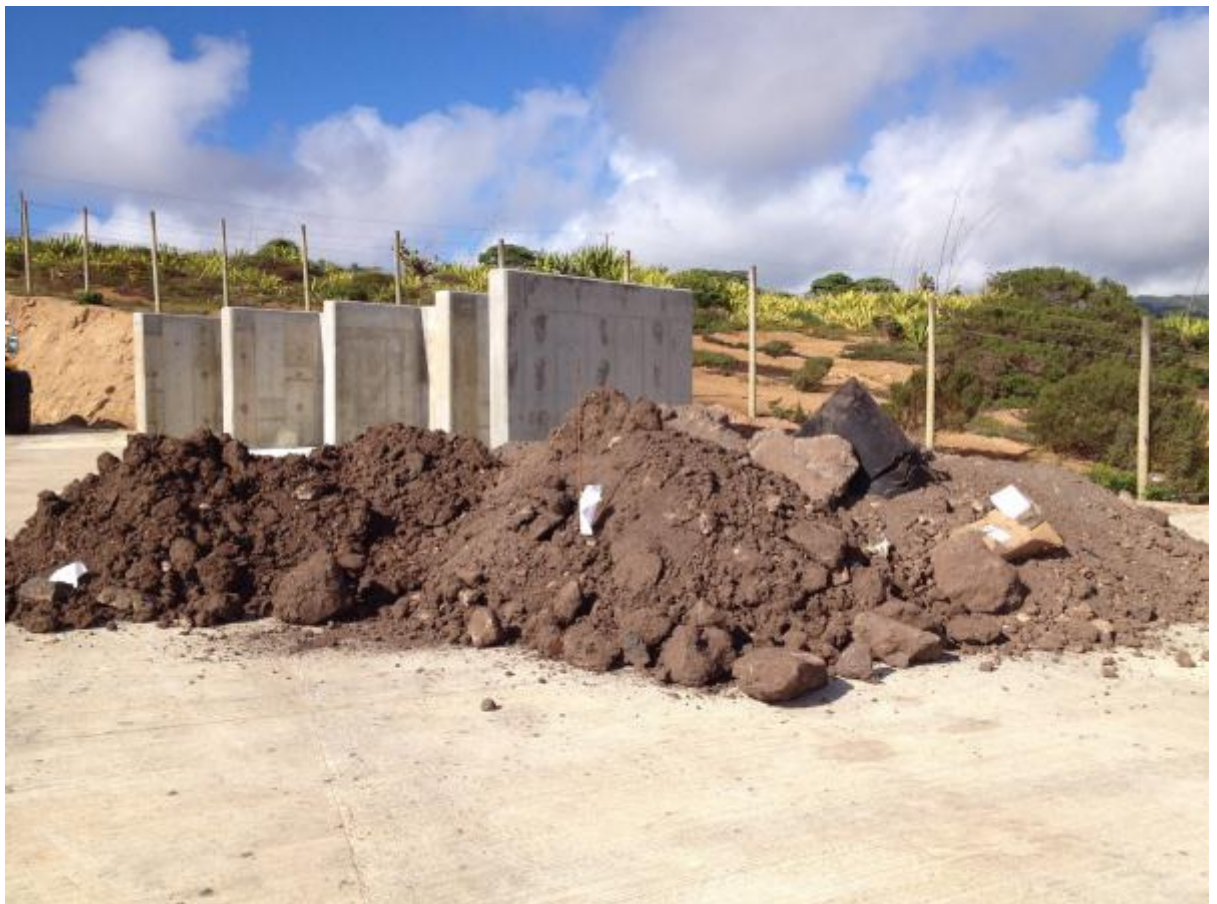
The soil was moved by lorry to Horse Point landfill and was temporarily stored in a stockpile on a large area of concrete hard standing in the new public recycling area (Plate 3). Public Health were alerted to the emergency stockpiling of contaminated soil at the public waste reception area.

Plate 3: Temporary Stockpile at Horse Point Landfill

On 21st August Public Health were alerted to the emergency stockpiling of contaminated soil at the public waste reception area. On 22nd August, EMD provided instruction to the landfill manager on the method to be employed to *ex situ* bio-remediate the contaminated soil. The method advised was via aeration of the soil by regular turning of the stockpiled soil by mechanical excavator.

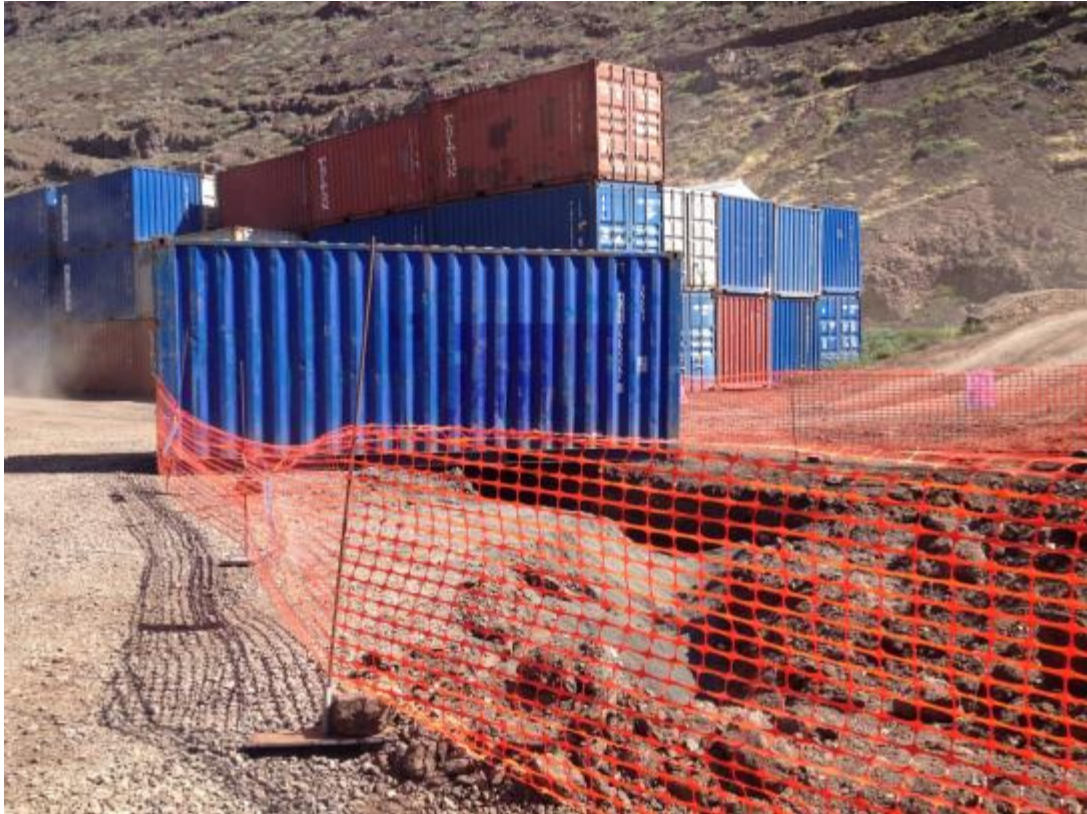
Plate 4: Temporary Backfill of Excavation and Barrier

Due to the impending Bank Holiday weekend, need to distribute fuel to all of the islands petrol filling stations and deadline for offloading the NP Glory 4, it was agreed that the temporary excavation would be backfilled with inert material and a barrier put in place so that Basil Read vehicles could offload the NP Glory 4 by the end of the

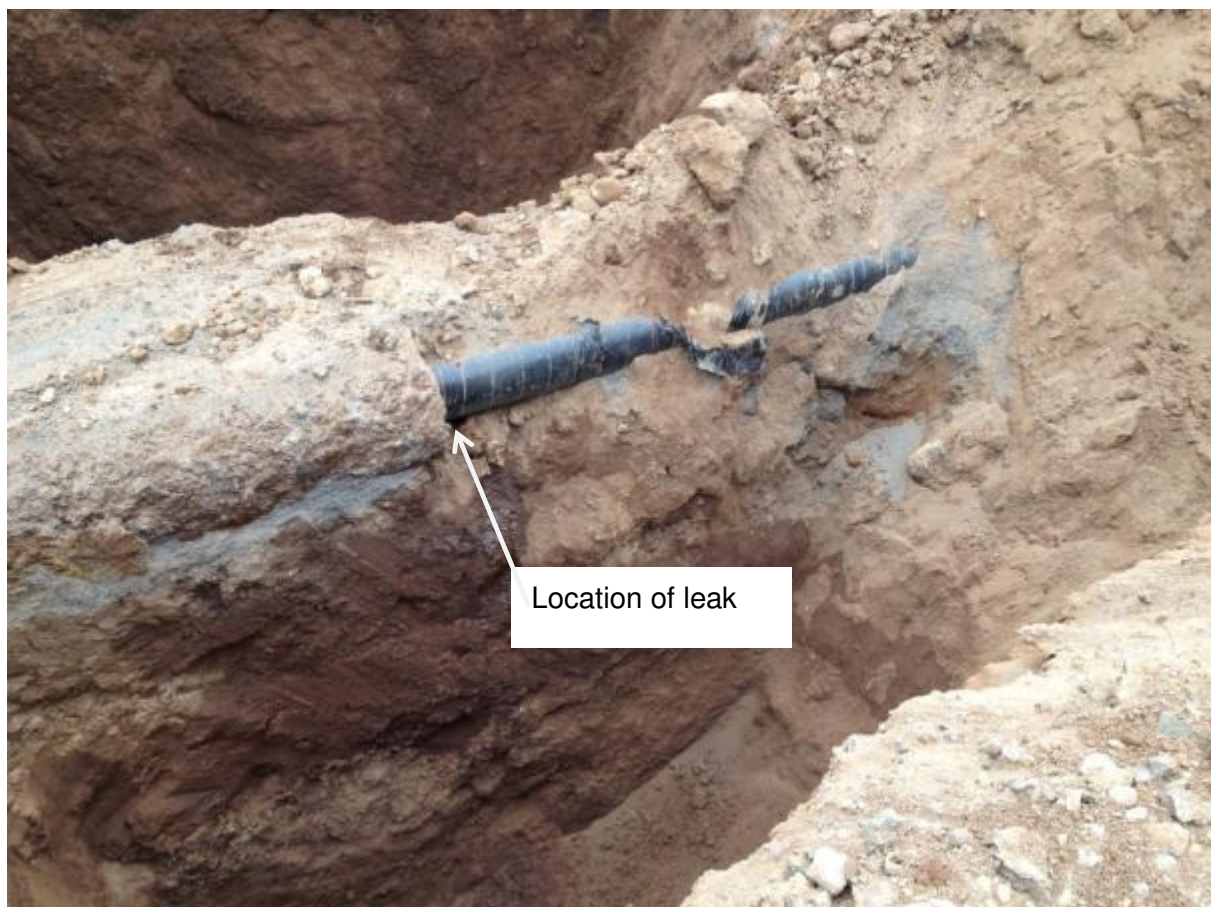
Plate 5 shows the final excavation area around the pipeline and the location of the leak. The maximum excavation depth was 2.5m below ground level.

A “saddle” supporting the fuel pipeline within the sleeve had broken and created a small fracture in the pipeline at the up gradient (south-east) end of the sleeve. Fuel was thought to have leaked through the fracture whilst being pumped under pressure (up to 7 bar) from the fuel supply ship to storage tanks in Rupert’s Bay. The investigation confirmed that unleaded petrol leaked from the pipe into the pipeline sleeve, which migrated down gradient inside the pipe sleeve before draining into the soil to the down gradient termination of the pipeline sleeve.

Note: hydrocarbon vapour was detected within residual soil beneath the repaired pipeline and in the side walls of the excavation. The excavation reached a maximum depth of ~2.0m around the excavated pipeline.

Plate 5: Location of Leak in Unleaded Petrol Pipeline

5. The location of the leak had been identified and repaired. The length of diesel pipeline adjacent to the leak also had joints and saddles replaced to ensure that the diesel pipeline was safe for future operation;

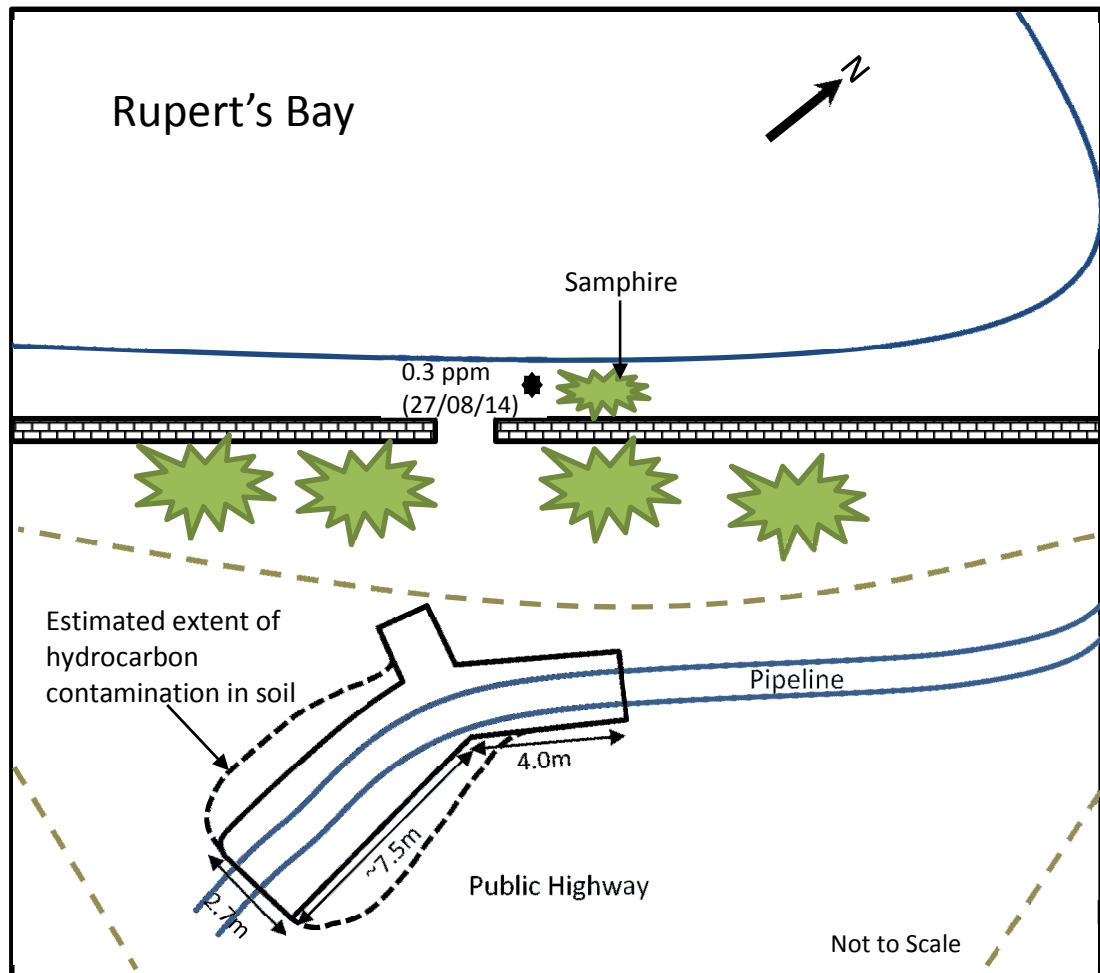
Figure 2 shows the extent of the excavation. The dashed line indicates the likely extent of the residual contamination in soil beneath the road.

Figure 2: Final Excavation and Estimate of Residual Contamination in Soil

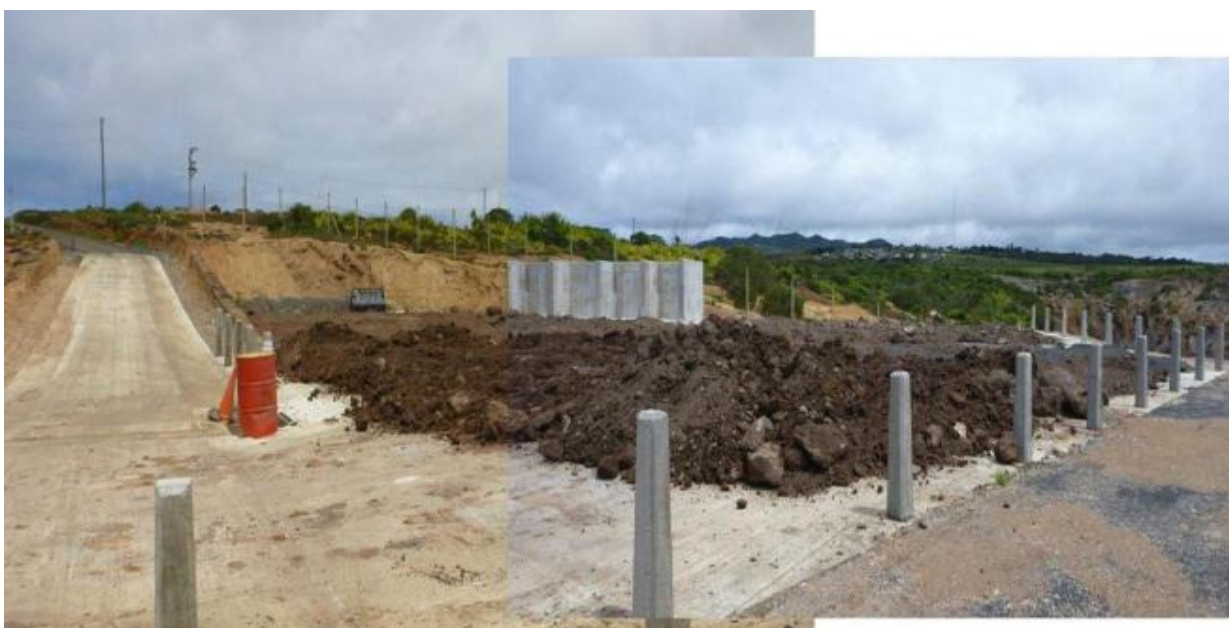
Additional lorry loads of excavated spoil were added to the stockpile during the investigation. The larger stockpile was regularly turned to ensure that the ex-situ bioremediation process was successful. Plate 5 shows the final extent of the temporary stockpile that was remediated at Horse Point Landfill.

Plate 5: Final temporary stockpile at Horse Point Landfill

On the 14th September 2014, Basil Read took the repaired PID to the landfill and tested a representative number of samples from the stockpile for VOC. Basil Read confirmed that all sample VOC concentrations were recorded as 0ppm. Based on this information, EMD instructed the landfill operator to stop all bioremediation activities move the stockpile from its temporary location and use the soil for landfill cell cover.

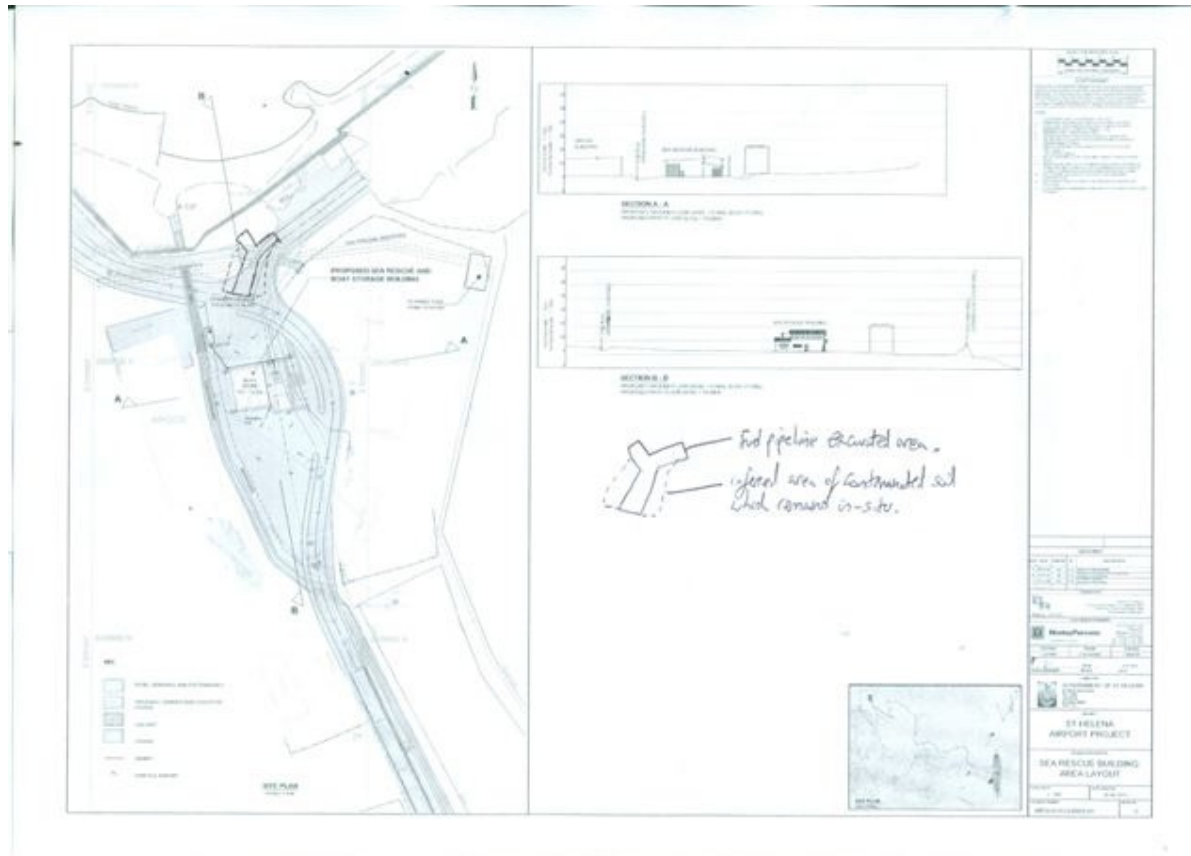
An annotated airport project site plan is presented in Figure 3 showing the location of the new sea rescue building and road layout. The figure has been annotated to show the excavated area and estimated area of contaminated soil which was left in-situ. Figure 3 is for illustration only and EMD do not provide any guarantee that the annotation is 100% correct, as a detailed site survey was not completed as part of the remediation and repair works.

Figure 3: New Rupert's Valley Road Layout Near the Old Sea Wall
