MECHANICAL INVESTIGATION INTO

**THE FAILURES OF WATER PUMP GEARBOXES FITTED  
TO FIRE TENDERS OPERATED BY ST HELENA AIRPORT**

St Helena Government

Dr Ross Beesley CEng MIMechE

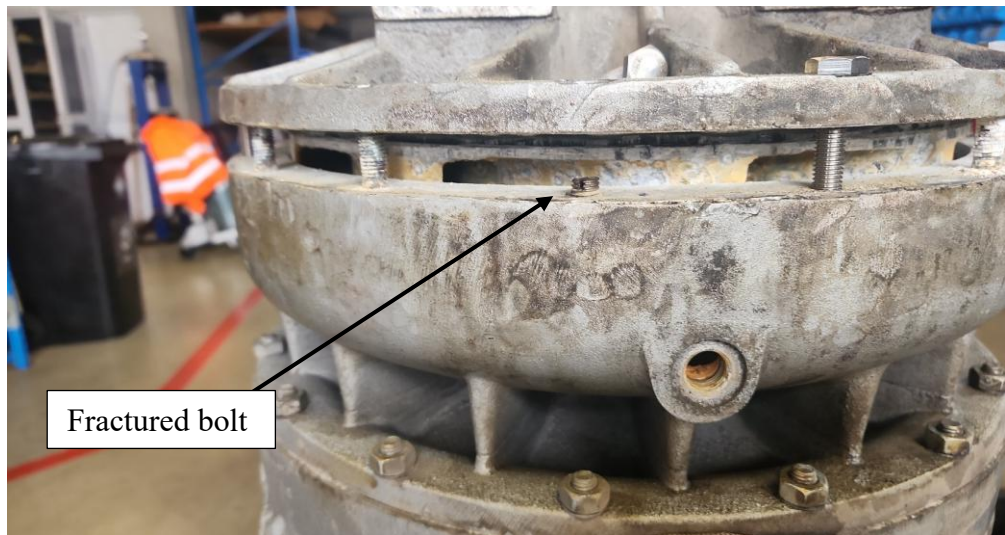
*Figure 18: Separation of pump casing*

- 10.2.12. On this basis, the presence of pitting on the pump casing could indicate that cavitation has occurred at some point during the life of the pump. However, in a similar manner to the corrosion, since this was the first time that the pump casing was opened, the full extent of pitting would not have been previously detectable, meaning that it is not possible to determine when the pitting first commenced. As such, I cannot preclude the possibility that the pitting had been developing over the entire life-time of the pump.

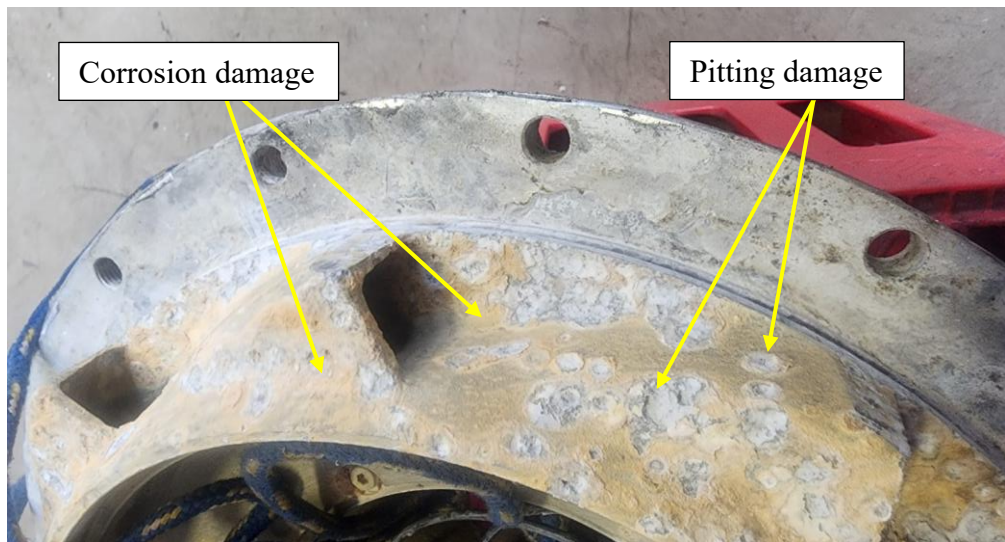
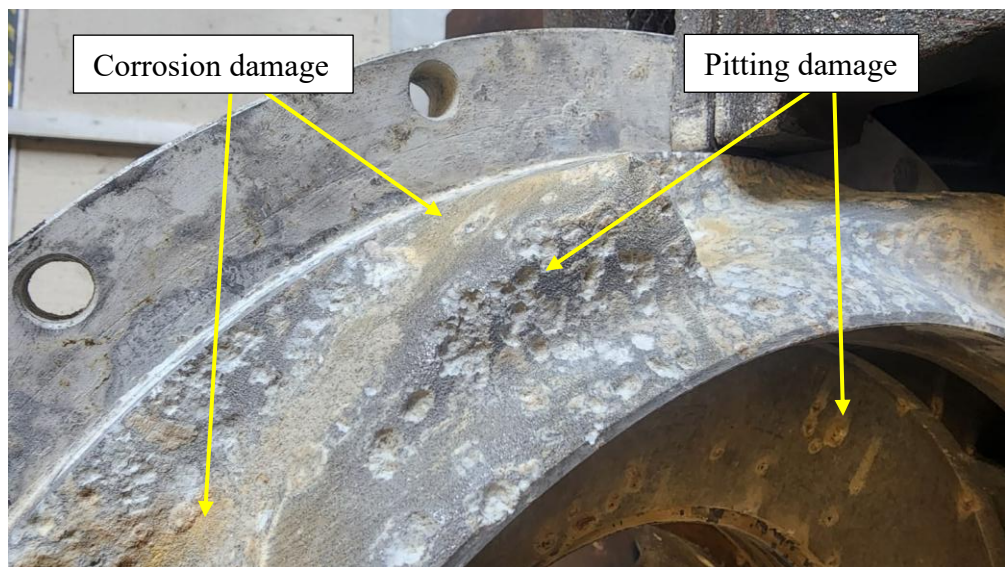
*Figure 19: Corrosion and pitting damage to interior of pump casing (1)*

*Figure 20: Corrosion and pitting damage to interior of pump casing (2)*

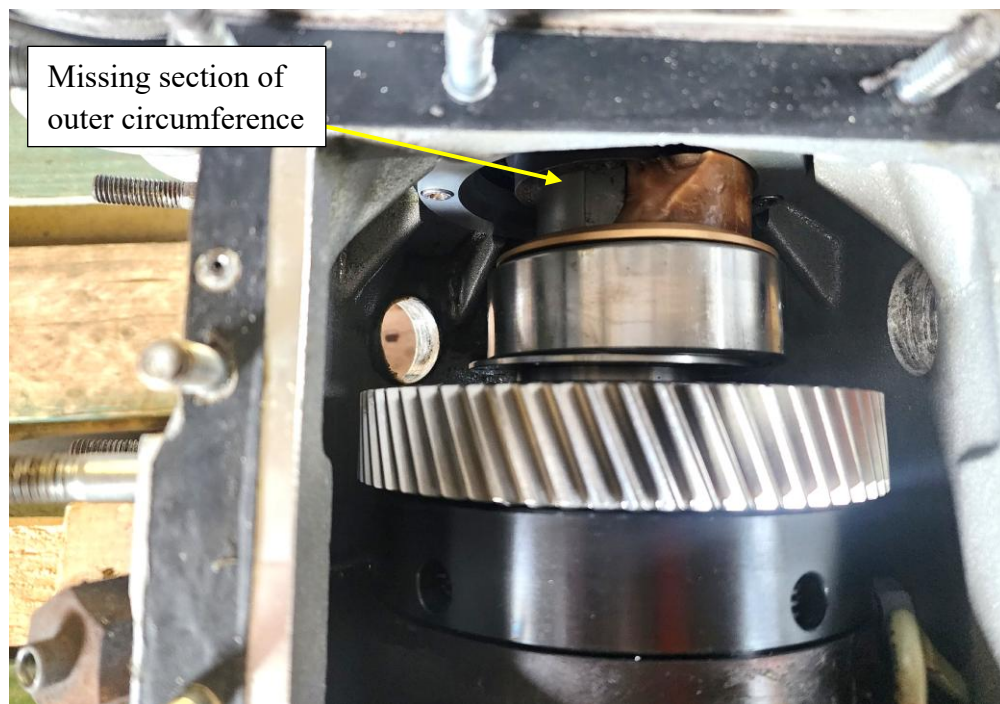
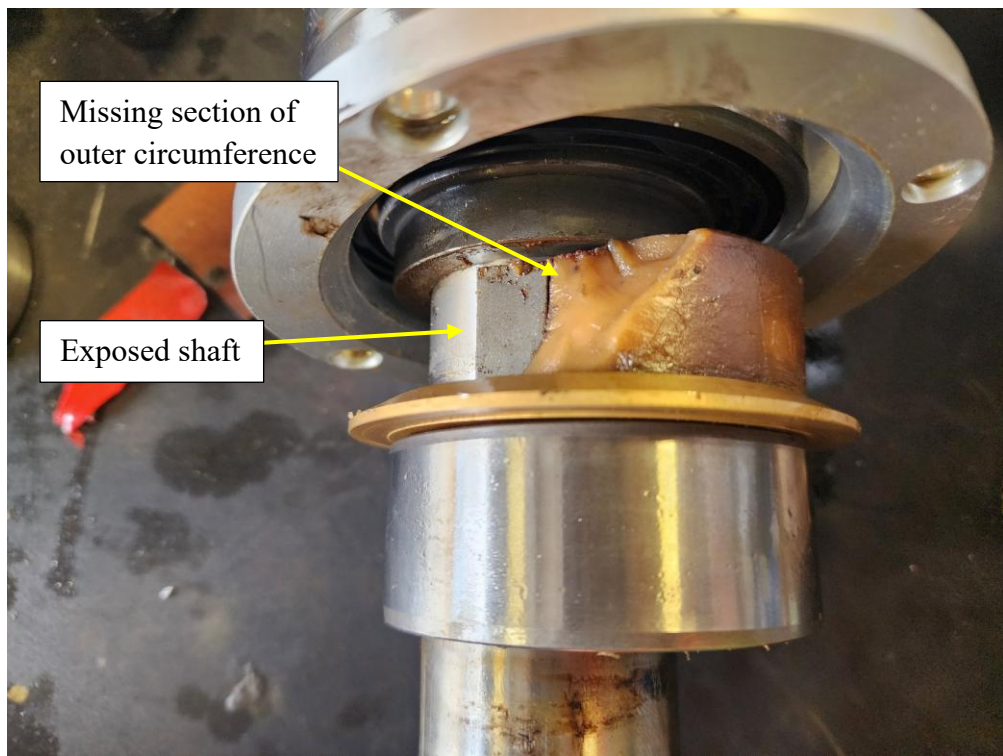
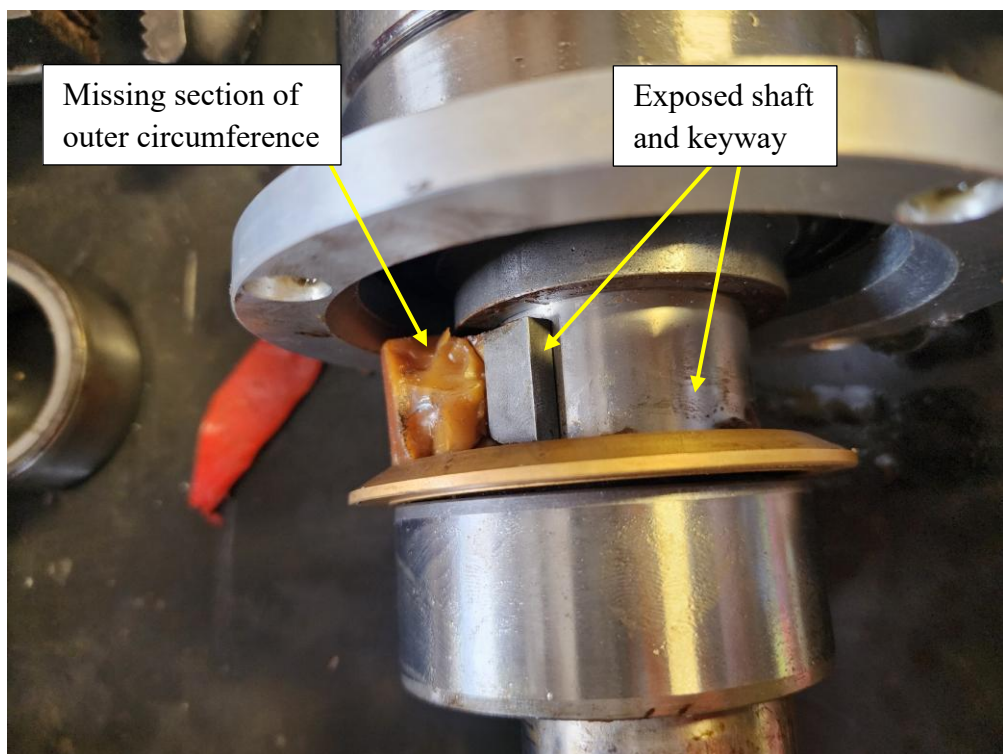
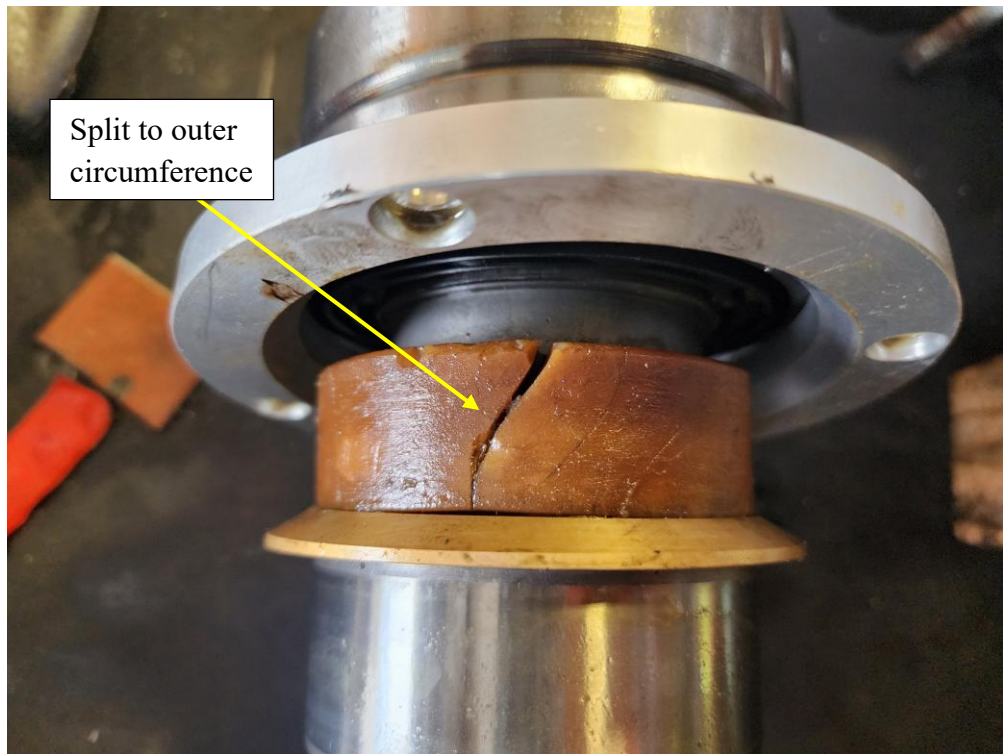
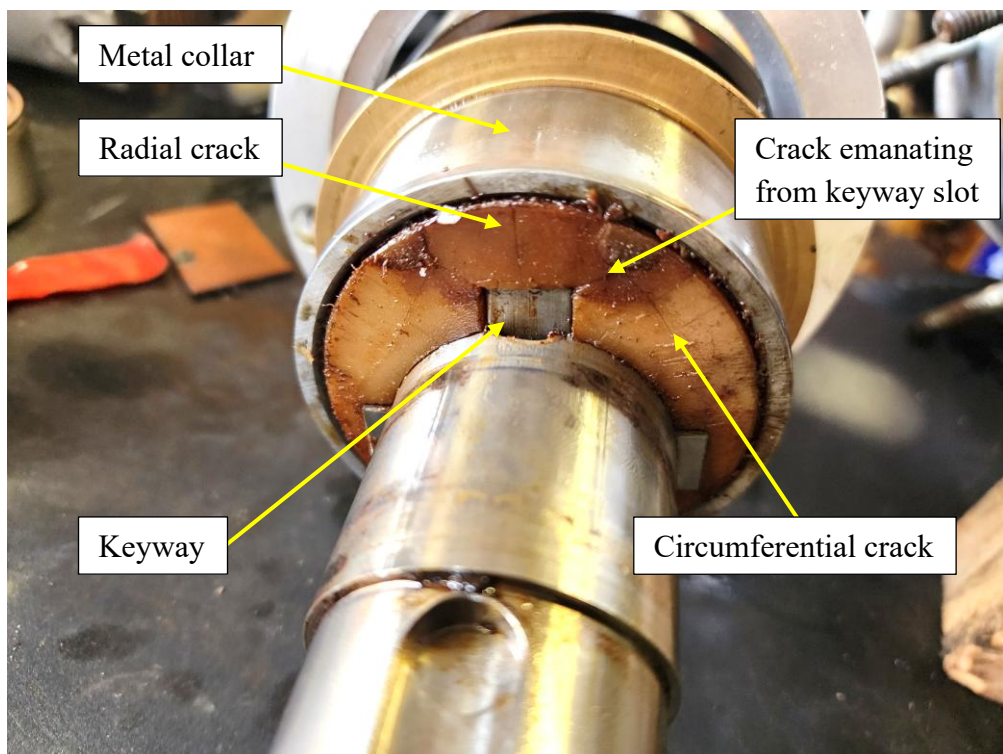
- 10.3.1. When the gearbox was opened, the damage to the eccentric could be observed.
- 10.3.2. A large section to one side of the outer circumference of the larger diameter end of the eccentric (i.e. the region not covered by the metal collar) was detached, exposing the shaft and locking keyway beneath.
- 10.3.3. The remainder of the outer circumference remained attached; however, there was also a large split to one side of the outer circumference.
- 10.3.4. When viewed from the smaller diameter end of the eccentric, there was also extensive fracture damage to the cross-sectional profile that extended in both radial and circumferential directions. Some cracks had also propagated from the corner of the keyway slots.
- 10.3.5. Photographs of the damage to the eccentric of R2 are provided in Figure 21, below, to Figure 25, on page 25.

*Figure 21: Damage to R2 eccentric (1)*

*Figure 22: Damage to R2 eccentric (2)*

*Figure 23: Damage to R2 eccentric (3)*

*Figure 24: Damage to R2 eccentric (4)*

*Figure 25: Damage to R2 eccentric (5)*

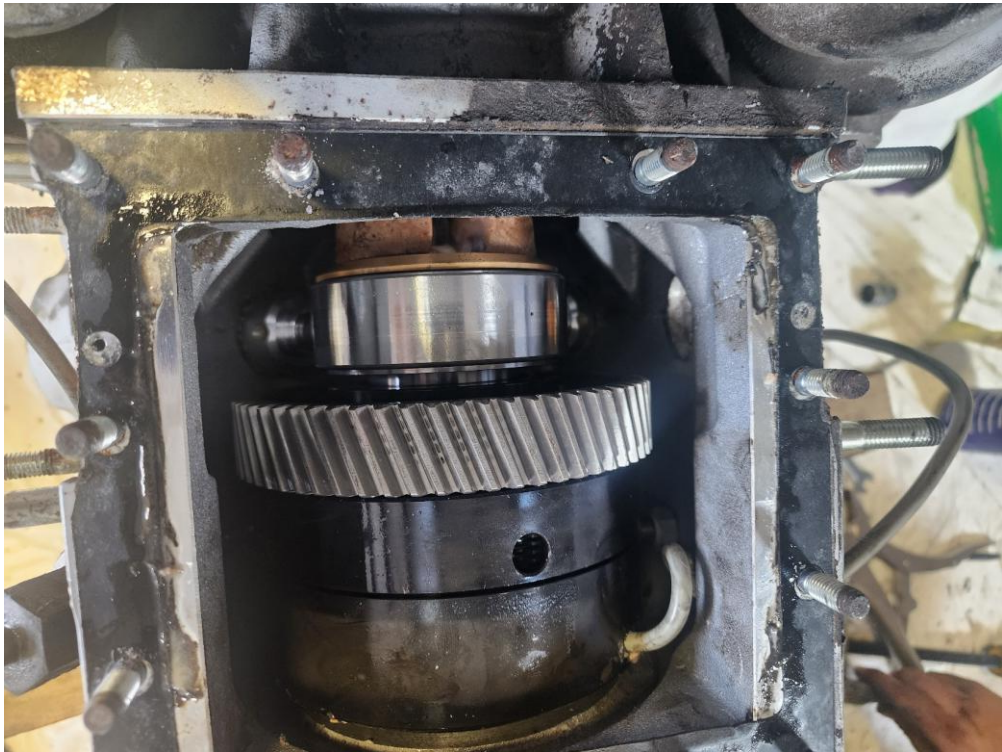
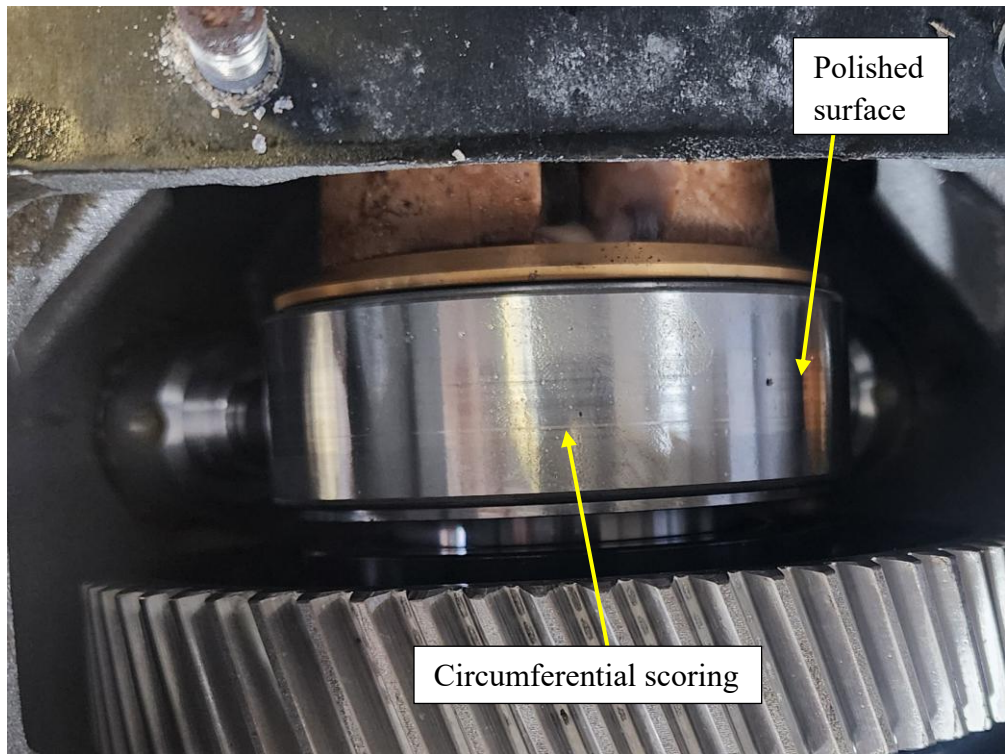
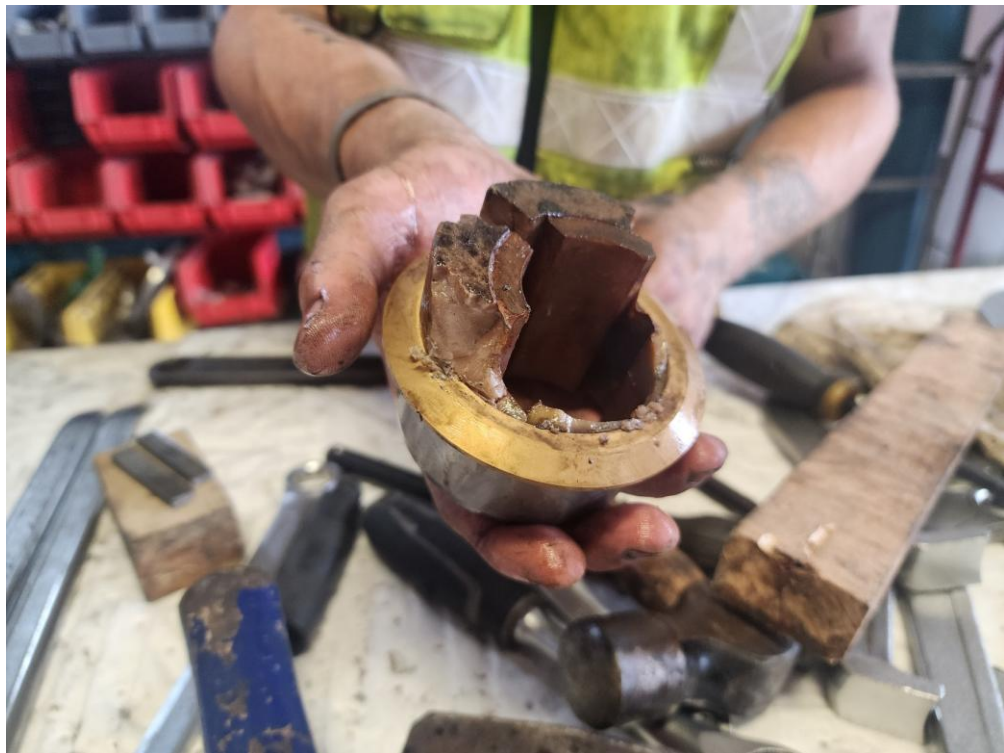
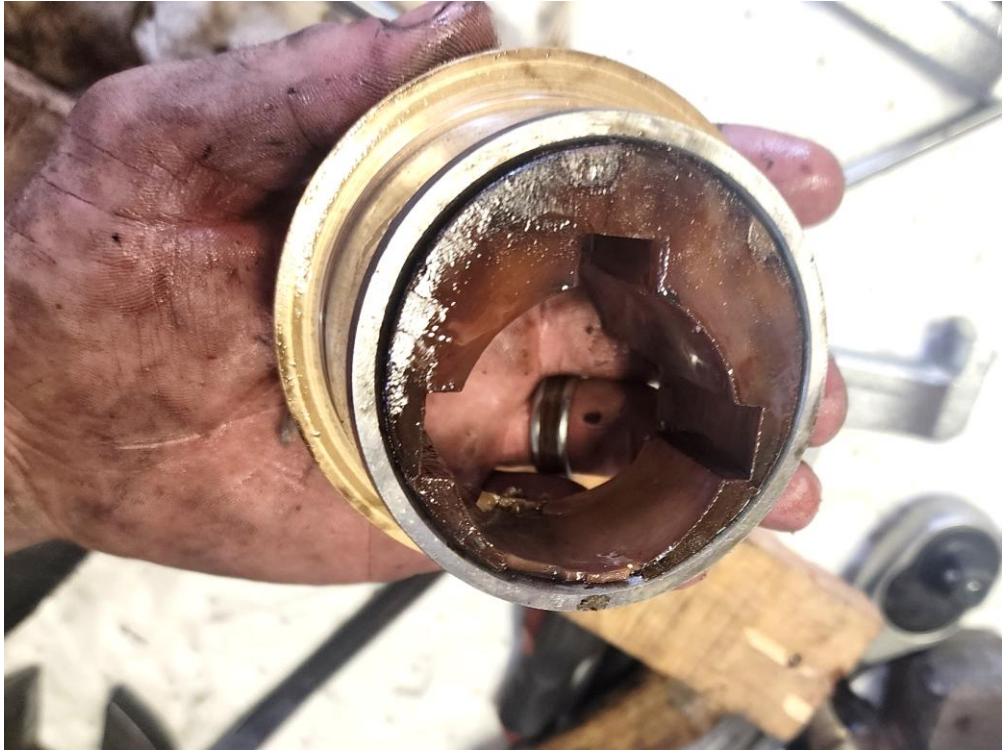
- 10.4.2. When the gearbox of R1 was opened, similar damage was observed to the eccentric. More specifically, a section of the outer circumference was detached, and cracks were visible on the cross-sectional profile.
- 10.4.3. There was also localised polishing and circumferential scoring to the outer surface of the metal collar at the contact patch with the Trokomat pistons.
- 10.4.4. Photographs showing the damage to the eccentric of R1 are provided in Figure 26, below, to Figure 29, on page 28.

*Figure 26: Damage to R1 eccentric (1)*

*Figure 27: Damage to R1 eccentric (2)*

*Figure 28: Damage to R1 eccentric (3)*

*Figure 29: Damage to R1 eccentric (4)*

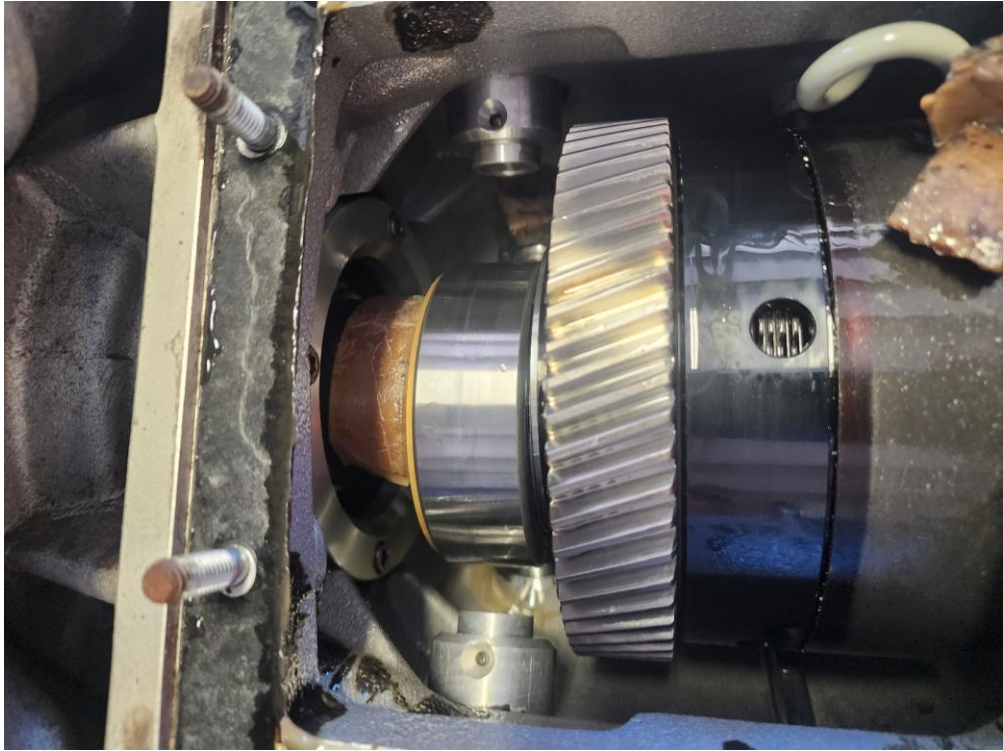
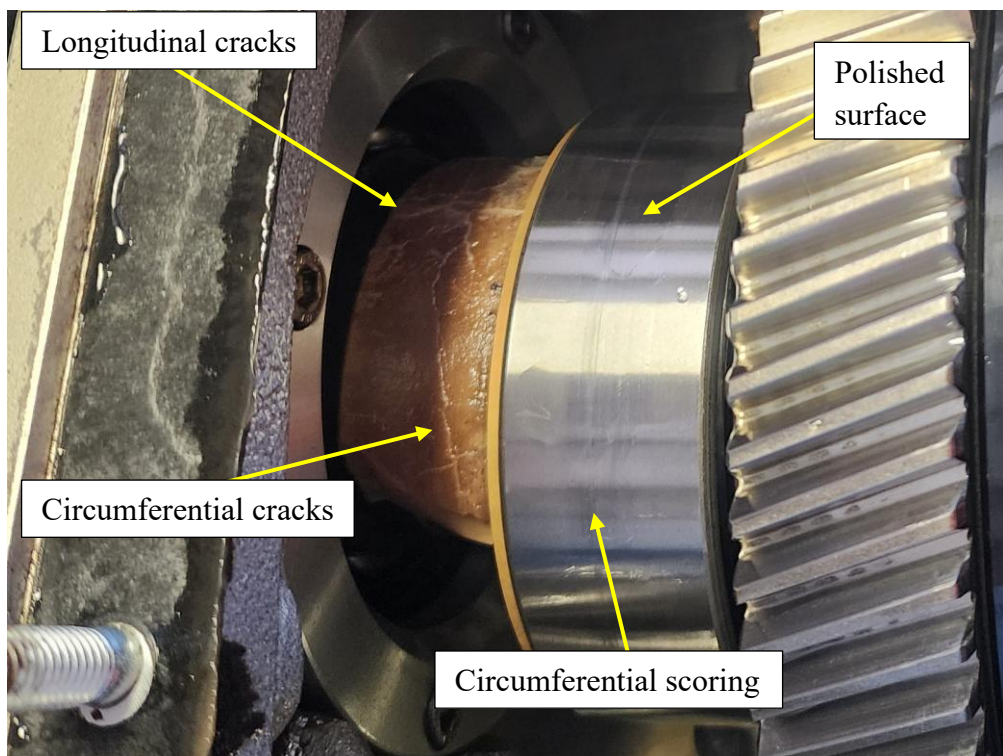
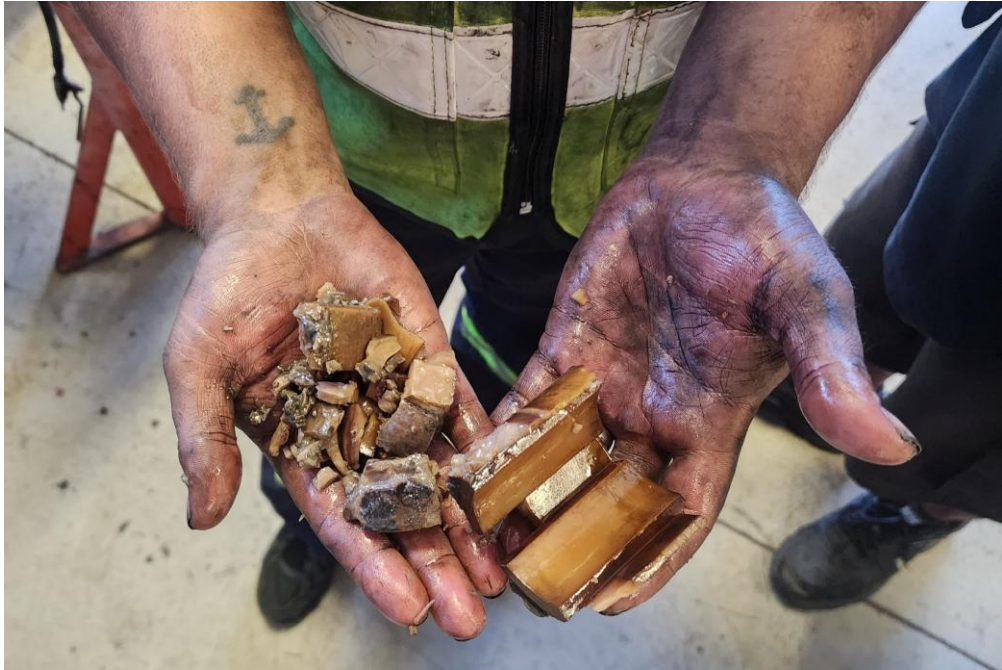
*Figure 30: Damage to R3 eccentric (1)*

*Figure 31: Damage to R3 eccentric (2)*

*Figure 32: Damage to R3 eccentric (3)*

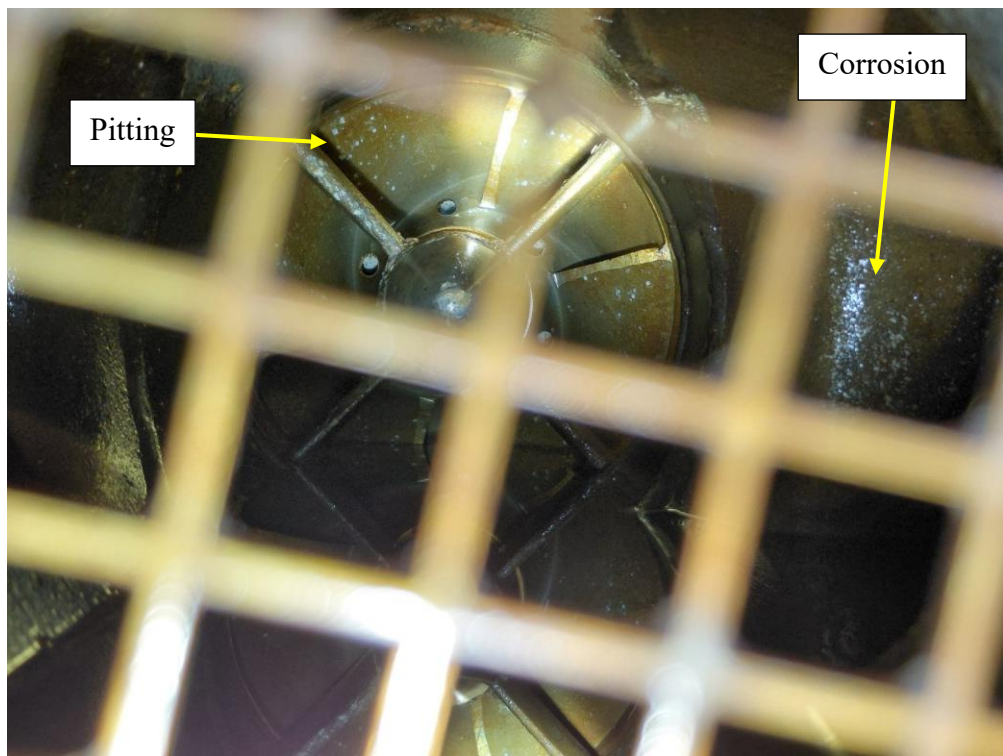
- 16.1. As described previously, during the disassembly of the R2 pump casing, corrosion and pitting damage was observed.
- 16.2. While a complete disassembly of the pumps was not conducted during my time at St Helena Airport, I inspected the drafting inlets and impellers of each of the ARFF vehicles, which showed surface corrosion to the inlets and pitting damage to the impeller blades. There also appeared to be limescale deposits at the inlets. It is important to note that the drafting inlets are fitted with a metal grate that acts as a coarse filter to prevent large foreign objects from entering the impeller. This impeded access to the impeller for inspection. Nevertheless, the pitting and corrosion could still clearly be seen.
- 16.3. Images of the impellers and drafting inlets of each ARFF vehicle are provided in Figure 90, overleaf, to Figure 95, on page 70.

*Figure 90: Pitting damage to R1 impeller*

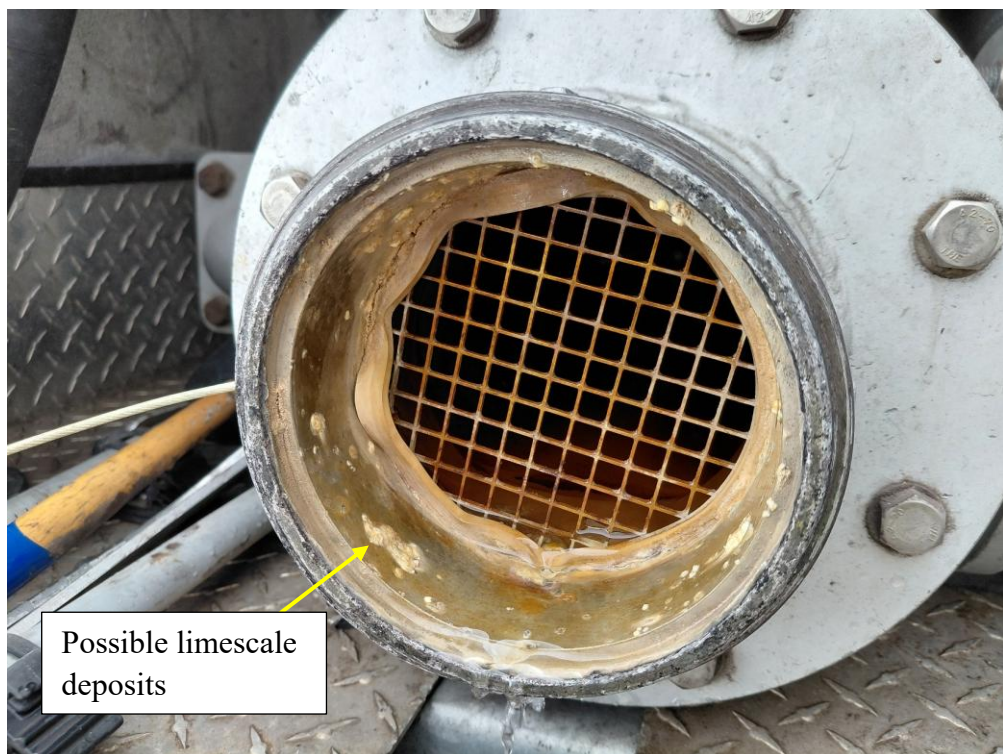
*Figure 91: Limescale deposits on R1 inlet*

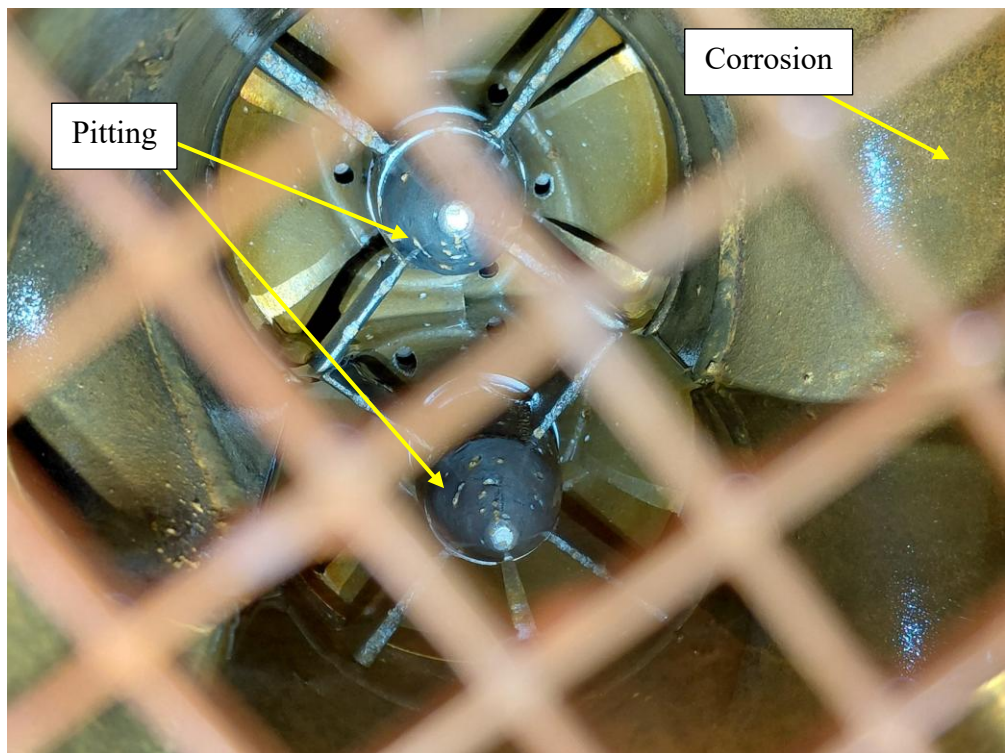
*Figure 92: Pitting damage to R2 impeller*

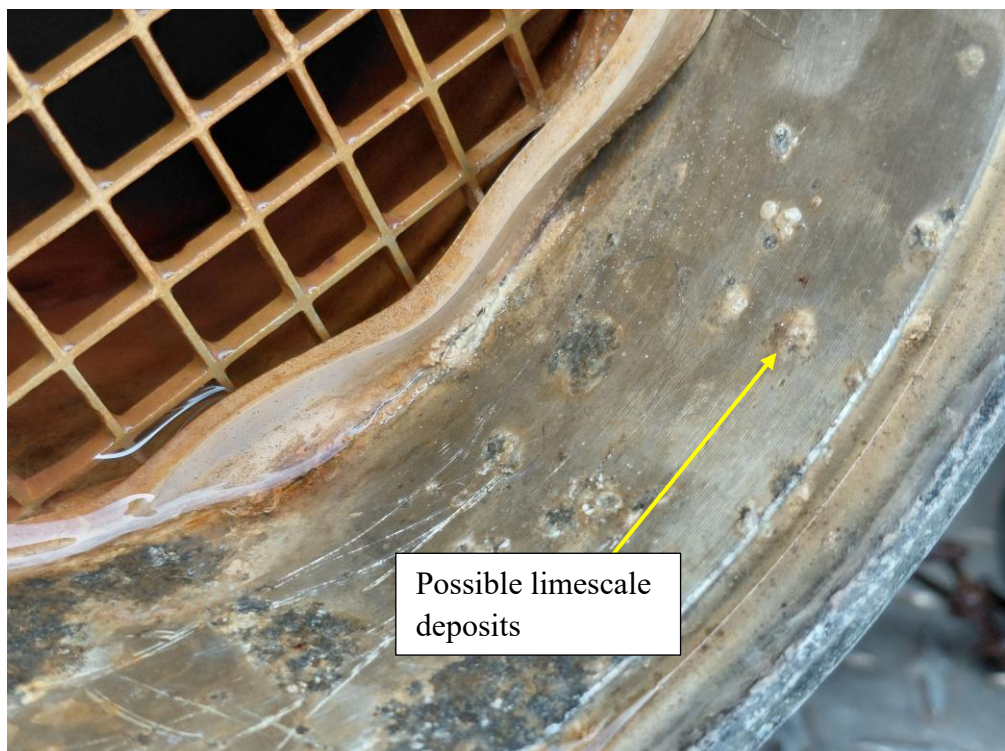
*Figure 93: Limescale deposits to R2 inlet*

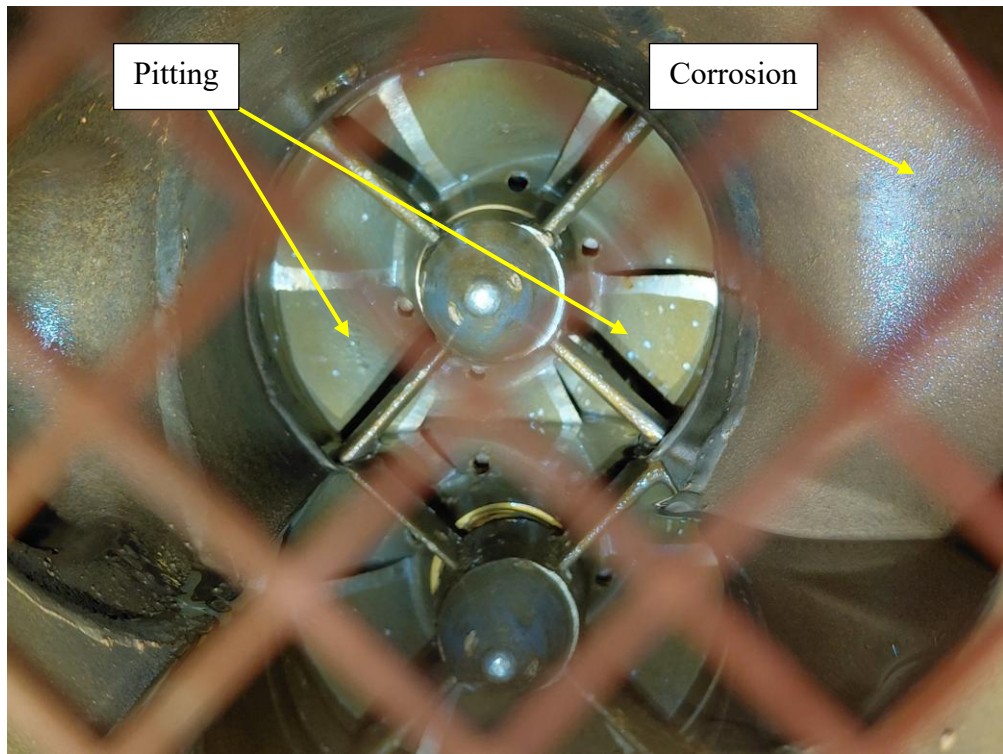
*Figure 94: Pitting damage to R3 impeller*

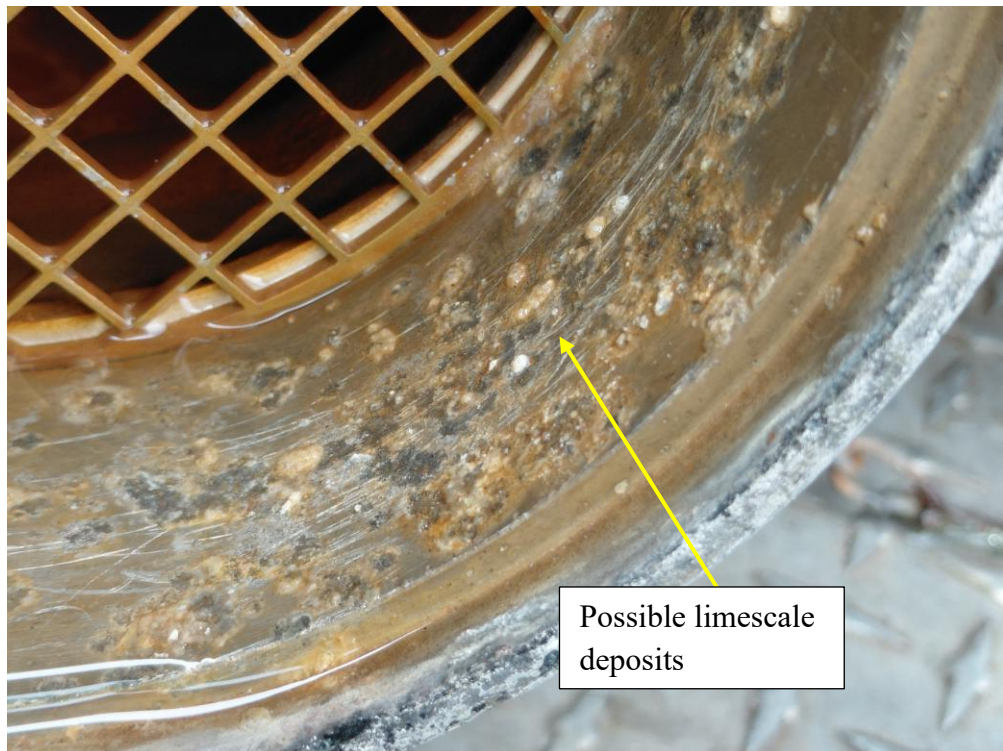
*Figure 95: Limescale deposits to R3 inlet*

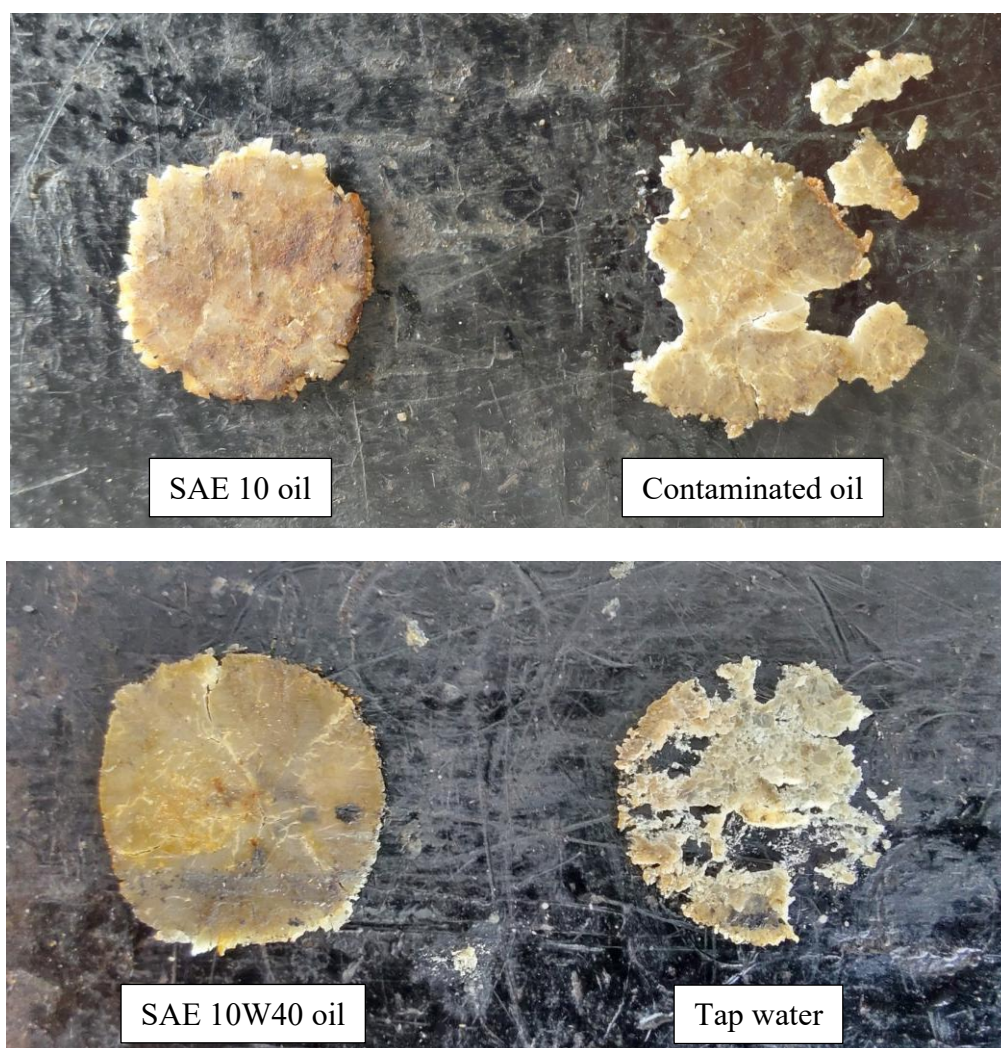
*Figure 102: Post-pressure test texture of elastomer samples exposed to different fluids*

- 18.15. In light of this preliminary test, it appears that the exposure to both grades of oil did not affect the structure of the elastomer material to any significant extent (at least within a three day exposure period). However, it also suggests that when exposed to water, the composition of the elastomer material was seemingly altered, causing it to become significantly more brittle, and more prone to disintegration.

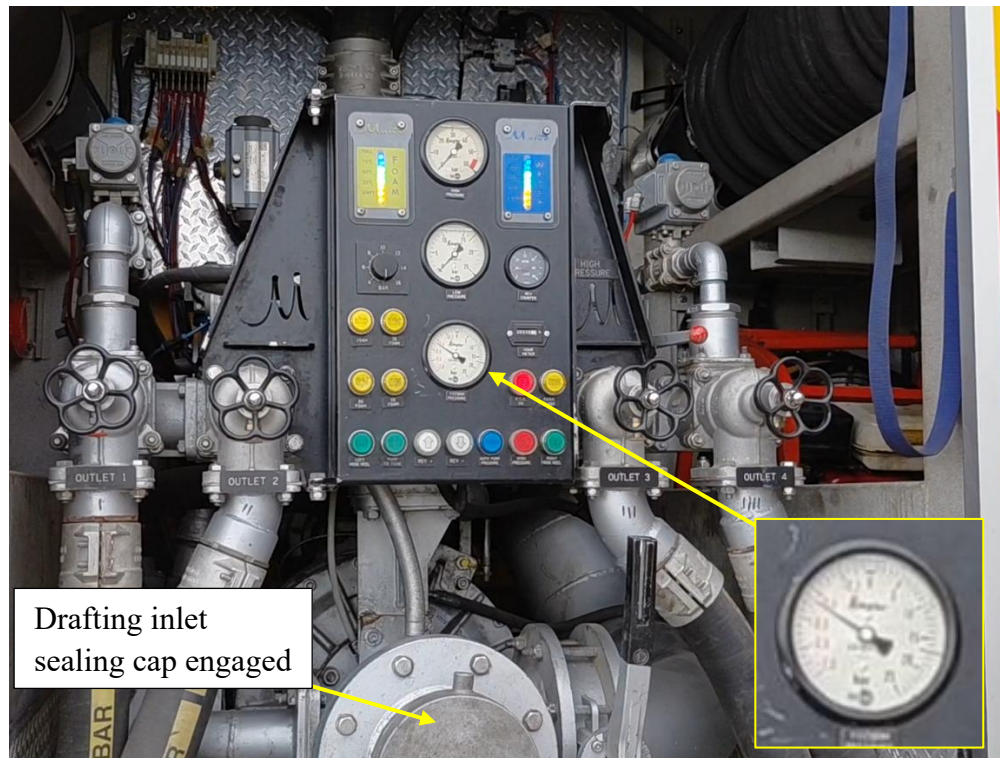
- 20.3.5. During the test that I witnessed, a negative pressure was first detected after the pump had been running for approximately 15 seconds, and a reading of -0.8 bar was achieved after approximately 30 seconds. The negative pressure of -0.8 bar was then sustained for in excess of 1 minute, at which point the test was stopped as it was deemed satisfactory. Images from the dry-vacuum test are provided in Figure 103, below, and Figure 104, overleaf. Instructions for this test are also outlined in the pump operating manual, and this is shown in Figure 105, also overleaf.

*Figure 103: Dry vacuum test: negative pressure detected after ~15s*

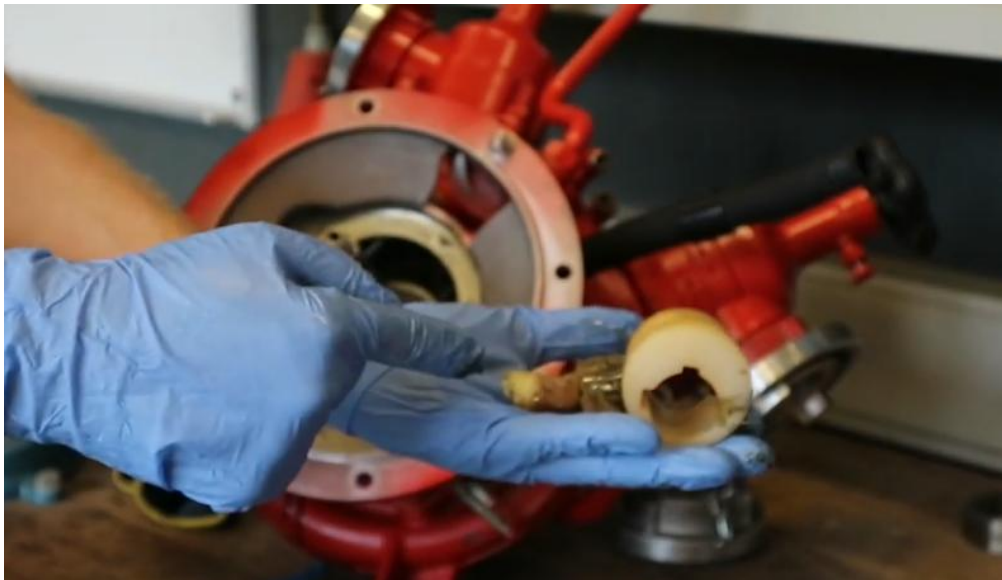
*Figure 119: Online video tutorial showing disintegrated eccentric (3) © 'Scotty's Maschinisten Channel' (<https://www.youtube.com/watch?v=XECFggaW3FA>) [accessed August 2026]*
