**ST HELENA AIRPORT PROJECT
ANNUAL ENVIRONMENTAL REPORT 2014-15
December, 2015**

**Prepared by
Bryony Walmsley
CEMPC**

ANNUAL ENVIRONMENTAL REPORT 2014-15

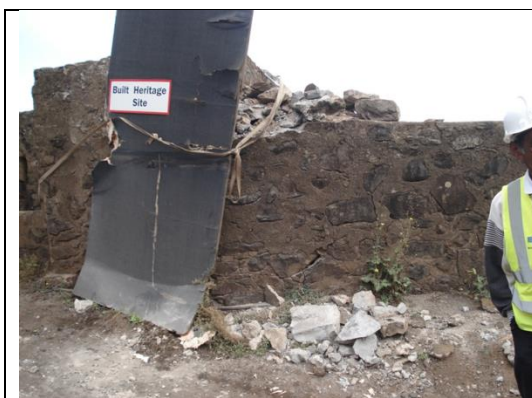
- 1) In an effort to provide additional protection to the historical Rupert's Lines after the protective hoarding fell off, a new board was attached to the wall with nails, which caused even more damage. The cumulative damage to the wall from this action and previous knocks from vehicles (Plate 3) has resulted in moderate harm to this heritage structure. However, all the damaged pieces of masonry and stone have been saved and the wall will be repaired once construction of the wharf access road has been completed.

Plate 3: Damage to the historic wall of Rupert's Lines

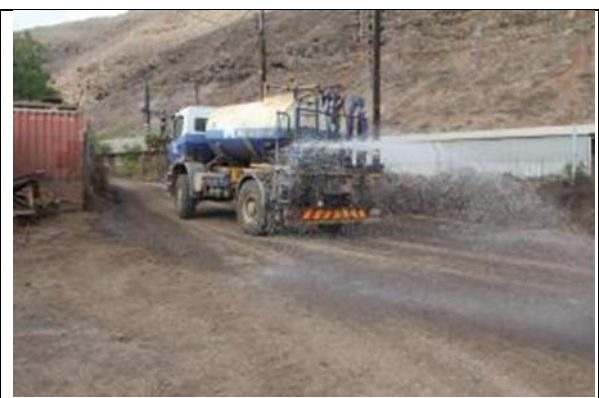
Plate 4: Increased dust suppression is required in Rupert's Valley to control dust

the Bottom Woods to Millennium Forest road. The elevated levels of dust were caused by a combination of speeding and insufficient dust suppression. If not mitigated, these dust concentrations could have a moderate, but reversible impact on health. However, greater efforts were taken to inform both BR and public drivers about the importance of adhering to the posted speed limits and dust suppression activities were increased (Plate 4). It can be seen from the dust monitoring results shown in Figures 14-16 that improved dust control measures had an immediate and beneficial effect on reducing particulate emissions.

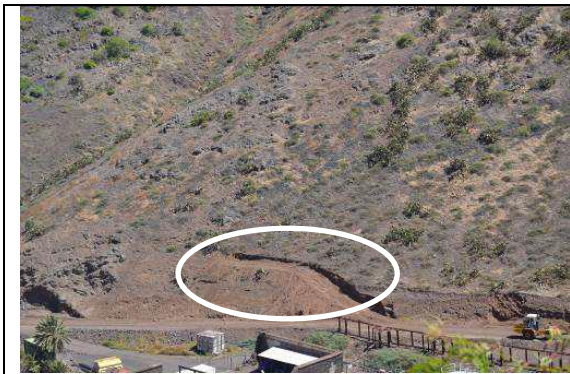
The only level 4 incident on site during the reporting period occurred on 12th December, 2014, when remains of liberated African slaves were unearthed at two sites while cutting back the batter on the access road just above the power station in Rupert's Valley to create space for the plinths for the fuel pipeline and for the final alignment of the access road (Plates 5 and 6). The site of the human remains was outside previously surveyed mass grave sites. No evidence that the site may contain human remains was observed during pre-construction site walkovers or during trial pitting. Once bones were unearthed, the site foreman stopped work immediately, the area was demarcated with barrier tape and the PMU was notified. SHG commissioned a study by archaeologist Dr Andrew Pearson to make recommendations on how to treat bones found *in situ*, and how to store bones for future research.

Plate 5: The location of the human remains

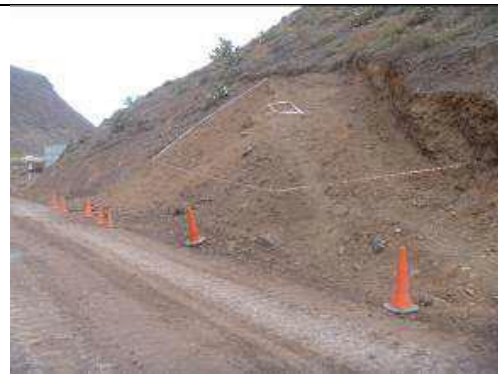
Plate 6: The site was cordoned off and all construction activities in the area were halted

Mitigation measures to be implemented during the excavation of plinth foundations for the fuel pipeline were identified and work was undertaken between 20 and 27 March 2015. Mitigation measures comprised:

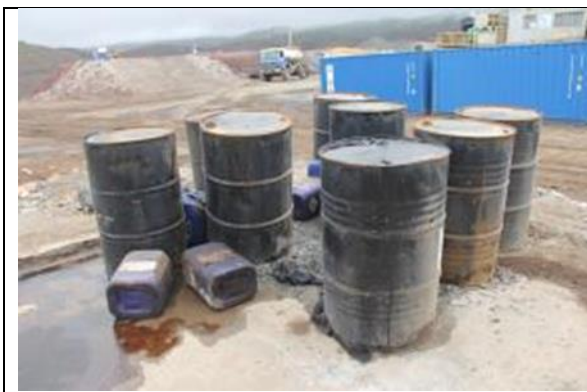
After the March 2015 audit, the auditor noted that while there had been a marked improvement in waste and litter management in certain parts of the site – especially Bradley’s camp, wharf and along the haul road, some areas still struggled to manage wastes successfully in spite of a Good Housekeeping Policy and monthly clean-ups. Although neither of the planned long-term solutions to hazardous waste disposal - the incinerator and the hazardous waste cell, was operational during the reporting period, the auditor was pleased with the improved organisation and management of the temporary hazardous and industrial waste storage area next to Bradley’s workshop. For the third audit in a row, no biosecurity incidents were noted, indicating that the control measures in Walvis Bay and at Rupert’s are working (see section 6.2.11).

Plate 13: Before corrective actions were taken at the PBP workshop area
