## Planning Officer's Report - LDCA JULY 2022

<b>APPLICATION</b>	<b>2021/47</b> – Annual Tree Maintenance at the Duke of Edinburgh Playground
<b>PERMISSION SOUGHT</b>	Permission in Full
<b>REGISTERED</b>	17 <sup>th</sup> June 2021
<b>APPLICANT</b>	Property Division, TI & SD Portfolio
<b>PARCEL</b>	JT080061 & JT080062
<b>ZONE</b>	Intermediate Zone
<b>CONSERVATION AREA</b>	Jamestown Conservation Area
<b>PUBLICITY</b>	The application was advertised as follows: <ul style="list-style-type: none"><li>▪ Independent Newspaper on 18<sup>th</sup> June 2021</li><li>▪ A site notice displayed in accordance with Regulations.</li></ul>
<b>EXPIRY</b>	2 <sup>nd</sup> July 2021
<b>REPRESENTATIONS</b>	None Received
<b>DECISION ROUTE</b>	<del>Delegated</del> / <b>LDCA</b> / <del>EXCO</del>

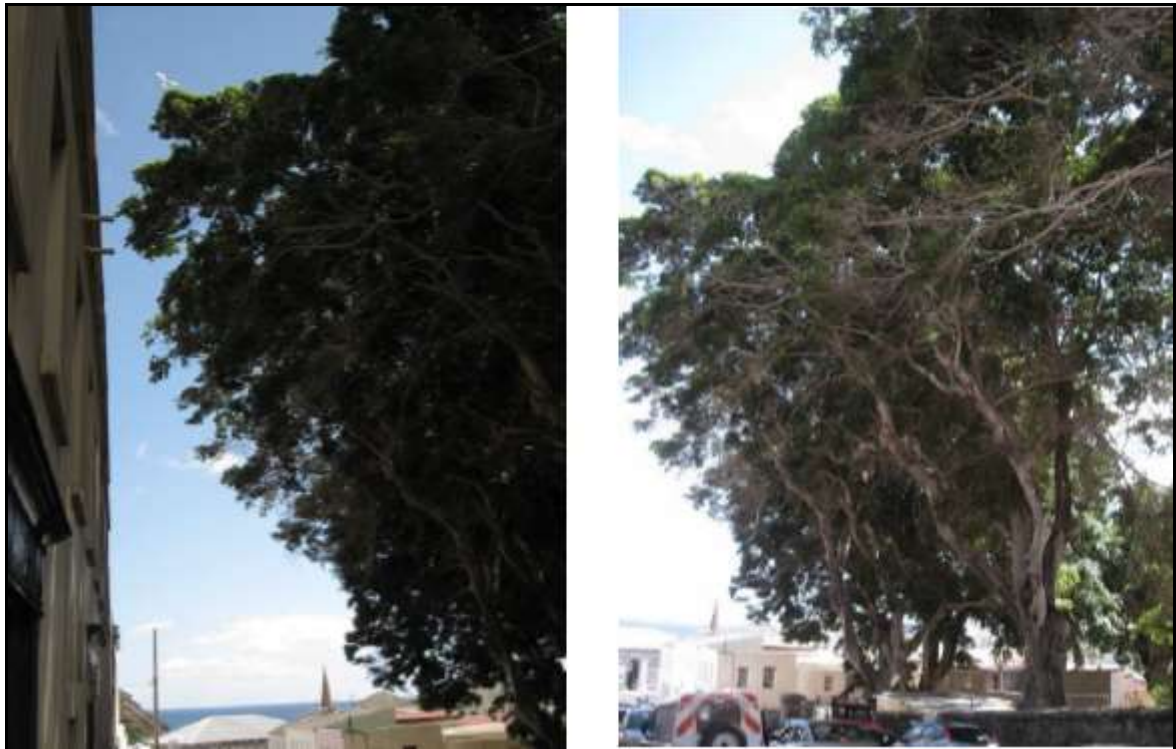
**Diagram 2: Dry limbs to be removed**

The canopies of the trees in the upper playground are transparent giving good visuals of the extent of their spread and condition. Overall an estimated 40% of the canopies are made up of dry material of small girth. It is worth noting that very little regeneration from previous cuts can be seen, especially of the nature seen on the trees of the Castle Gardens. The regeneration seen in the Duke of Edinburgh Playground is young, leafy growth, not developed as yet into limb materials at heights of 20 plus feet, interestingly on sections of the trees that were pruned approximately 10 plus years ago.

- **2022 Annual Tree Maintenance Schedule** – Removal of all dry limbs within the tree canopies, and removal of all low hanging limbs that may cause an obstruction to all users of the area.
- **2022-2023 Annual Tree Maintenance Schedule** – Topping of trees 1 and 2 only to a management height for future tree maintenance.
- **Year 2023-2024** – Topping to a manageable height for future tree management – trees 3 and 4.

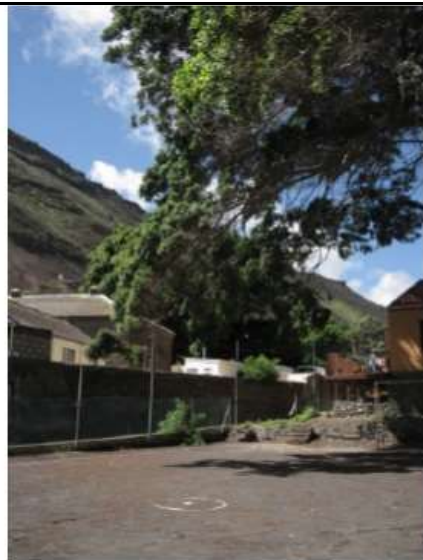
Figure 3: Dry limbs for removal, DoE (2021)

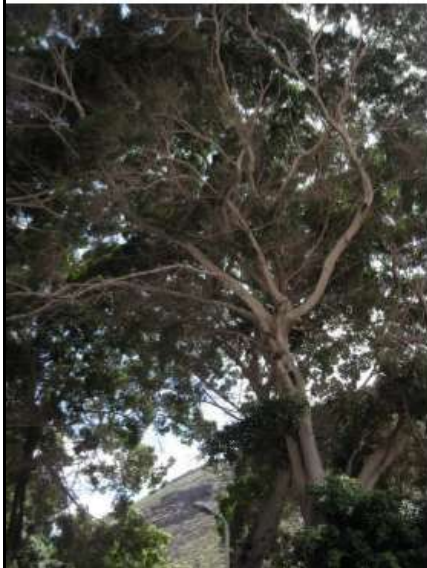
Figure 4: Low hanging limbs for removal, DoE (2021)
