ST HELENA AIRPORT PROJECT

ANNUAL ENVIRONMENTAL REPORT FOR PHASE 1: CONSTRUCTION 2016-17

December, 2017

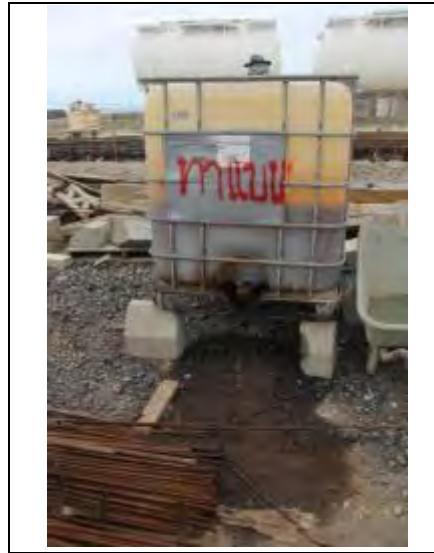
Plate 10: Poor management of Chryso spillage at the AFF site observed during the July 2016 audit

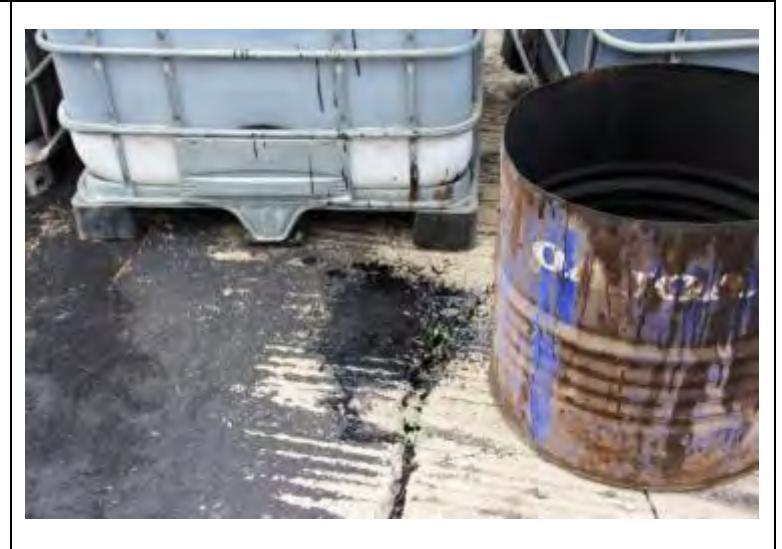
There was a significant decrease in the number of major findings observed during the July/August 2016 audit – from 18 recorded in the February 2016 audit to three, and this downward trend continued into February 2017 (Figure 7). The major findings in July/August 2016 related to leaking Chryso containers (Plate 10) and excessive noise and dust in Rupert's Valley, while the February 2017 audit recorded noise in Rupert's Valley and incorrect storage of leaking bitumen drums as the two major findings (Plate 11).

Plate 11: Poor management of bitumen containers and spillage in upper Rupert's observed during the February 2017 audit

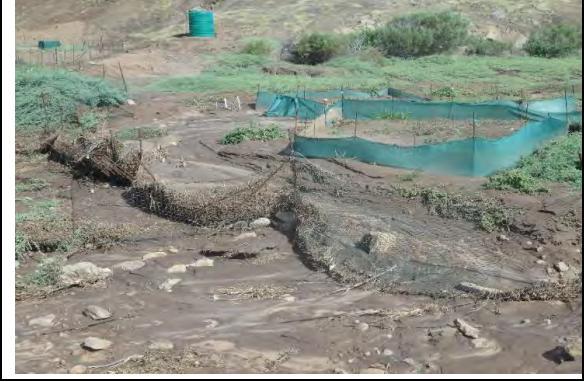
Overall the plant survival rate has exceeded the target of 50% with an average rate for all species being 69%, while for some, survival rate is over 80%. The gumwoods along the road just east of Reggie's are showing significant growth in spite of the drought earlier this year (Plates 35 and 36). Samphire is the only species below the target rate at 36%. This is due to some significant early losses due to inadequate protection against rabbits, as well as flood damage, particularly in Dry Gut (Plate 37).

Plate 37: Flood damage in Dry Gut which has destroyed some of the planted samphires (Photo: LEMP)

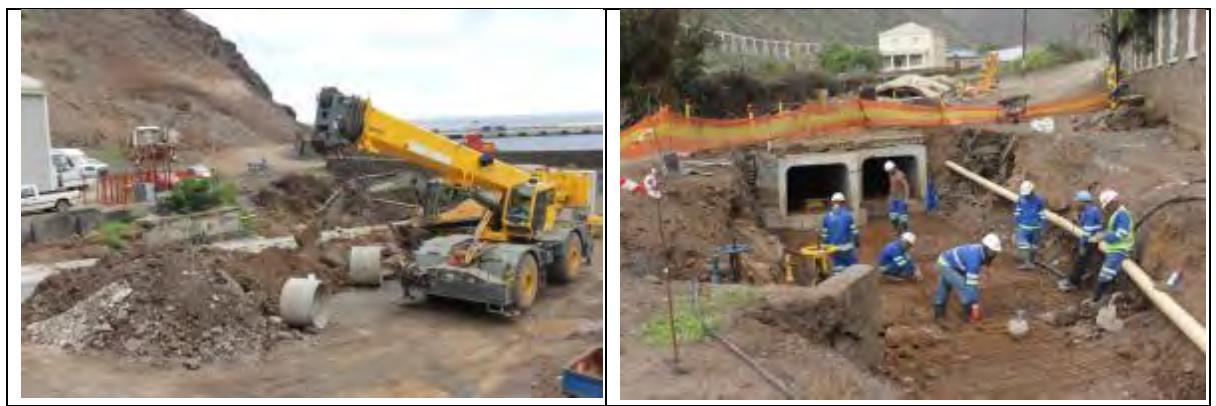
Plate 39: Construction works in lower Rupert's accounted for spike in dust in September 2016

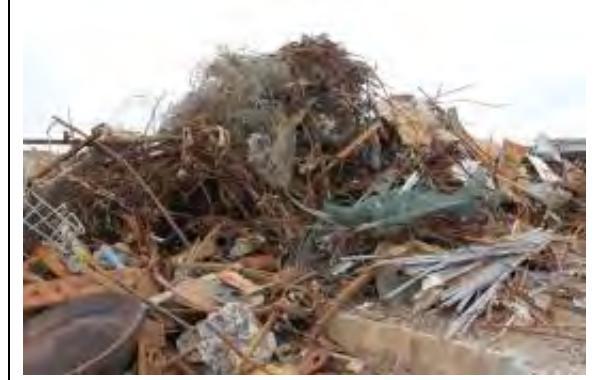
Plate 43: Temporary waste storage area next to Bradley's workshop in September 2015

Plate 44: Temporary waste storage area cleaned up and decommissioned in June 2017
