## Planning Officer's Report - LDCA JULY 2022

<b>APPLICATION</b>	2021/46 – Annual Tree Maintenance at the Castle Gardens
<b>PERMISSION SOUGHT</b>	Permission in Full
<b>REGISTERED</b>	17 <sup>th</sup> June 2021
<b>APPLICANT</b>	Property Division, TI & SD Portfolio
<b>PARCEL</b>	JT040007
<b>ZONE</b>	Intermediate Zone
<b>CONSERVATION AREA</b>	Jamestown Conservation Area
<b>PUBLICITY</b>	The application was advertised as follows: <ul style="list-style-type: none"><li>▪ Independent Newspaper on 18<sup>th</sup> June 2021</li><li>▪ A site notice displayed in accordance with Regulations.</li></ul>
<b>EXPIRY</b>	2 <sup>nd</sup> July 2021
<b>REPRESENTATIONS</b>	None Received
<b>DECISION ROUTE</b>	<del>Delegated</del> / LDCA / EXCO

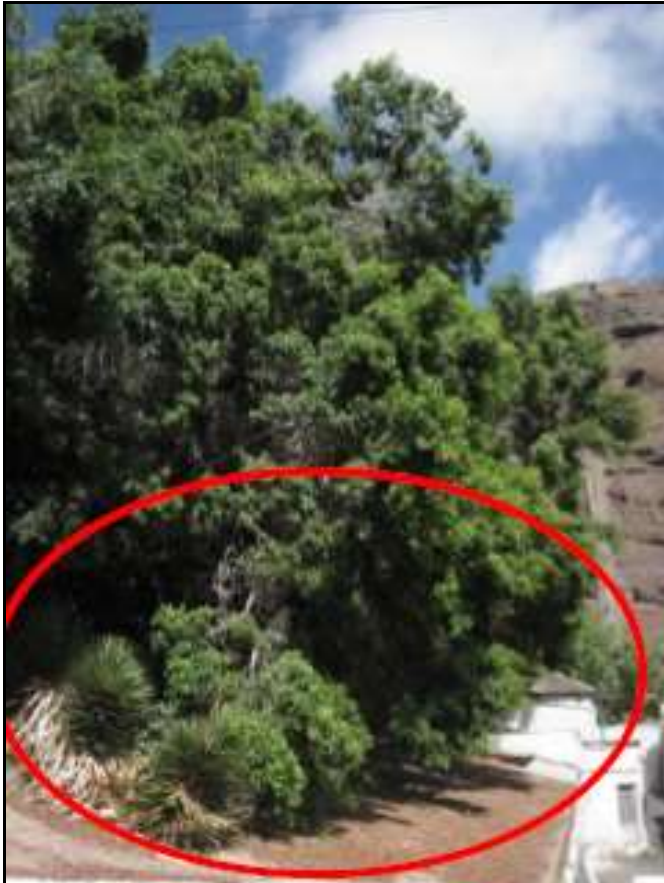
**Diagram 2: Low Hanging Limbs for Removal, Trees 7 – 9**

- Injury to users of the area from small falling dry limbs and or damage to property (Tree 5, 8 & 12)
- Deterioration to roof structures of ex PSWD workshop roofs from decaying matter deposited by trees (Trees 7-9)
- Damage to the roof of SAMS building through abrasion caused by movement of limbs in wind, rain etc (Tree 10)
- Damage to Ann's Place through abrasion caused by movement of limbs in wind, rain etc (Tree 11)

- Removal of all dry limbs from all affected canopies.
- Raise of low hanging limbs, where they exist that impact all identified energy and telecommunication lines, roofs and pedestrian traffic.
- **Year 2023-2024** – Topping to a manageable height for future tree management – trees 3 – 5 only.

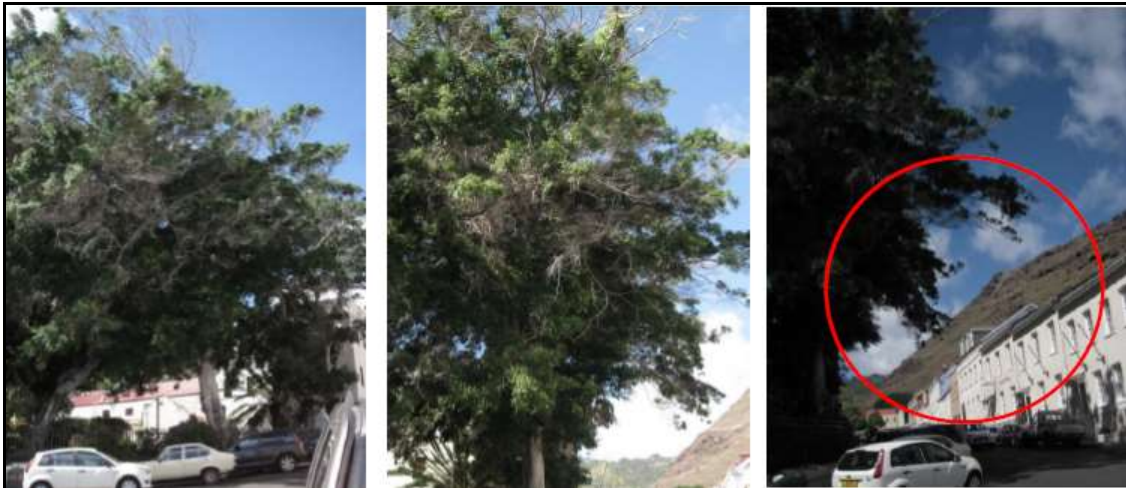
**Diagram 5: Dry limbs for Removal Trees 1 & 2**

The tree canopies are less stable in that they are littered with dead and drying limbs of various sizes that have been unable to be removed due to capacity, logistical and mechanic issues, during past maintenance works. This dry mass equals an estimated 60% - 70% of the overall canopy composition.

- **2022 Annual Tree Maintenance Schedule** – Removal of all dry limbs within the trees canopies that exist within trees 1-5 and 7. Remove of all low hanging limbs that may cause an obstruction to all users of the area and those now impacting the street and designated car parks located directly adjacent to the Castle Gardens.
- **2022-2024 Annual Tree Maintenance Schedule** – Topping of trees 1 and 2 only to a management height for future tree maintenance.
