Planning Officer's Report - LDCA NOVEMBER 2022

| APPLICATION | 2022/63 – Proposed Tree Topping at the Duke of Edinburgh Playground |

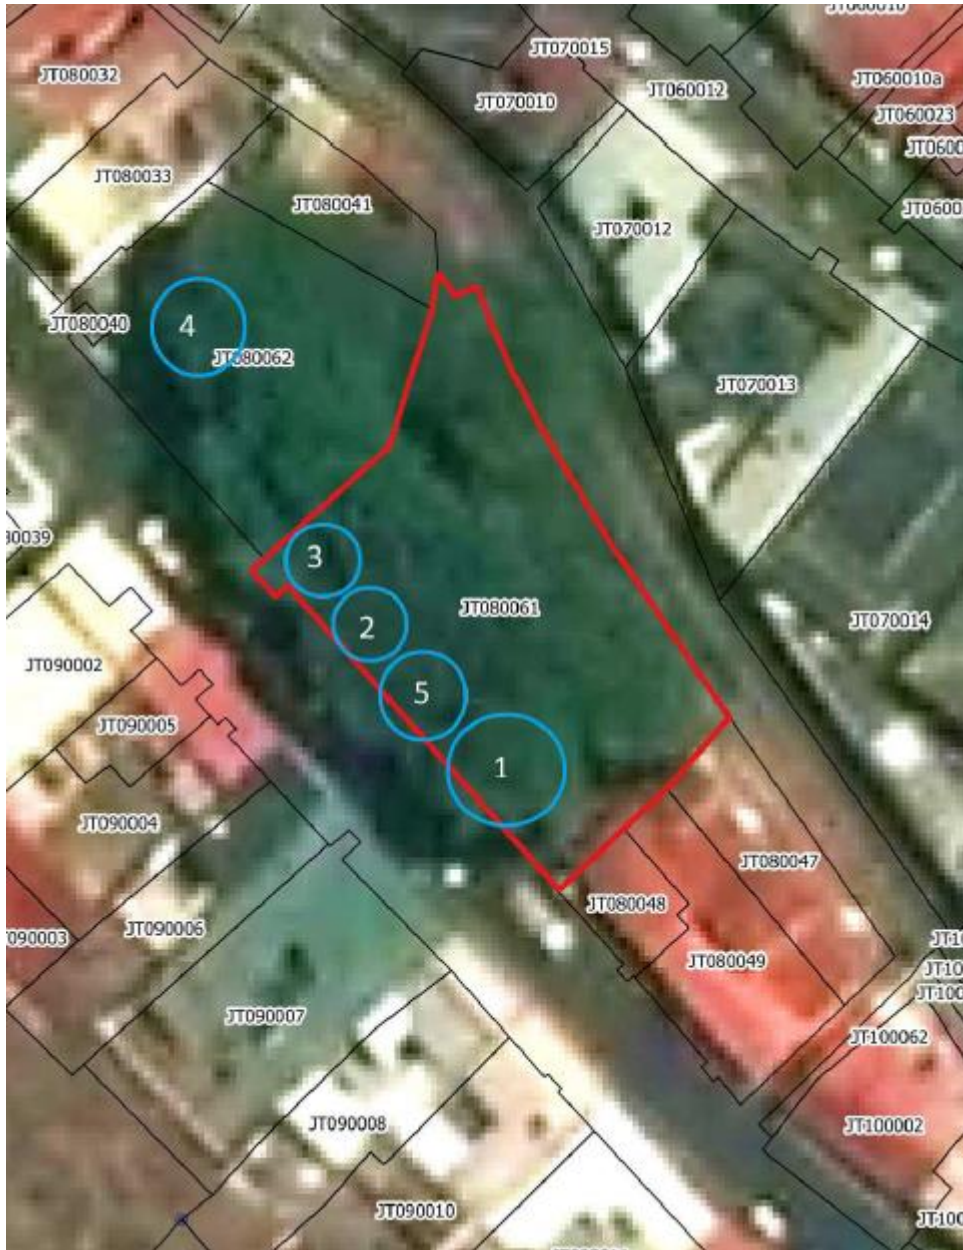
Diagram 1: Location of Trees

The application is for the proposed topping of tree number 5 in the Duke of Edinburgh Playground as shown on the location plan below. In July 2022 the LDCA approved the topping of trees numbered 1 to 4.

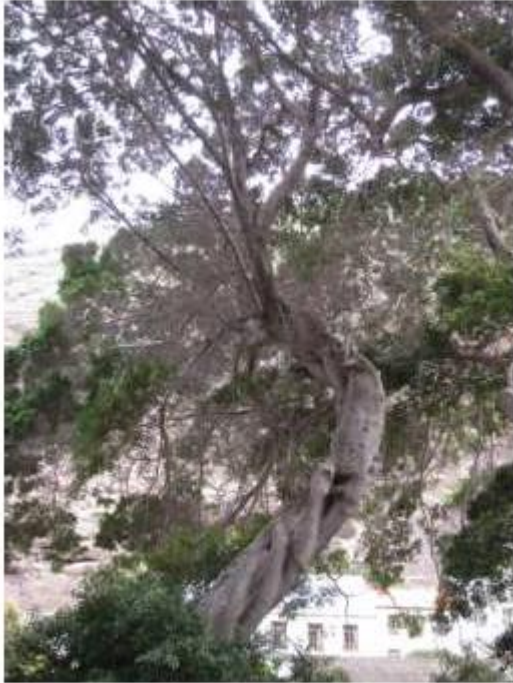
The canopy of the tree is littered with dry material of small girth (an approximate 40% of the canopy is made up of dead or dying limbs). The canopy is significantly intertwined with the canopies of trees one and two reported on in the Annual Tree Assessment Report, Annual Tree Maintenance, DoE 2021, and cannot be addressed in isolation. It is proposed that this tree is addressed to reduce the height and spread of the canopy and to relieve the risk associated with its current extent in tandem with Tree No 1, reported on in the aforementioned document and Decision Notice.

Figure 1: Indicating extent of canopy over DoE

- Topping to a manageable height for future tree management. While an ideal solution to mitigate the risk identified, this option if undertaken has negative implications for the tree. Topping is a practice that removes limbs of a tree at any point to reshape and resize the trees canopies and will be effective in reducing the height and spread of the existing canopies. However, this practice involves making cuts in a manner that reduces the trees ability to heal and to seal wounds and in doing so the opportunities for pest, disease and decay increases, leading to a severely stressed tree that is less tolerant of future surgery works.

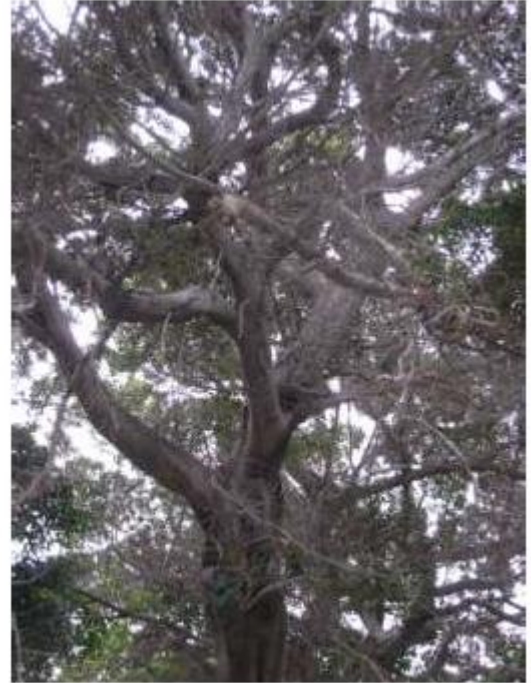
As with the remaining trees, this tree is in reasonable condition, despite there being a number of concerns in relation to the stability of the canopy caused by far reaching limbs and the sheer volume of dead and dry limbs that exist within.

Figure 2: Photo showing limbs extending into DoE and dry limbs in tree canopy

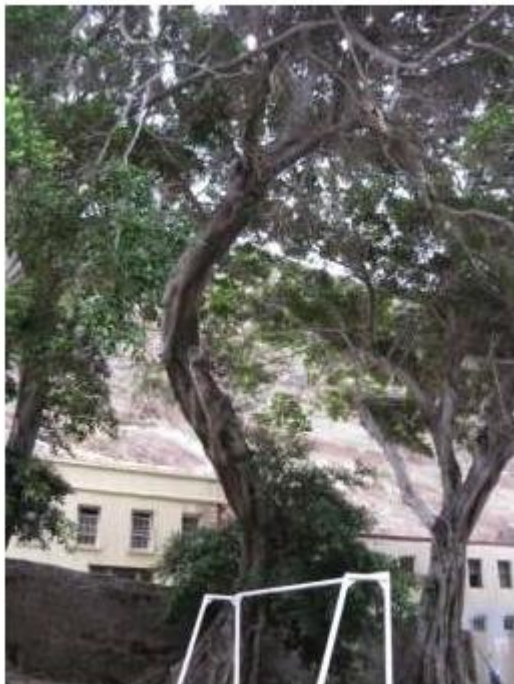
- The risk posed by this is significant, the location of this tree and the presence and use of public facilities directly below the canopy poses a direct risk to human life as well as private or public sector property.

Figure 3: Indicating low hanging limbs in DoE
