**ST HELENA AIRPORT PROJECT
ANNUAL ENVIRONMENTAL REPORT 2012-13
February 2014**

ST HELENA AIRPORT PROJECT

ANNUAL ENVIRONMENTAL REPORT 2012-13

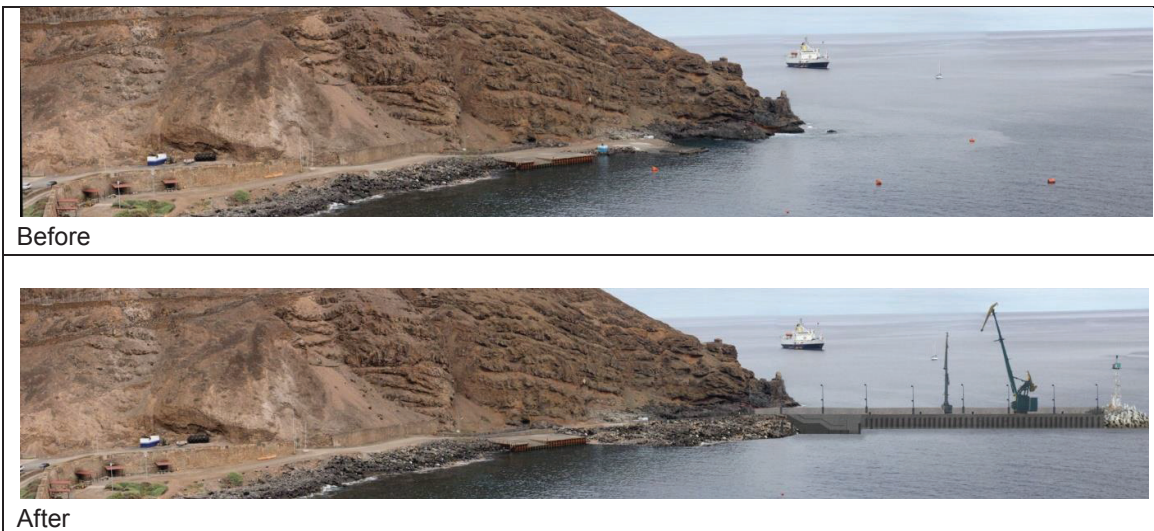
Plate 8: Visual simulation of the new wharf from Bank's Battery path (Photos: B Walmsley; simulation by Newtown Landscape Architects)

The visual impact could be viewed as being a major negative or positive impact depending on the viewer's perception.

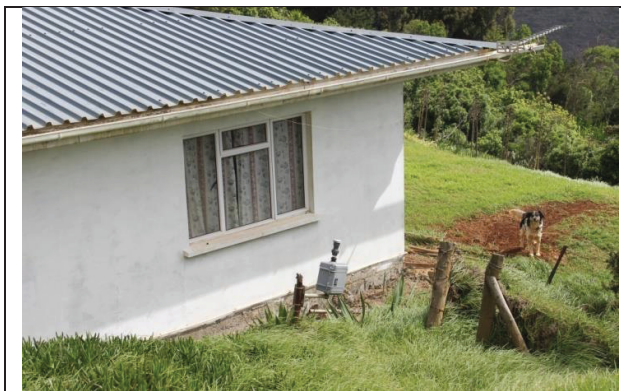
Plate 13: MiniVol PM10 dust sampler outside a house in Deadwood (Photo: B Walmsley)

While PM10 has been monitored at the main construction sites during the entire reporting period, namely at Rupert's Valley and PBP, problems in obtaining the correctly sized dust buckets has prevented the team from monitoring TSP during this period.

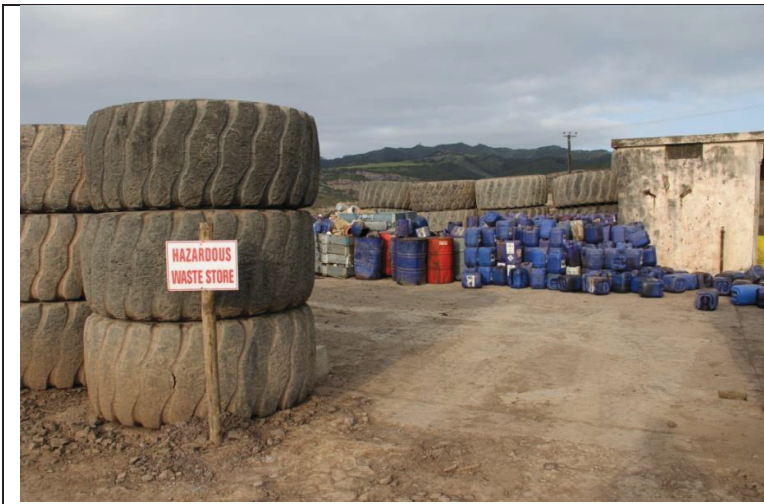
Plate 16: Hazardous waste store at Bradley's workshop
(Photo: B Walmsley)

Until a long-term, sustainable and permanent solution has been agreed, all hazardous waste is stored in clearly signed, bunded storage areas.

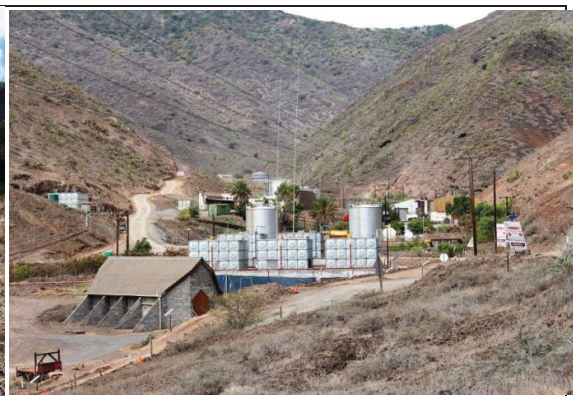
Plate 20: Rupert's Valley after construction of the temporary fuel farm and haul road (April 2013) (Photo: B Walmsley)

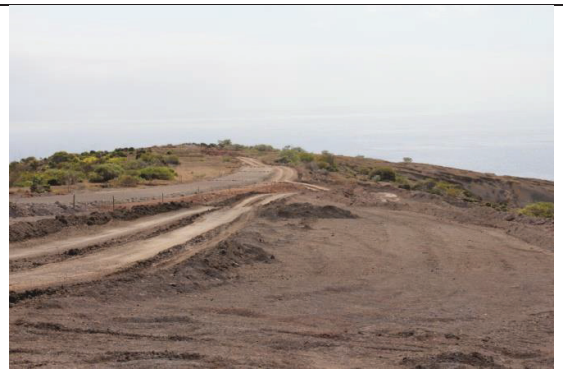
Plate 22: Same view showing the new access road under construction (September 2013) (Photo: B Walmsley)

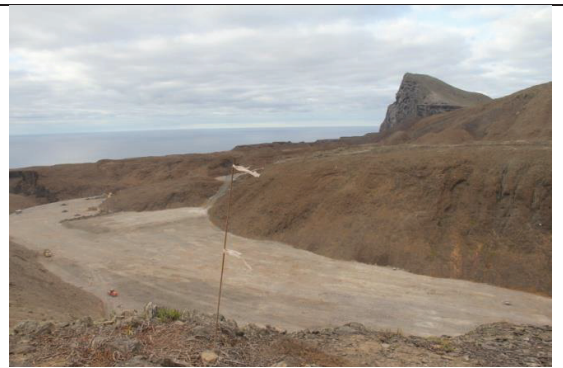
Plate 24: Similar view of Dry Gut with rock filling in progress (April 2013) (Photo: B Walmsley)
