ST HELENA AIRPORT PROJECT ANNUAL ENVIRONMENTAL REPORT 2013-14

March 2015

**Prepared by
Bryony Walmsley
CEMPC**

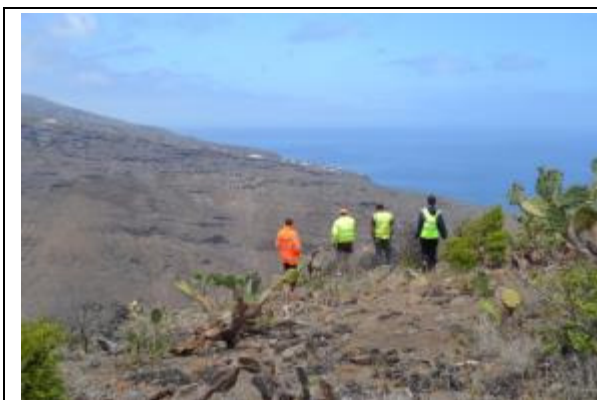
Plate 1: Inspection of the potential site for a quarry at the top of Rupert's Hill. The quarry was not developed due to environmental and geotechnical constraints

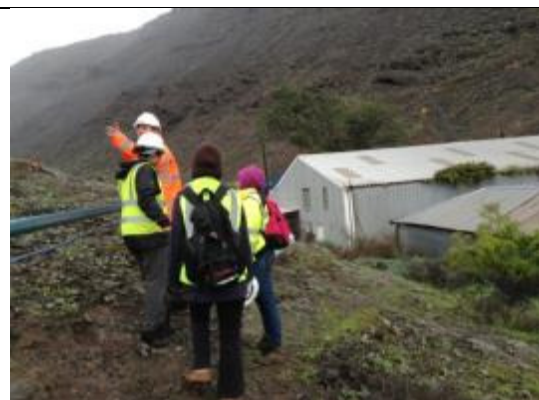
Plate 2: Inspection of routes for the new fuel pipeline from the wharf to the new bulk fuel installation

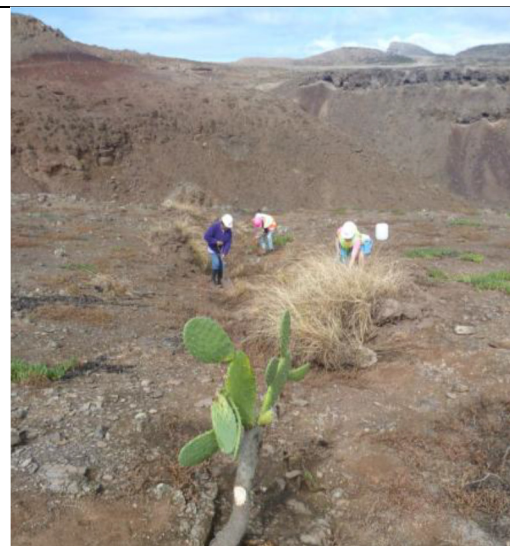
Plate 14: Translocation of Tropical Finger Grass and Fishbone Grass - the preferred habitat for the St Helena grass fly

Despite the barren and inhospitable nature of the site, it holds a diverse invertebrate fauna including many endemic species, some of which are apparently quite scarce. It is probable that these species are more widespread in the area as they are poorly studied and little is known of their ecology. Further endemic species are almost certainly present amongst the taxa that could not be identified to species level (Pryce and Paajanen, 2014). While it was concluded that the impact of construction works on the invertebrate fauna would be quite low, as all species are known from other sites, some mitigation works were undertaken in June, 2014. This involved the removal of 20 trays of grass tufts which had been identified as preferred habitat for the St Helena grass fly (*Anarista vittata*), to a new location about 50 m away (Plates 13 and 14).

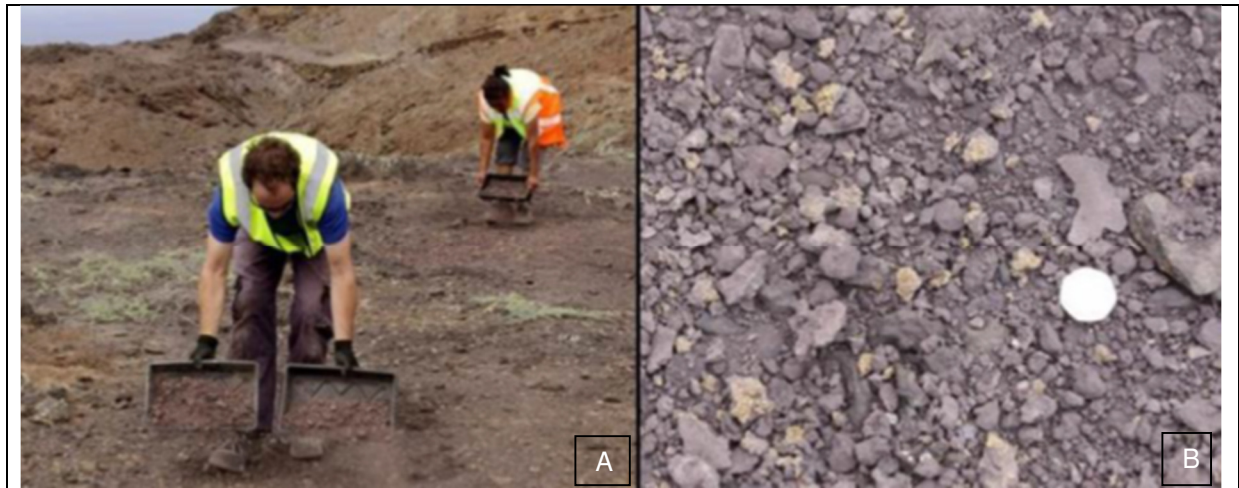
Plate 15: Scattering the soil crust, *Dimelaena triseptata*, at the storage site (A) and a close up of the soil crust at the storage site (B)

The scarce endemic lichen *Dimelaena triseptata* was found to be present across the site in good numbers and so 64 trays of the soil crust containing the lichen were collected and replaced in similar

habitat nearby (Plate 15). In addition 16 trays of lichen-covered rocks were collected and placed to the east of the site in an area that will be unaffected by the runway works.

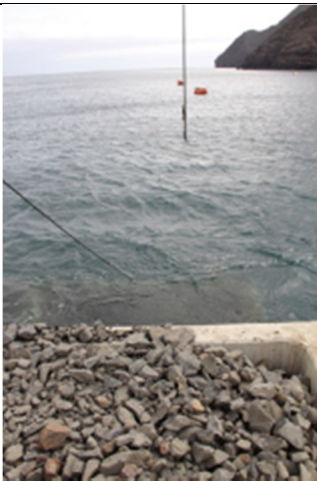
The design of the wharf involves the placement of concrete block walls on top of a layer of crushed rock. Once each block wall is placed, it is filled with crushed rock to create a level platform for the next block wall to be placed on top (Plate 16). The toe of the wharf will be protected from the swells and currents by Core-locs which are interlocking concrete structures that diffuse wave and current action and protect the wharf structure from damage (Plate 17). Manufacture of the block walls and Core-locs commenced in January 2014 at specially constructed facilities in Rupert's Valley (Plate 18).

Plate 16: A block wall being filled with crushed rock

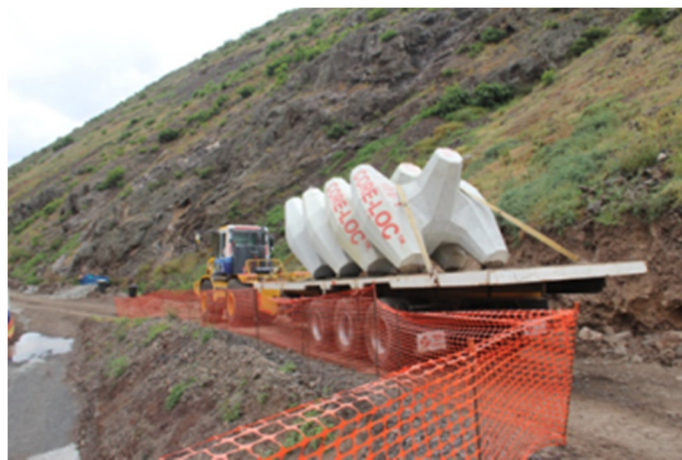
Plate 17: Core-locs being transported from the pre-cast yard in Upper Rupert's Valley to the wharf site

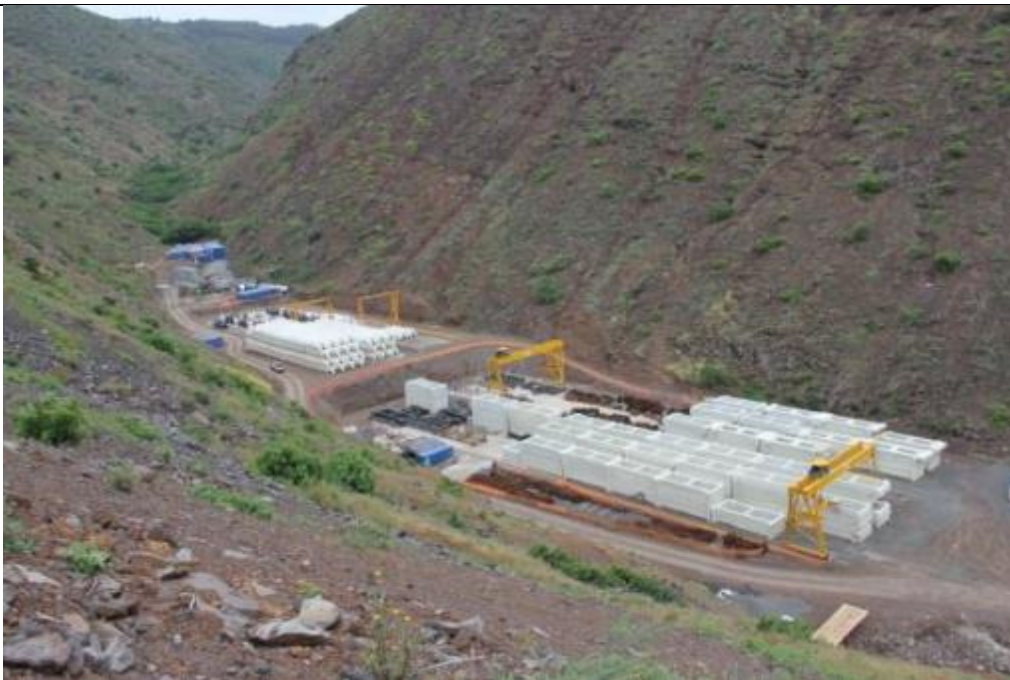
Plate 18: From left to right: concrete batch plant, Core-loc yard and block wall pre-cast yard in upper Rupert's Valley

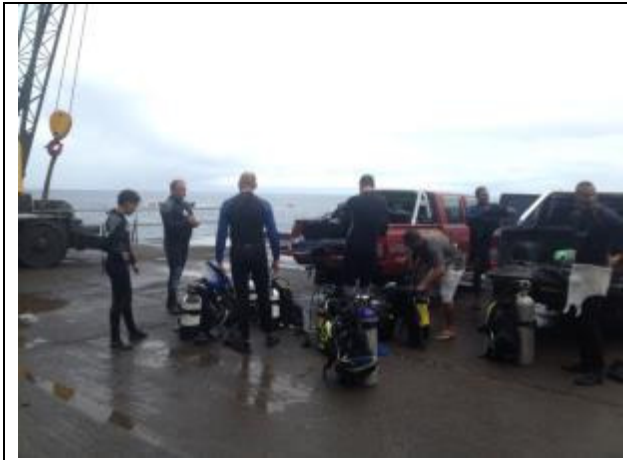
Plate 19: A group of divers prepares to conduct a marine species rescue and translocation operation at the wharf

Prior to the commencement of construction at the wharf, the Marine Darwin Project team, with the assistance of BR divers conducted a rescue and translocation of marine species to similar habitats nearby (Plate 19). In addition, the Marine Darwin personnel identified a suitable sandy area to the seaward side of the wharf where sediment pumped from the footprint of the wharf could be deposited without smothering important marine life. Subsequent marine surveys in the area have shown that the impacts on marine life have been minimal, as predicted in the EIA study.

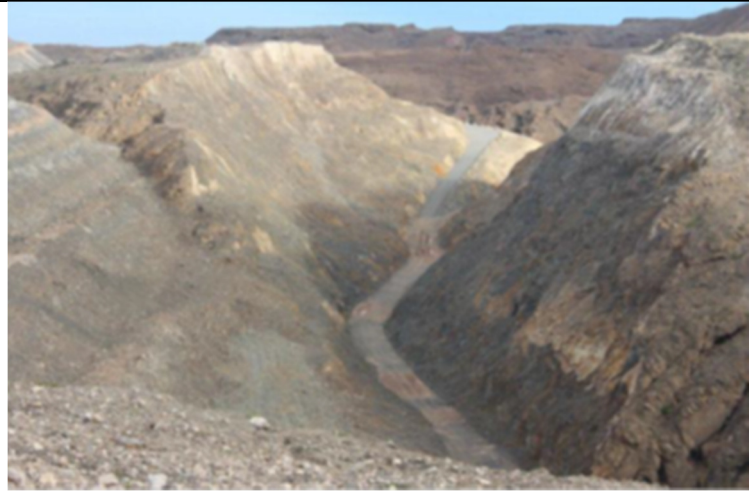
Plate 20: The open channel was completed on 14th June 2013. It discharges into Little Dry Gut valley (out of picture). Note Dry Gut fill in foreground left of picture.

The construction of the open channel had two main objectives: to provide rock for the Dry Gut fill and to divert the Dry Gut water course around the fill rather than conveying it through a culvert under the fill. The rock was found to be geotechnically sound for fill material with almost no wastage, and the channel has already received stormwater flows through it (Plate 21). These flows, as well as the winter rains have resulted in a considerable amount of natural revegetation along the base and sides of the channel (Plate 22), but care will have to be taken to ensure that invasive species such as wild mango do not proliferate; the environmental team is monitoring this.

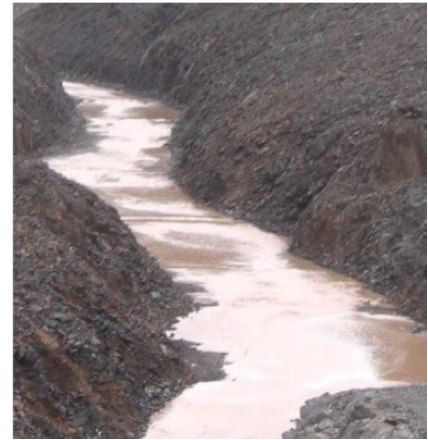
Plate 21: Rainfall in the upper Dry Gut catchment on the following day (15th June) resulted in flow through the channel.

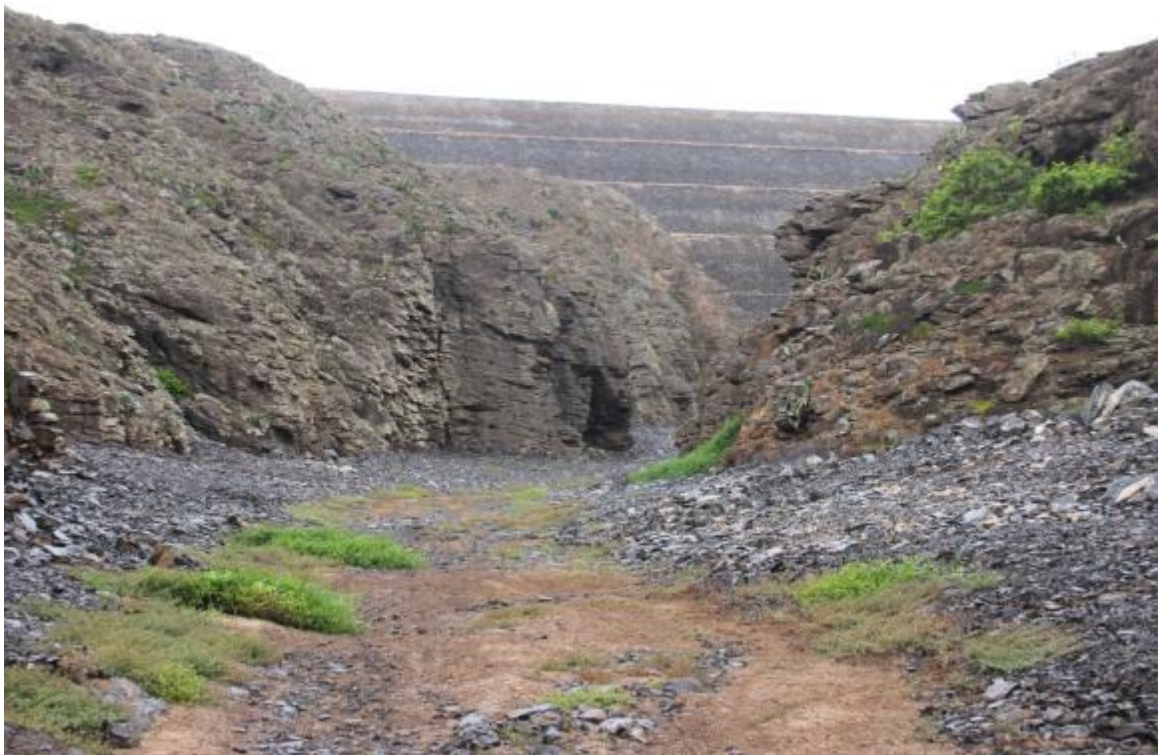
Plate 22: Natural revegetation of the bed and sides of the open channel after rain. Note the Dry Gut fill in the background.

From the above evidence, it would seem that the prediction in the EIA Addendum that the open channel would have a minor adverse impact on the ecology was correct and that natural systems are already recovering. However, it will take time for the walls of the channel to be colonised with lichens and other natural species.

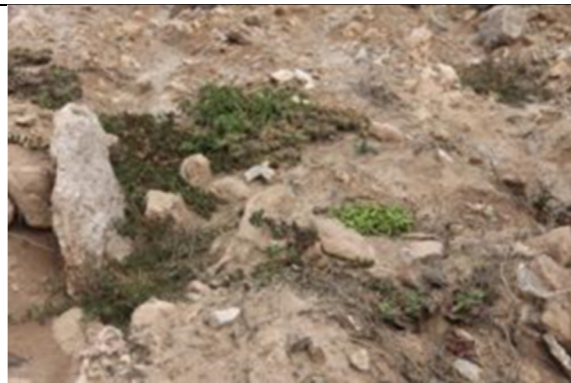
Plate 23: Four different self-sown species in rehabilitated area of Creeper Hill (babies toes, samphire, salt plant and creeper)

- Ripping and topsoiling the old site access road on Creeper Hill in October 2013 (Plate 23);
- Weeding out of Common Goosefoot on the northern side of Creeper Hill to prevent it from hybridising with the endemic St Helena Goosefoot, and collection of seeds from the latter;

- Dry Gut open channel (Plate 22);
- Dry Gut fill terraces;
- Line of sight batter (Plate 27A);
- Cut slopes behind terminal building (Plate 27B);
- Mole spider hill (Plate 23);
- Topsoil stockpiles (Plate 27C);
- On slope below haul road leading out of Rupert's Valley (Plate 27D);
- On cut and fill slopes along the access road.

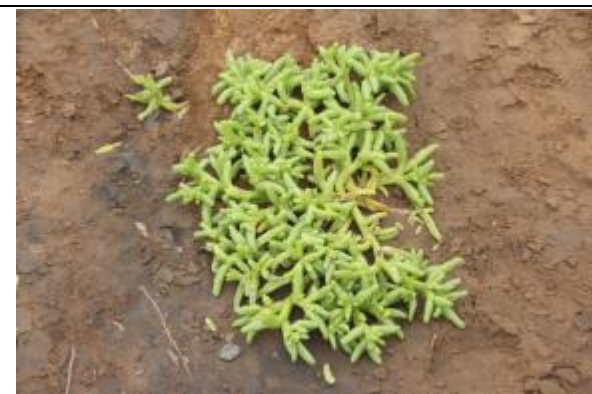
Plate 26: Babies Toes flourishing on the Dry Gut terraces

- Ongoing collection of seed from Babies Toes, Samphire, native grasses. Much of this has been sown on the Dry Gut terraces (Plate 26);
- Collection of Tufted Sedge plants on Pipe Ridge in July 2013, which were taken to the Bradley's nursery. Unfortunately all the plants died of root mealy bug;

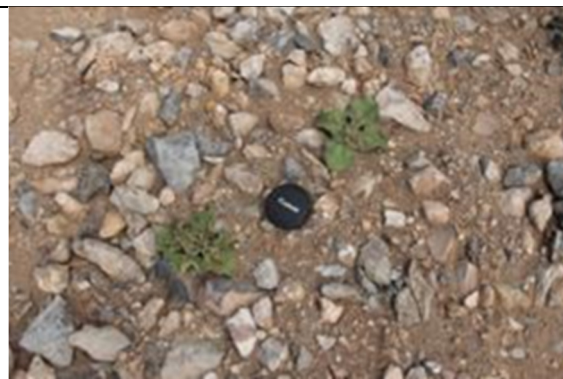
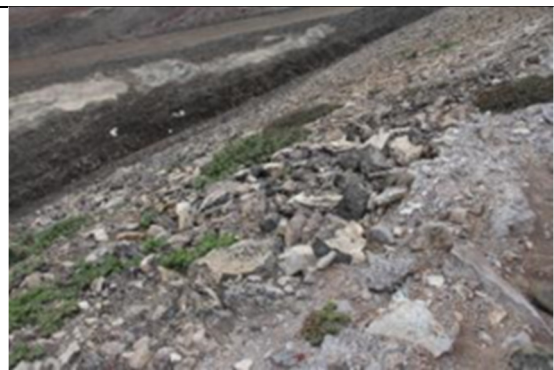
Plate 27: Natural revegetation is occurring across the site

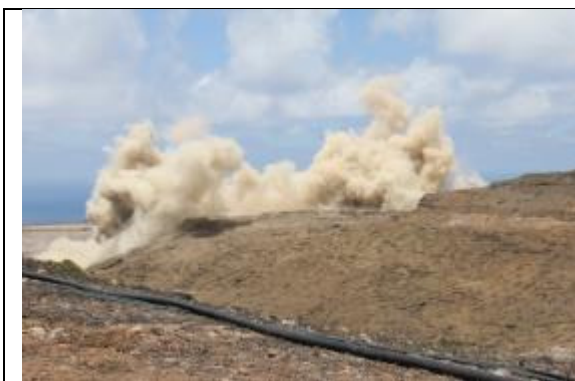
Vibration readings are taken at the airport site to monitor blasts on the runway and during blasting for the open channel (Plate 28). Readings are within specified limits for buildings (see AER, 2013). Ad hoc readings were also taken following complaints of vibration when the rollers were in use for road construction (Plate 29). Vibration levels (peak particle velocity) were found to be below the British Standard 6472 guideline limit of 1.5 mm/s outside residential buildings (Figure 17).

**Plate 28: Blasting for the open channel
(February 2014)**

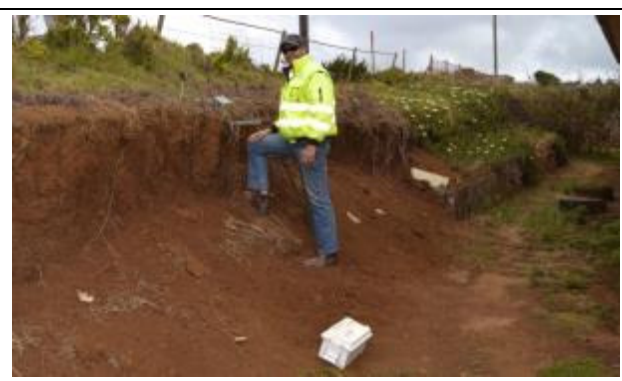
**Plate 29: Monitoring vibration during use of the
heavy roller near a house in Deadwood
(November 2013)**

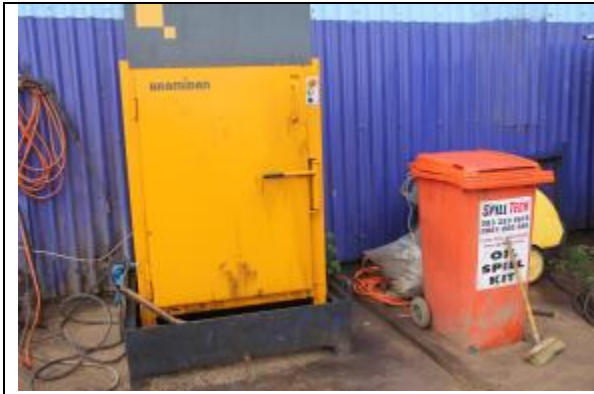
Plate 30: Drum compactor

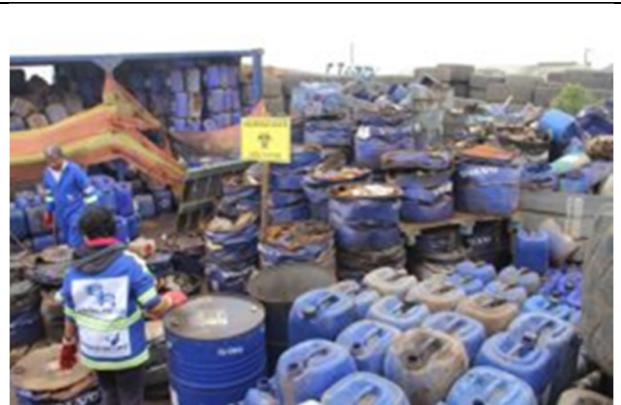
Plate 31: Drums containing oil filters after having been compacted. Note that the jerry cans cannot be effectively compacted and still take up excess storage space before being cleaned.

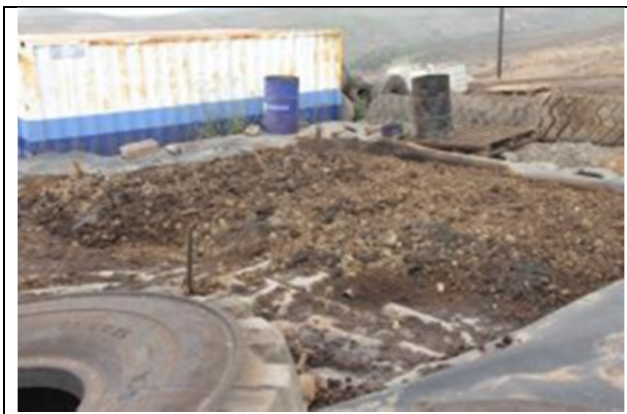
Plate 32: Bioremediation pad in operation at Bradley's. A photo-ionising detector is used to determine when the hydrocarbons have been broken down enough to render the soil as 'clean'.

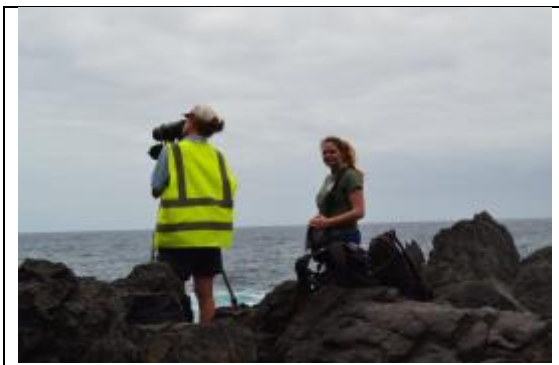
Plate 33: Monitoring seabirds at Gill Point.

Members of the BR environmental staff are assisting the EMD with monthly seabird monitoring at Gill Point. Seabird observations are made at the top and bottom of Gill Point looking out towards Shore and George Islands (Plate 33). Black Noddies are the most numerous species, numbering up to

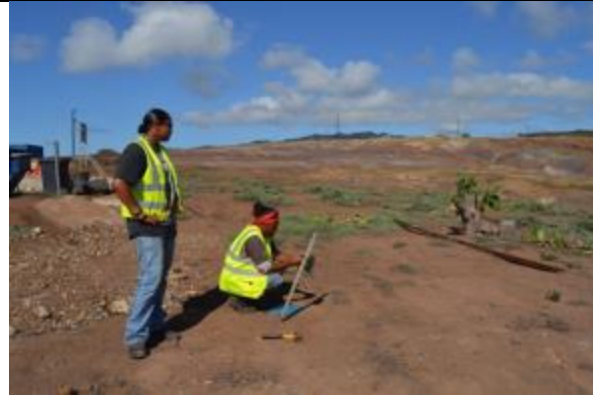
Plate 34: SHNT personnel setting up a camera trap near Bradley's

Rabbits, mynahs, rodents and cats are monitored at 45 locations across the entire construction site. Rodents are monitored using tracking tunnels and camera traps (Plate 34), cats are caught using cat traps (Plate 35) and the presence of mynahs is monitored during the monthly Wirebird monitoring 'sweeps'.

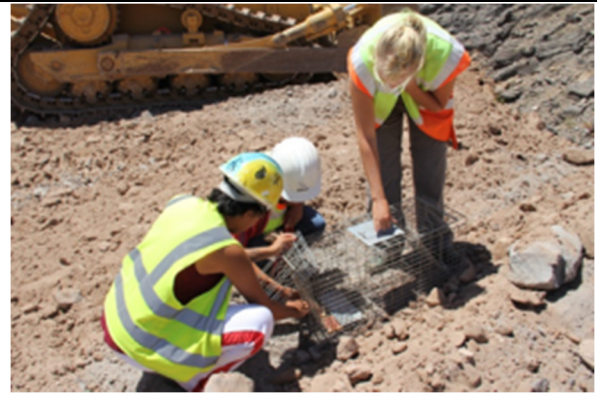
Plate 35: Members of the BR environmental team preparing a cat trap in Middle Fill

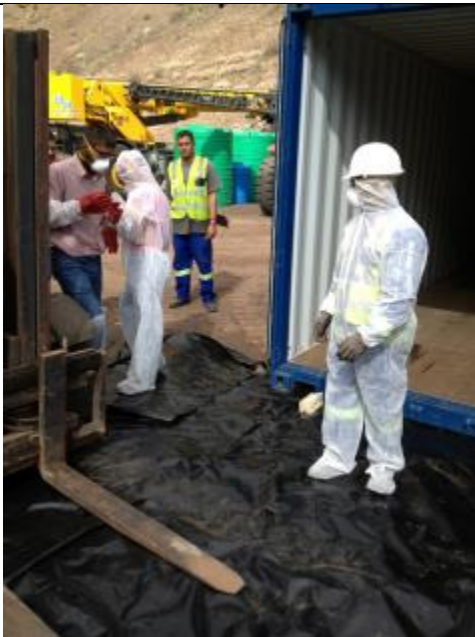
Plate 36: Environmental and biosecurity personnel inspecting containers as they arrive

Thus, all containers, vehicles and equipment are sanitised or fumigated and inspected before they are loaded onto the NP Glory 4 at Walvis Bay and they are inspected again as they are off-loaded in Rupert's Bay (Plate 36). Imported building sand also poses a risk; it is fumigated at source and a random 10% sample of the batch is inspected for live and dead animals or pupae. In addition to regular inspections, monthly monitoring for weeds is carried out where the containers are unloaded in Rupert's Valley and where imported sand is used on site to make sure that no alien species have escaped. One batch of Namibian building sand was found to contain viable seeds of the Namibian ice plant, which started to grow in the sand at the terminal building site. The plants were pulled up and destroyed and procurement of sand from that source in Namibia was discontinued.

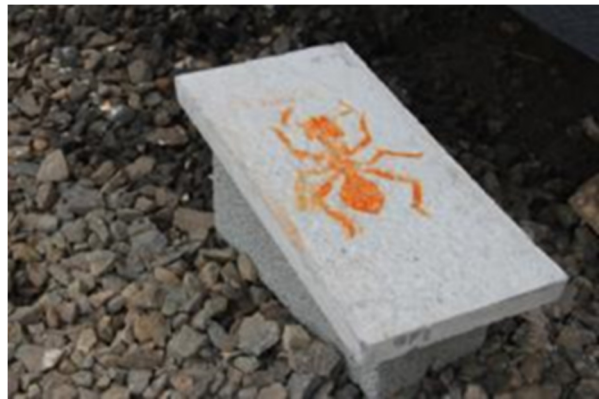
Plate 37: An insect 'hotel' used to monitor whether alien species have escaped into the environment

The monitoring method comprises the deployment of invertebrate refuges or 'hotels' (breeze blocks stuffed with scrunched up newspaper) and two sticky traps in each refuge (Plate 37). The monitoring sites are located at the Customs bonded yard (2), the batch plant at the pre-cast yard (1), Bradley's camp kitchen (1), Bradley's garage (1), explosives magazine (1), Prosperous batch plant (1), BME containers (1) and the combined building site (1).

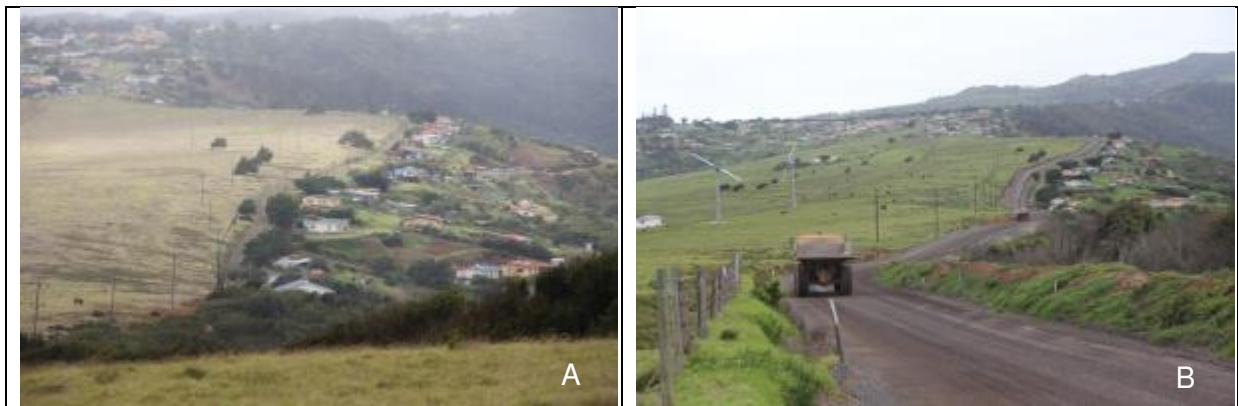
Plate 39: View of the old Deadwood road in January 2012 (A) and the new road in 2014 (B) (Note new wind turbines)
