ST. HELENA AIRPORT AND
ASSOCIATED INFRASTRUCTURE

FIGURE 11.4
RUPERT'S, BANKS' & SANDY BAY LINES

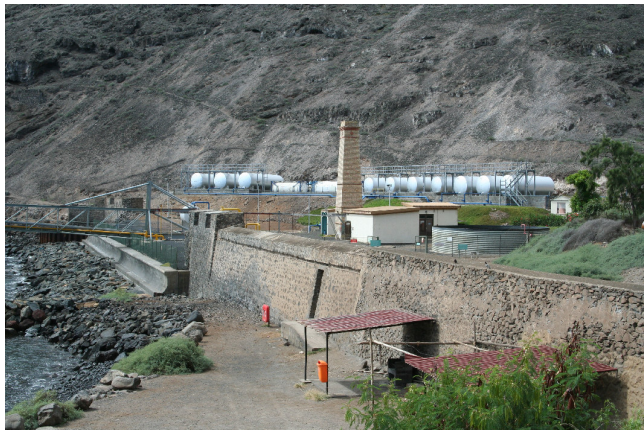
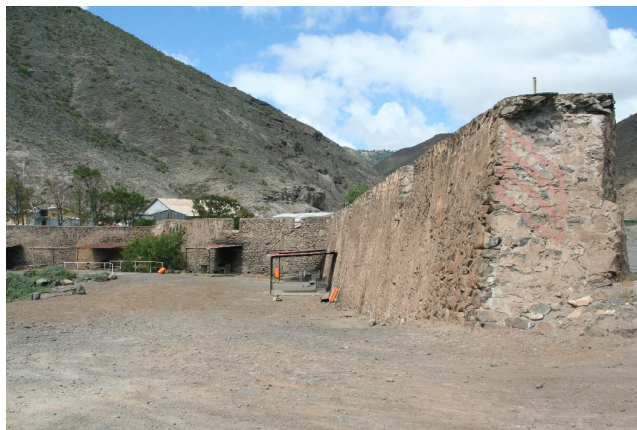
Top left and right: Rupert's Lines, showing the break in the defences caused by marine erosion, and (in the foreground), made deliberately for an opening for the road to the the Shears. Note also the lean-to structures now fastened to the front of the defences

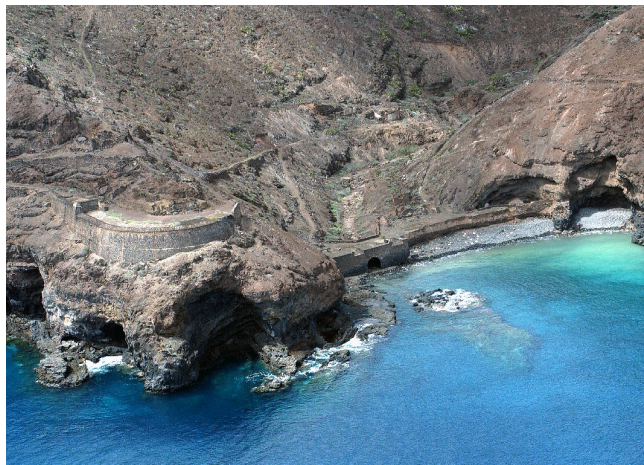
Centre left: Banks' Lines in the present day

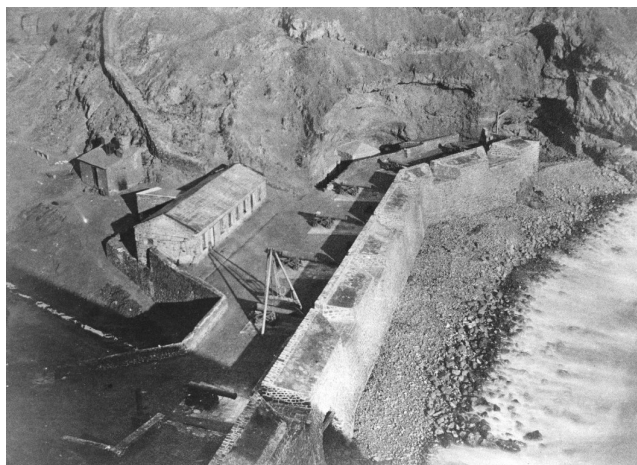
Centre right: Photograph of Banks' Lines taken at an unspecified date in the 19th century. At this time the site was still in operation, as shown by the cannons in place behind the parapet. The buildings behind the defences and the revetted track leading to Rupert's Bay are also in an excellent state of preservation. However, erosion of the defences had already begun, with the undermining of the base of the curtain wall at the far (south) end

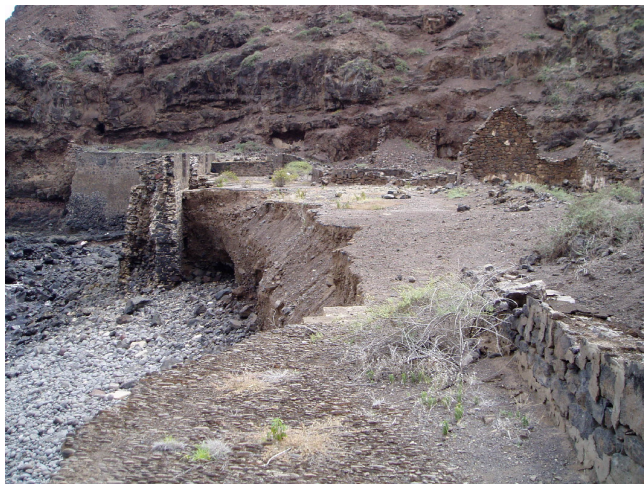
Bottom left: Banks' Lines, showing the extent of marine erosion to the defences, the cobbled surface behind the Lines (foreground) and contemporary buildings

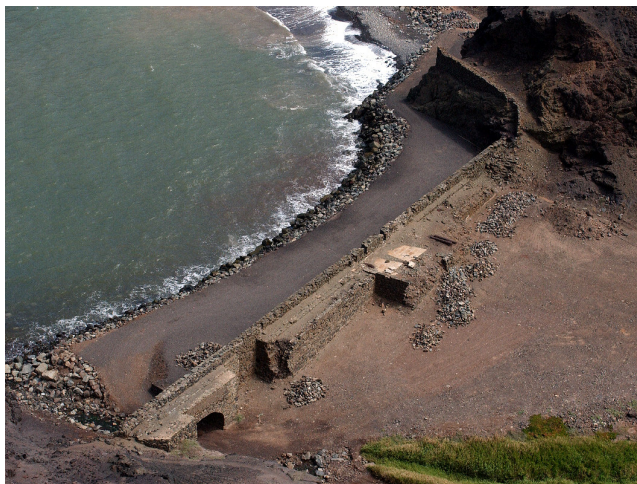
Bottom right: The Lines at Sandy Bay, destroyed by erosion and since reconstructed
