ST HELENA AIRPORT PROJECT

**Planning Statement: Request for  
Amendment to Development  
Permission for Airport Project Works in  
Prosperous Bay Plain**

**Realignment of Security Fence Near the Doppler  
VHF Omnidirectional Range (DVOR)**

May 2016

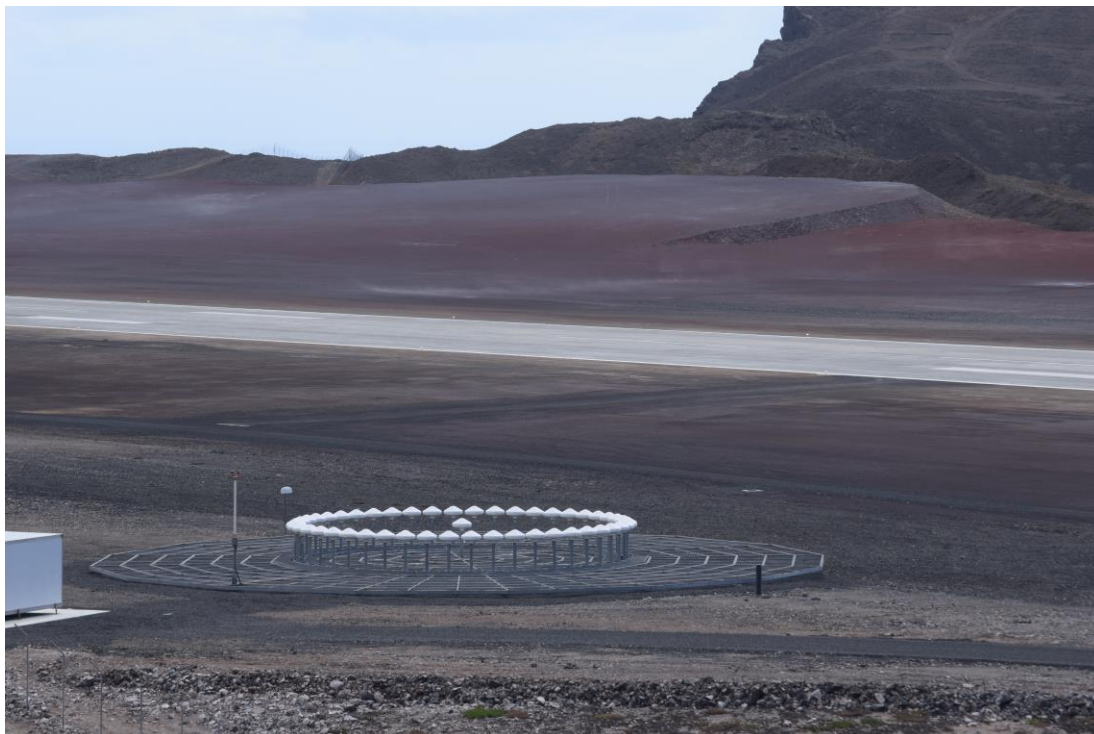
The DVOR is one of the essential navigational aids needed to operate St Helena Airport. It was originally located near Bradley's Camp but following the first calibration flight in September 2015, it transpired that this location was not workable. Following consultation with the SHG Planning Department the DVOR was relocated to the 1 in 7 batter near the Airport Buildings at Prosperous Bay Plain.

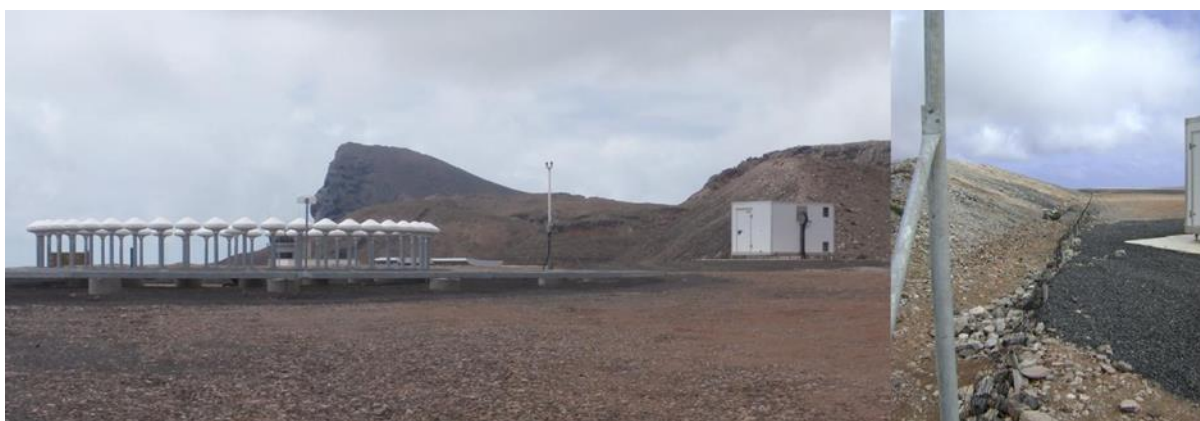
Background. As part of the navigation aid fit for St Helena airport, the DVOR was re-located to a mid-position to the West of the runway. Locations available within the Airfield Development Area allocated by the Client were very limited. This was done to significantly improve the technical performance and the modelling studies done beforehand required a section of security perimeter fencing be removed.

The existing metal fencing was identified as a significant risk causing reflections impacting on the DVOR performance and a large section of it was removed. This document expands on these issues and is intended to propose appropriate mitigation to satisfy both airport security and aircraft safety.

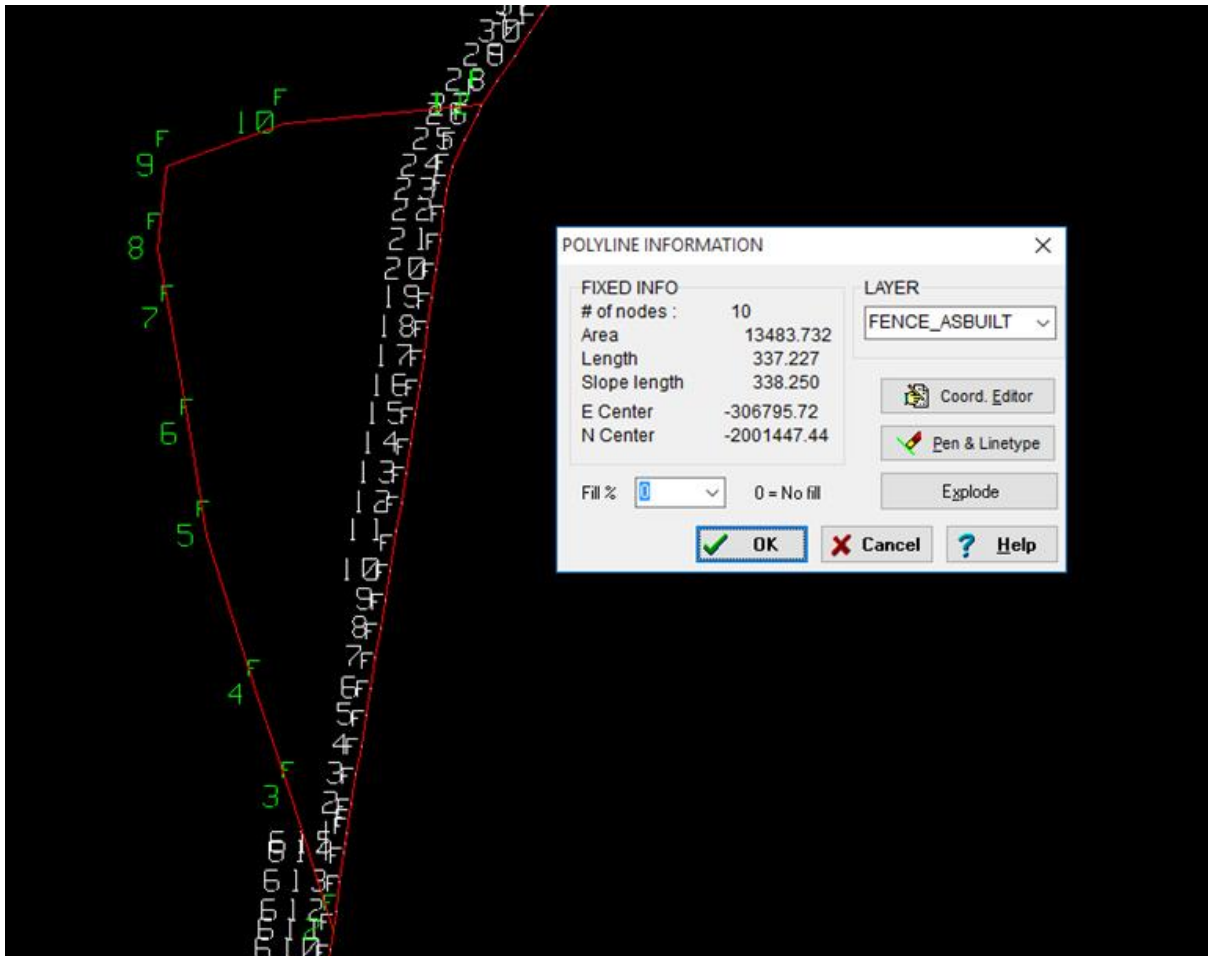
Simple Mitigation. The problems associated with reflections of various types of fencing, necessarily considered due to the fenceline proximity, can be very simply mitigated by routing the fenceline differently. If routed such that it is hidden behind the natural rising ground to the West, which is known to have no effect, then neither the Safety and Operation of the DVOR, nor the Security characteristics of the fence are compromised. This option also has the benefit that vehicular (and pedestrian) traffic could not park on top of that rising ground and introduce operationally damaging temporary reflections.
