RFA DARKDALE SURVEY

SALVAGE AND
MARINE
OPERATIONS

SURVEY REPORT

This document was prepared following the survey of *RFA Darkdale*, at St Helena in 2012 by Salvage and Marine Operations.

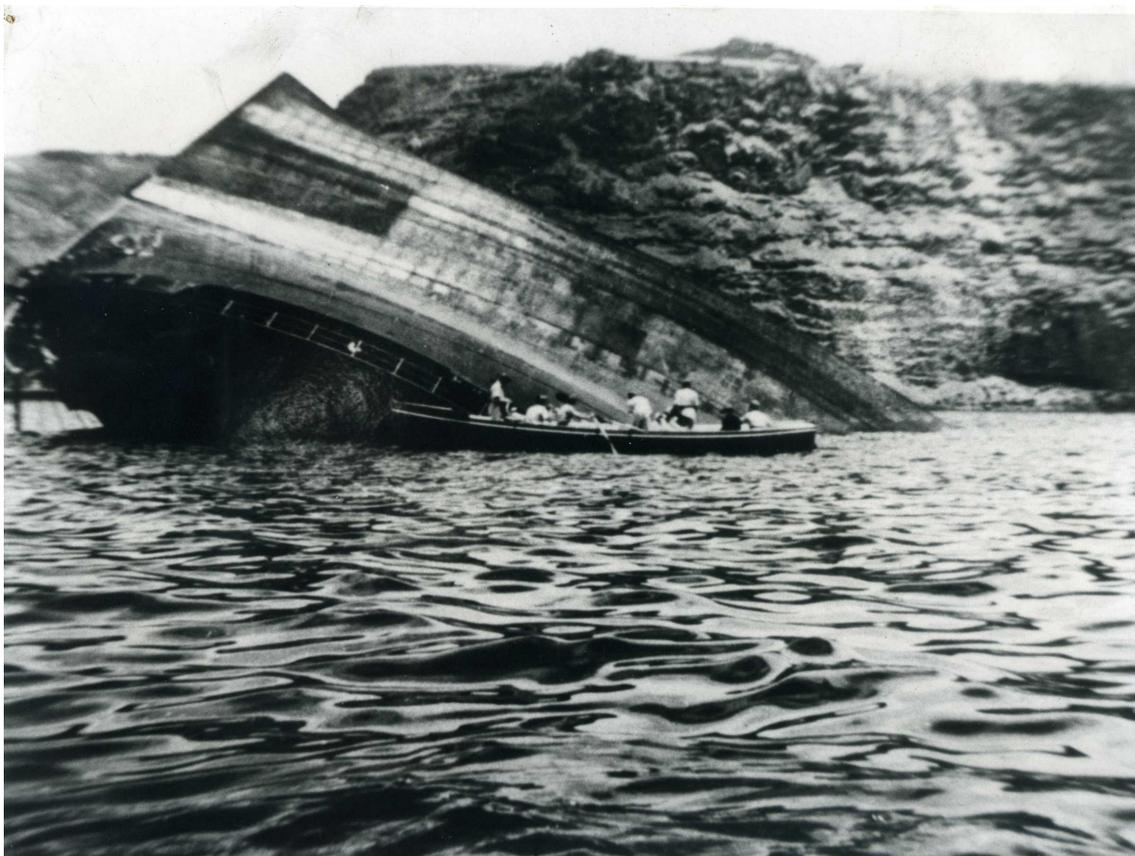
Figure 4 - Bow section shortly after sinking. (Picture courtesy of St. Helena Museum)

54. The attack resulted in the loss of significant amounts of oil from the ship. Although the amount is difficult to quantify it was sufficient to leave the water around the wreck burning for several hours after the attack.

57. The diver survey therefore may well have provided the British with a useful, and non-sensitive, means of pinning the attack on a submarine. The report likely to have been produced by the divers has not been sourced. However, it appears they found the bow section of the *Darkdale* in much the same position as that shown in the photograph in Figure 4. *HMS Milford* departed St Helena on 13 November.

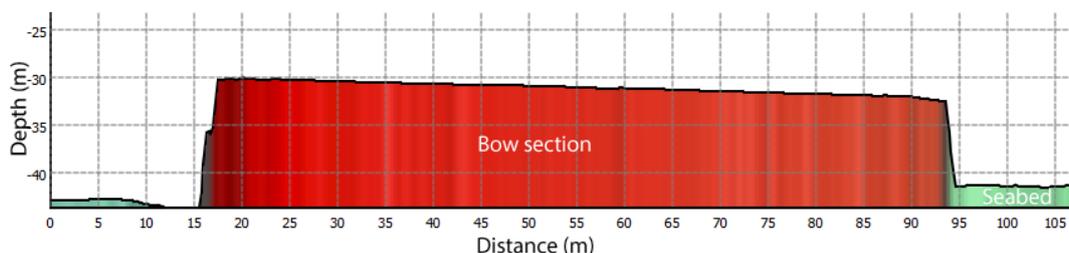
Figure 8 – Longitudinal slice through bow section (bow on left of image, break on right)

103. The bow section is 75 m long and lies inverted, flush to the sea bed. It sits approximately 5 degrees from vertical to starboard (north) with no noticeable torsion, hog or sag.

104. The bow section is trimmed 2 m by the stern, the shallowest point of the bow section being at 30 m deep. The trim appears to be caused by the shape of the foc's'le as there is no burial or settlement evident towards the aft end of this section. It appears that the Bridge and accommodation structure is crushed or missing and provides no support to the aft end of this section.

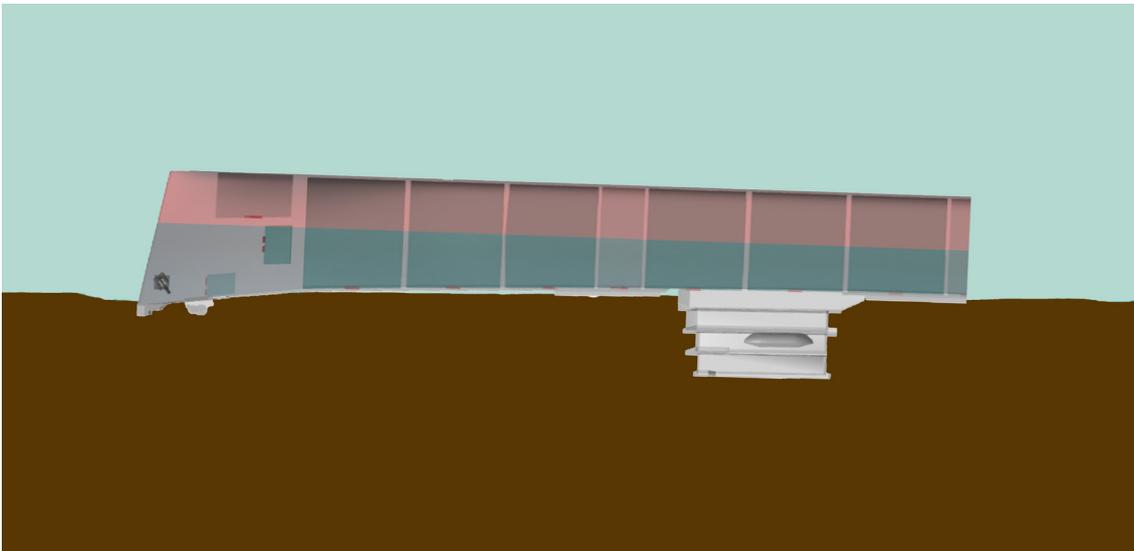
Figure 15 – Bow section upturned showing where the Bridge and accommodation would have been.

143. As described earlier, following the loss, a dive team carried out some work to sink the bow section and reduce the hazard to other shipping. It is likely that the accommodation block was destroyed as part of this work. The remaining steel work will have buckled under the load of the hull above with a small amount of burial in the seabed.

144. It is possible that the steel from the accommodation block could have penetrated the deck above. Whilst this would breach the tank, the buoyancy of the oil contained within would prevent its escape, keeping it trapped in the envelope of the hull above.

145. On the upturned hull there is no evidence of damage or deformation to the tanks that once would have supported the accommodation.

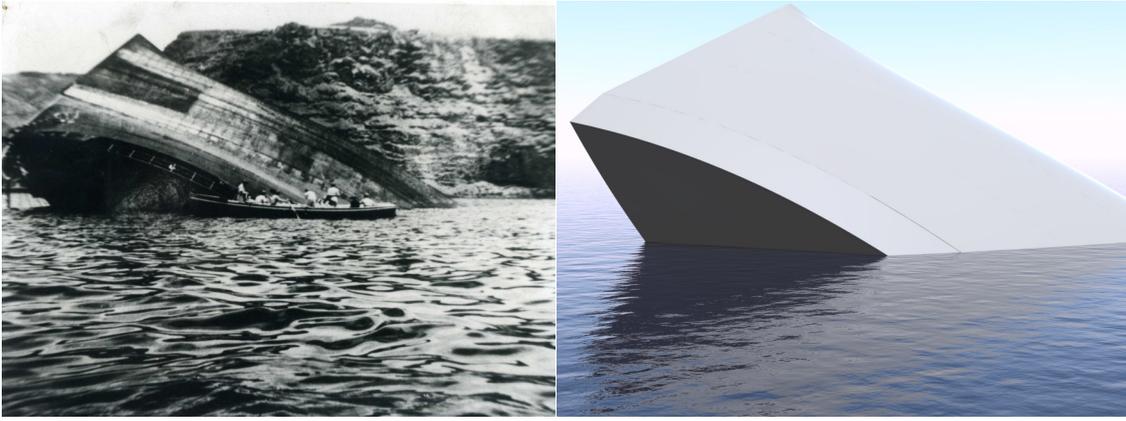
Figure 25 – Bow section following attack – photograph¹ and computer model rendering

198. A number of load cases were generated to try and replicate the angle of list and trim seen in the post sinking photograph. This angle was calculated as 27.5 degrees to starboard with a trim of 52.89m.

199. The range of load cases identified two feasible damage scenarios that would replicate the condition seen in the photograph. The worst case of these scenarios was No. 4 and No. 5 Cargo tanks both ruptured and the oil lost to the environment with the remaining tanks being intact. In this scenario, the total quantity of oil remaining onboard is 4952 m³.

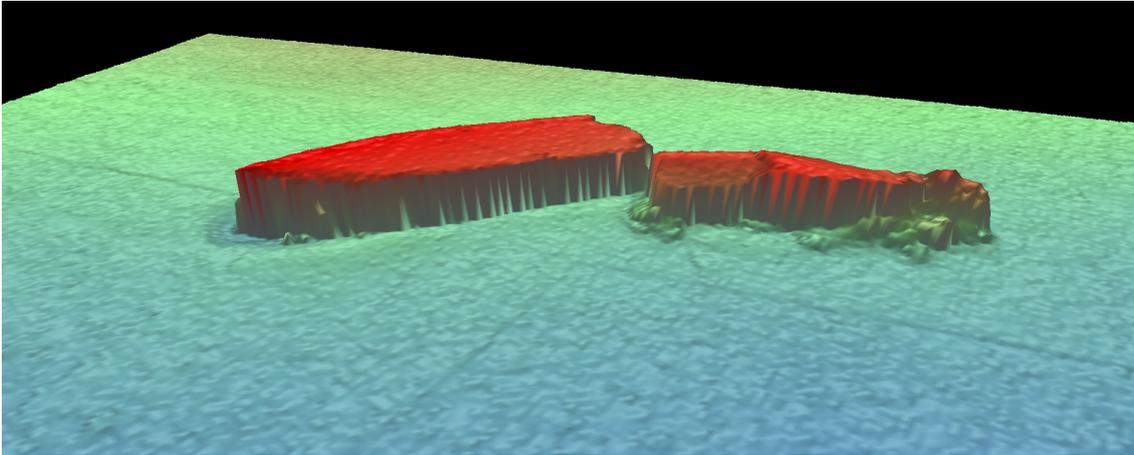
Figure 26 - Multibeam of the wreck site showing smooth seabed around the wreck

202. The surrounding seabed is smooth and flat with no significant form and only a gentle slope.

203. There are no significant features close to the wreck; no boulders, large pieces of debris or other items of note. Given the severity of the attack on *Darkdale* it is perhaps surprising that there is not a significant debris field extending from the wreck, this may be due to the speed the vessel sank.

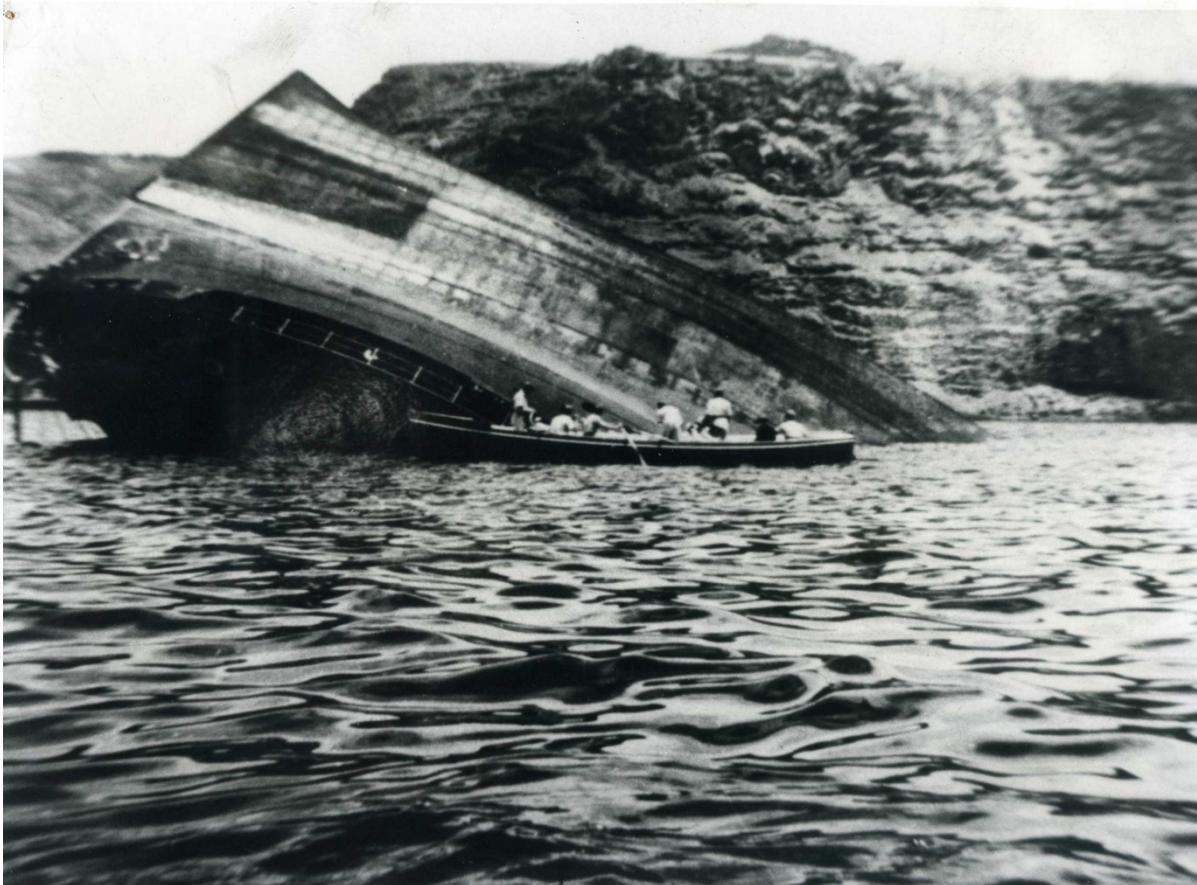
Figure 4 – The wreck of the *Darkdale* before the bow section was sunk by Royal Navy divers from *HMS Milford*

The attack resulted in a significant release of oil from the ship. Although the amount is difficult to quantify it was sufficient to leave the water around the wreck burning for several hours after the attack. Although a black and white picture, a photo of the *Darkdale*'s bow above the water taken after her sinking seems to show the sea covered in oil (figure 4).

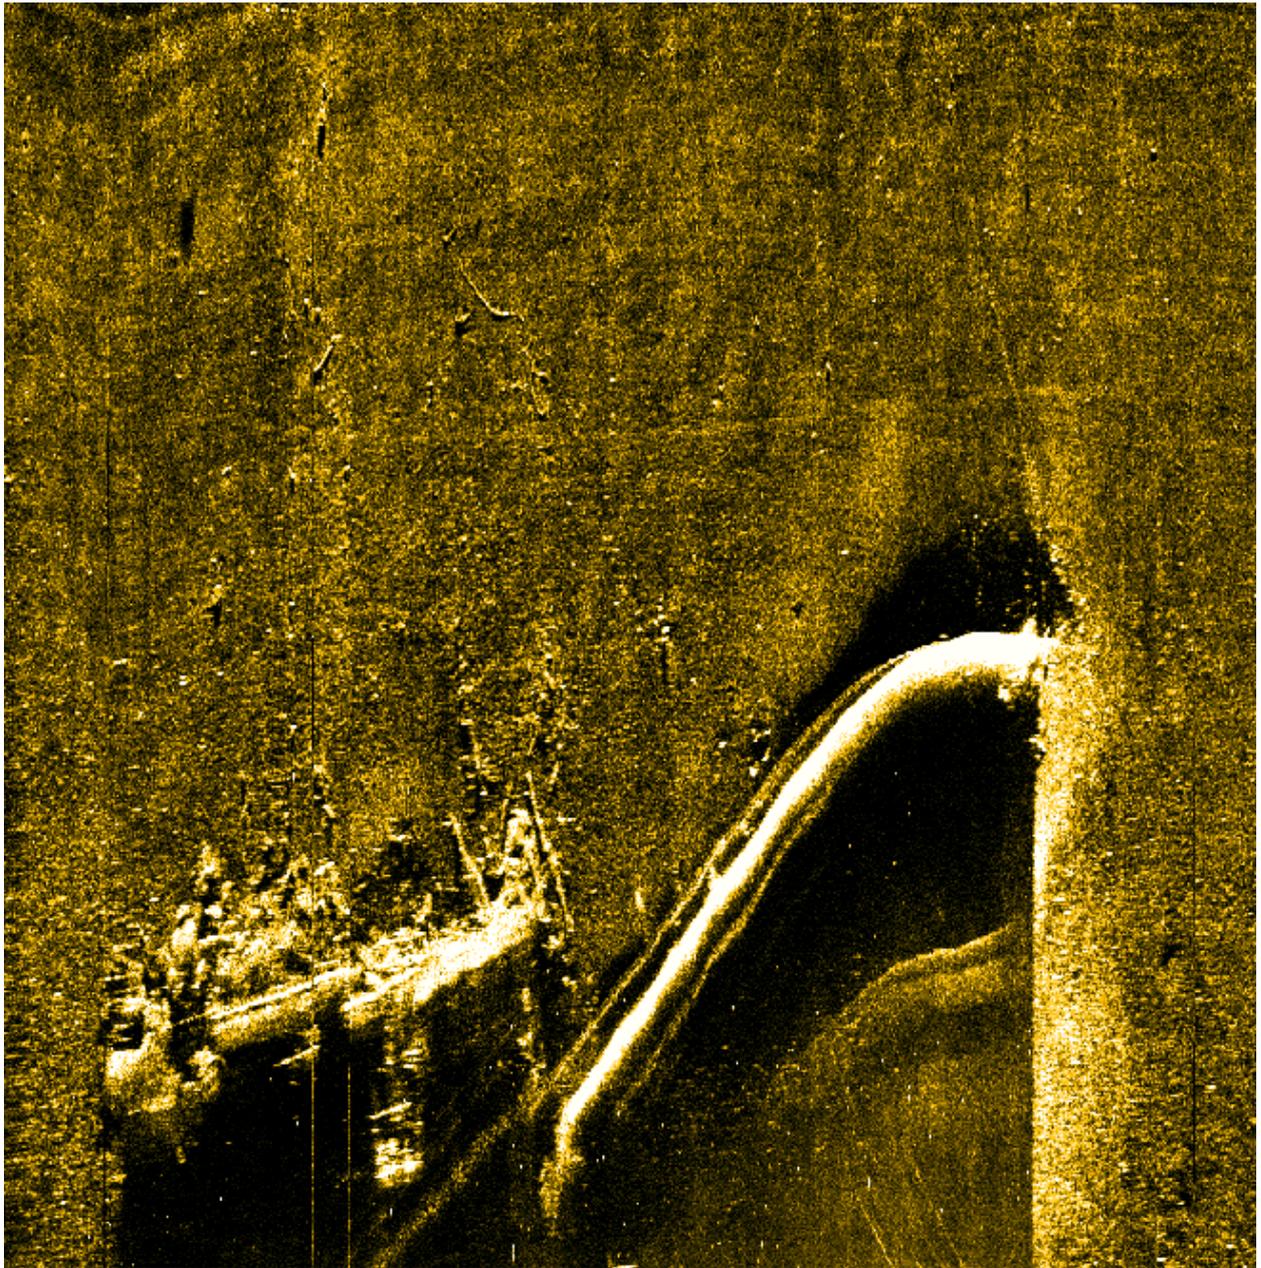
Figure 5 - Side scan sonar image of the wreck site

The wreck site of the *Darkdale* extends for approximately 130 m on a south-west to north-east orientation and is approximately 110 m wide at its widest point (excluding the deployed anchor chain). Analysis of the sidescan image indicates that the wreck covers an area of approximately 250 m² (figure 5).

The wreck lies broken in two sections. The bow section lies in approximately 30 m of water on a heading of 035° and is inverted with the deck lying very slightly angled to starboard. The stern lies on its port side on a heading of 056° approximately 8 m from the bow section in 40 m of water. The seabed is generally flat with a gentle slope from the bow section down to the detached stern section. Although of comparatively low resolution the multibeam survey of the wreck conducted by *HMS Protector* in late 2012 provides a useful overview of the wreck site and surrounding seabed (figures 6 and 7).

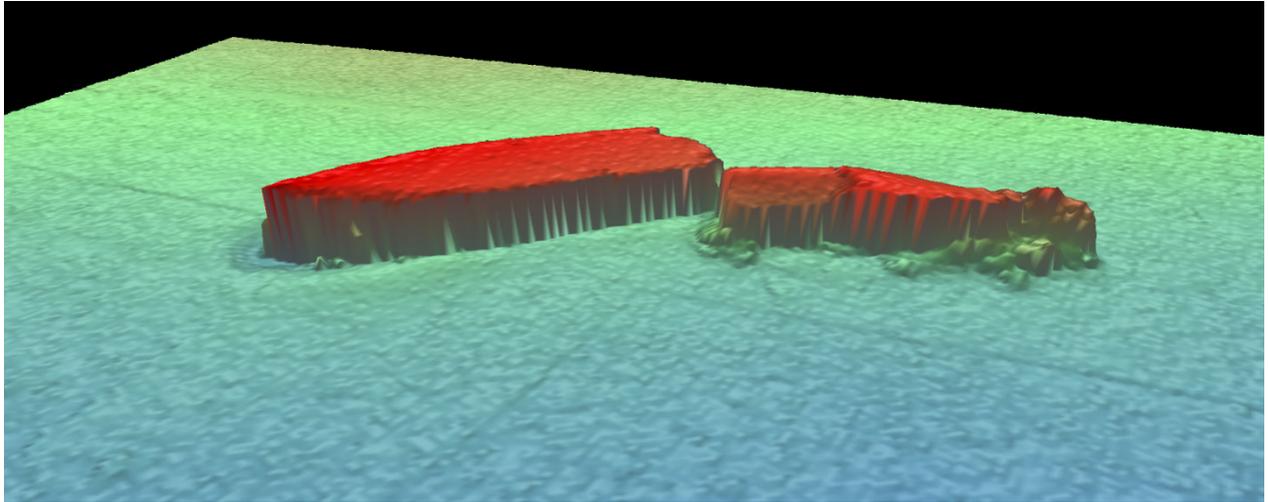
Figure 7 - Multibeam image of the wreck site looking south east, note the limited debris field adjacent to the stern section

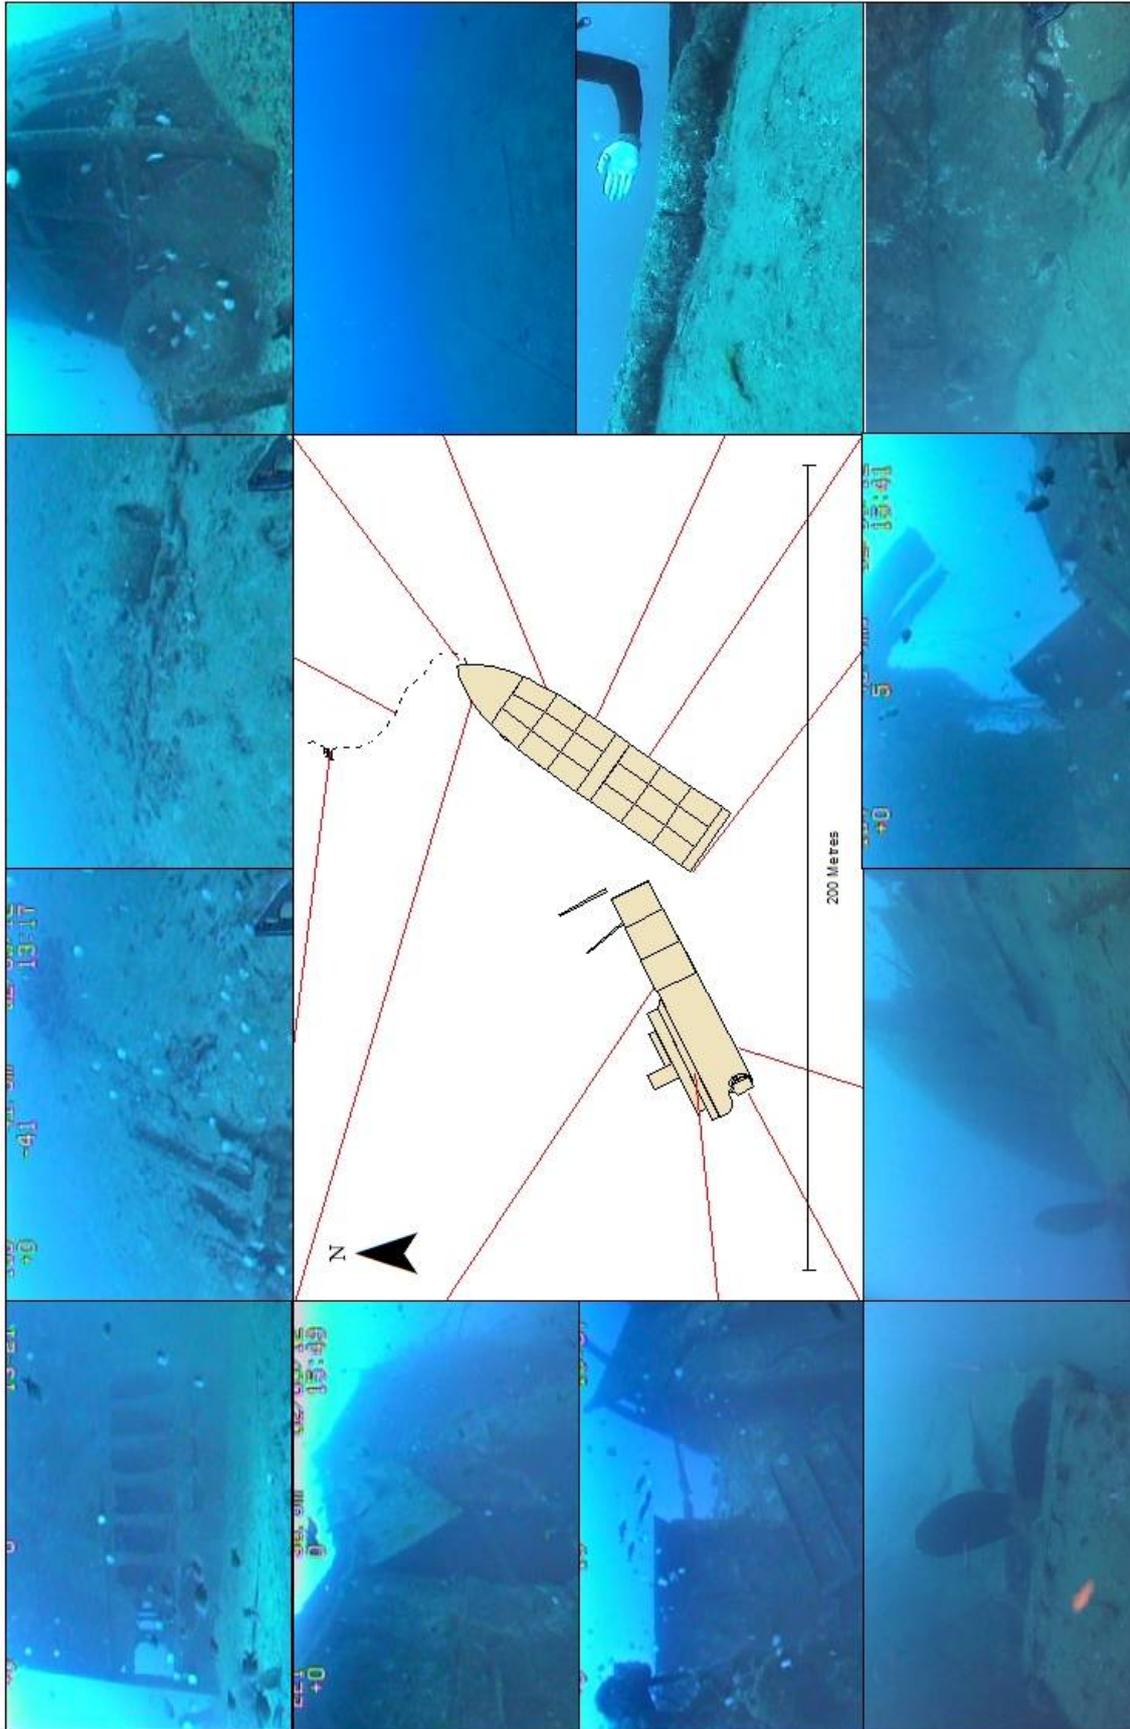
Figure 8 – Photo overview of the wreck of RFA Darkdale

The hull of the bow section is substantially intact and, except in the immediate vicinity of the break, shows few signs of damage. There is, however, no sign of the bridge originally situated atop the midships section of the wreck. Although this may have entirely collapsed under the weight of the upturned hull it is believed that its absence may be partly attributed to explosive clearance work undertaken on the wreck by Royal Navy divers from *HMS Milford* within a few days of the vessel's loss.

There are few indications that the wreck has suffered any significant interference since the war. The only obvious damage that might be attributed to recent activity are the sections of broken bilge keel overhanging the bow in various places. The damage to the bilge keel was probably the result of

anchors dragging across the wreck. Elsewhere, clump weights, shot lines and tangles of mono filament line attest to fishing activity in the vicinity of the remains.

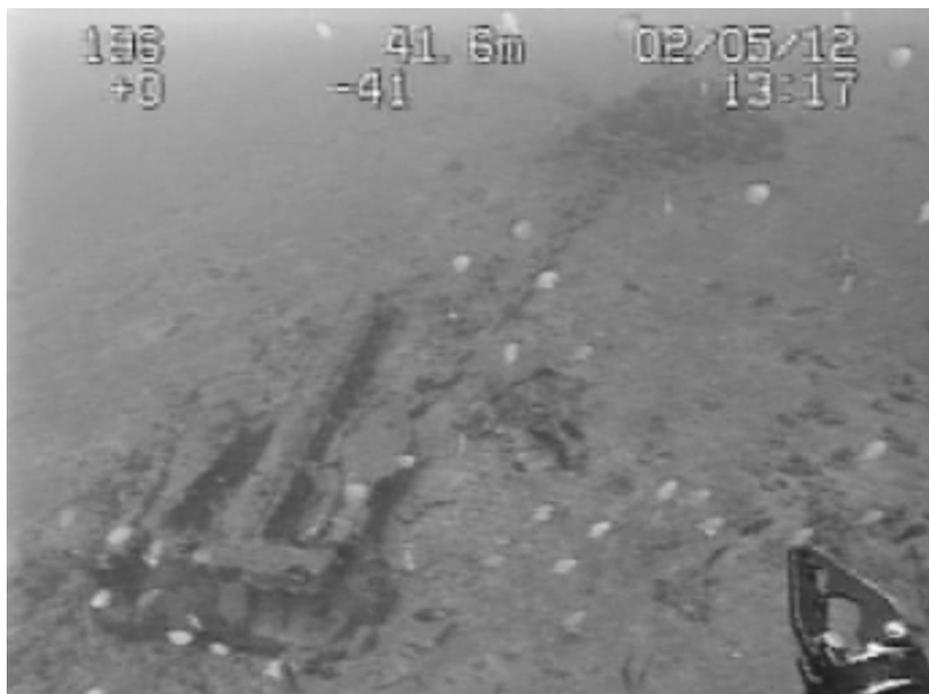
The starboard bow anchor lies to the north-west of the wreck and the exposed anchor chain runs back to the upturned stem (figure 9). Four barrels lie in close proximity to the chain and it is believed these may have formed part of the cargo of lubricating oil, originally stowed in barrels on the ship's deck (figure 10). All appear to be holed and presumably sank after being damaged in the explosions and fire resulting from the attack. The anchor runs up to the stem but is no longer attached to the ship. The starboard hawse pipe is missing as is a single line of strakes on both sides of the vessel in the vicinity of the forward paint locker (figure 11). The line of missing strakes on the port side extends aft from frame 90F to frame 86F and that on the starboard side (figure 12) is slightly longer, running from frame 90F to frame 83F.

Figure 9 – The ship's anchor lying to the north of the ships bow

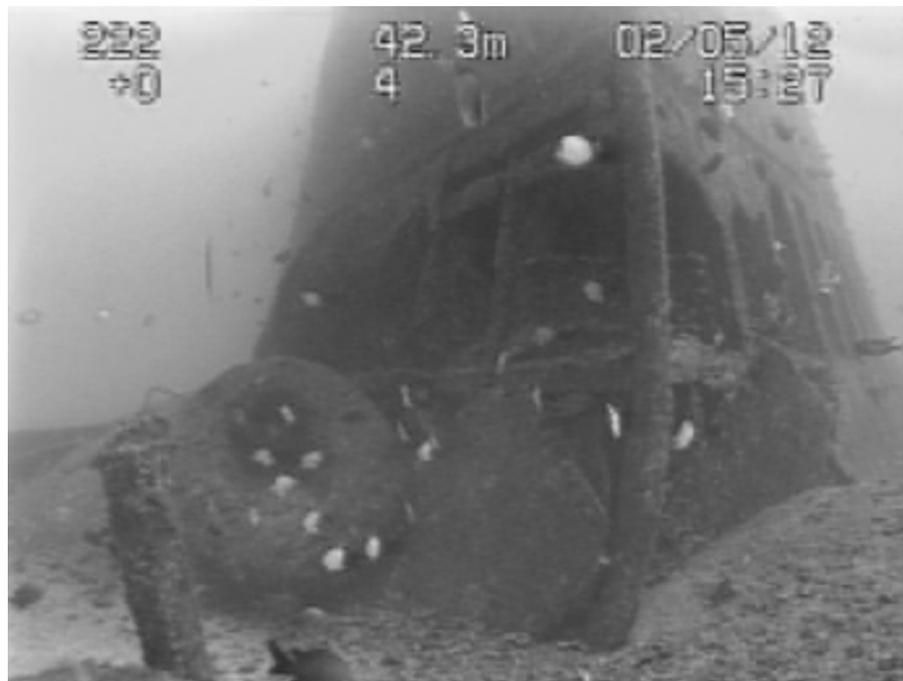
Figure 11 – The ship's stem

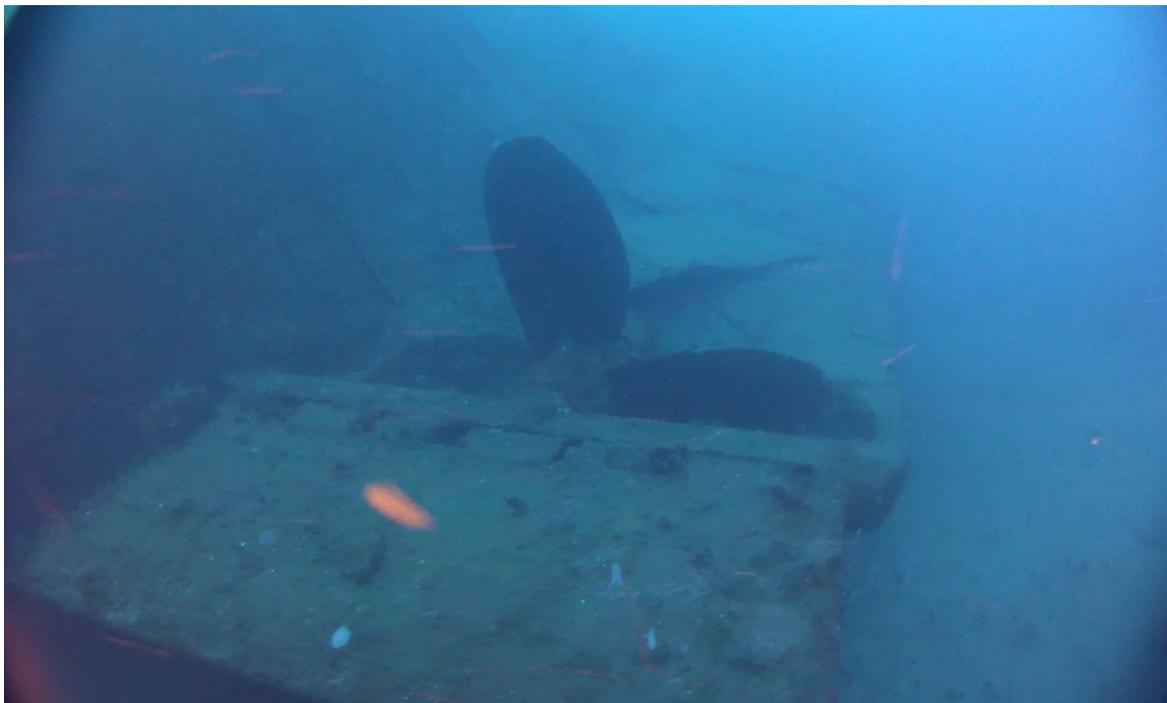
Moving further aft along the starboard side the damage in the vicinity of frame 80A that adjoins the triangular split in the deck noted above becomes apparent (figure 24). On this side the damage consists of a gaping hole running from the gunwale down the side and a series of misshapen and dislocated plates. Right aft, the ship's balanced rudder and propeller are in place and are both in excellent condition (figure 25).

Figure 25 – The *Darkdale*'s propeller and rudder
