**ST HELENA AIRPORT PROJECT  
ANNUAL ENVIRONMENTAL REPORT 2015-16**

**January, 2017**

**Prepared by  
Bryony Walmsley  
CEMPC**

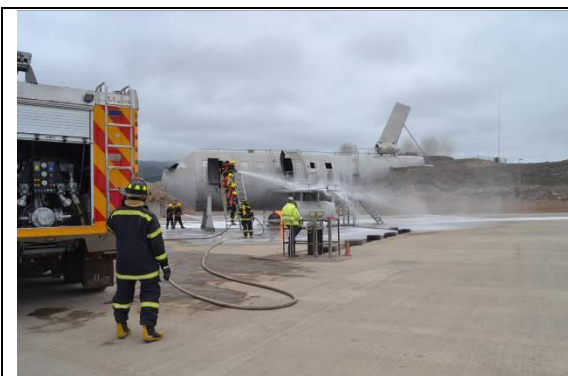
Of the 44 recorded incidents, it can be seen that the majority (86%) involved no damage or low to minor, reversible harm to the environment. However, project activities caused seven incidents which had a moderate impact on the environment, heritage and/or the health and safety of local communities over the past 12 months (Figure 4 and Plates 5-7). One of these incidents resulted in a

**Plate 7: Effluent from the first fire training exercise ran off into the surrounding environment**

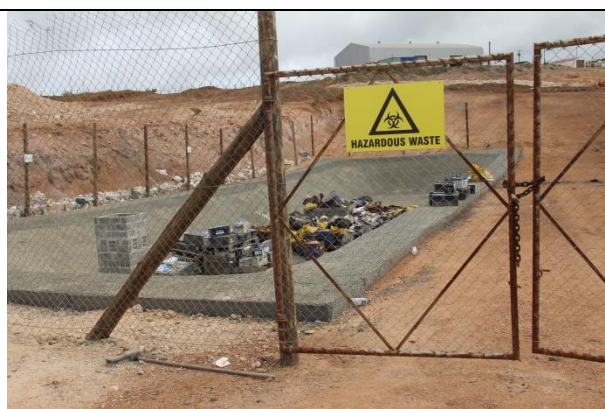
**Plate 10: Operational hazardous waste cell at Horse Point landfill site**
