MECHANICAL INVESTIGATION INTO

**THE FAILURES OF WATER PUMP GEARBOXES FITTED  
TO FIRE TENDERS OPERATED BY ST HELENA AIRPORT**

St Helena Government

Dr Ross Beesley CEng MIMechE

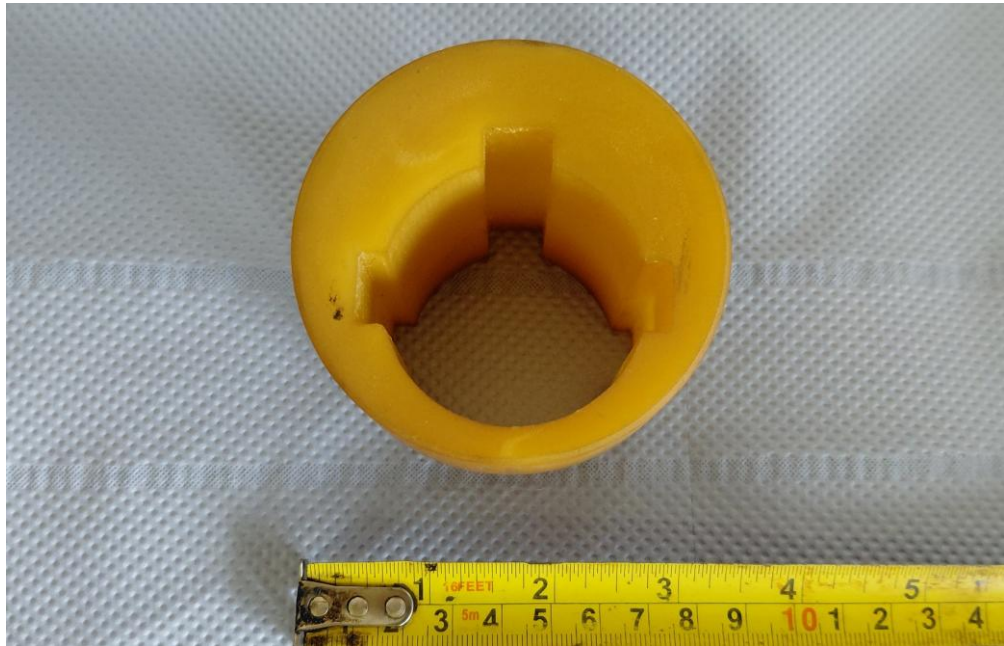
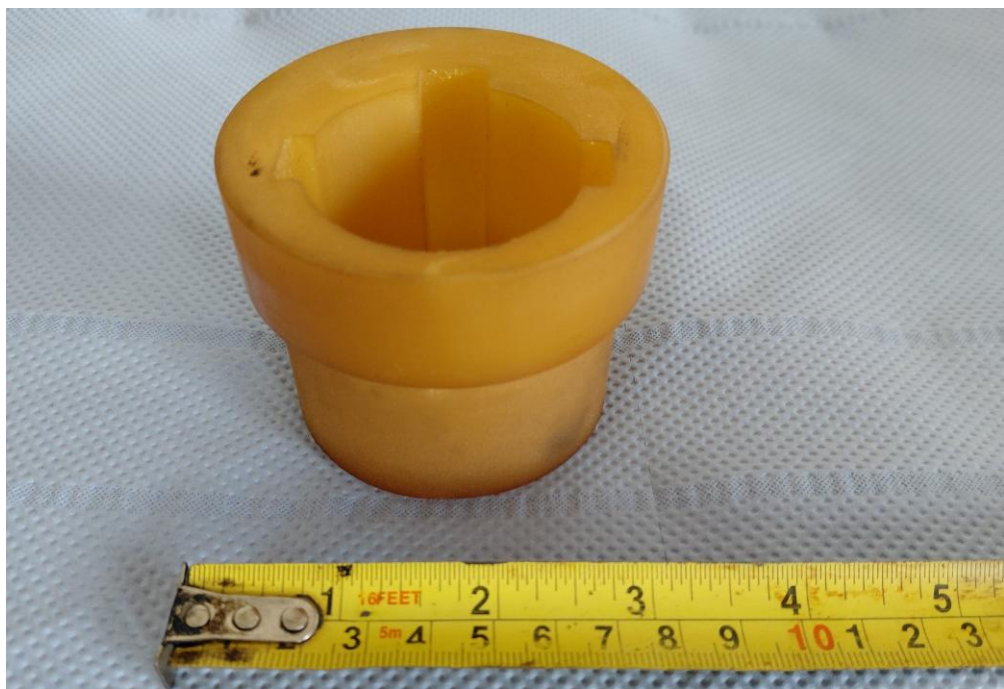
- 14.2.1. In addition to the damaged eccentrics, I was provided with a new, unused eccentric for comparative purposes. This allowed me to gain an understanding of the original structure and composition of the material, prior to use.
- 14.2.2. The exemplar eccentric was light brown/tan in colour, and exhibited a degree of pliability, and light pressure on the structure caused slight elastic (i.e. non-permanent) deformation. The exemplar eccentric is shown in Figure 34 and Figure 35, below.

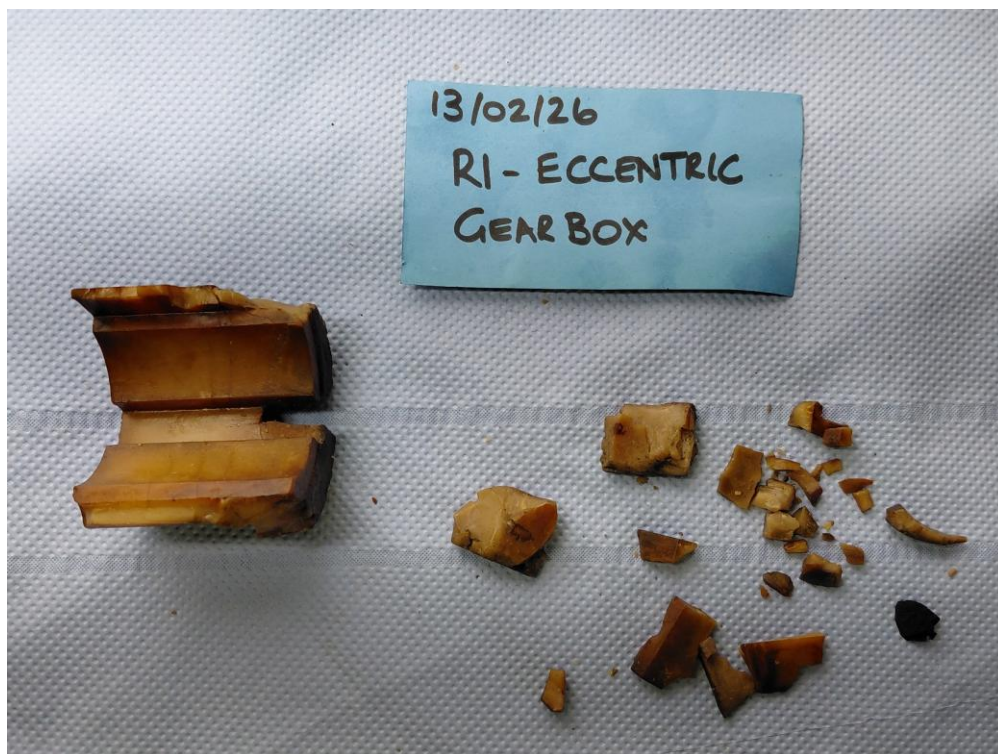
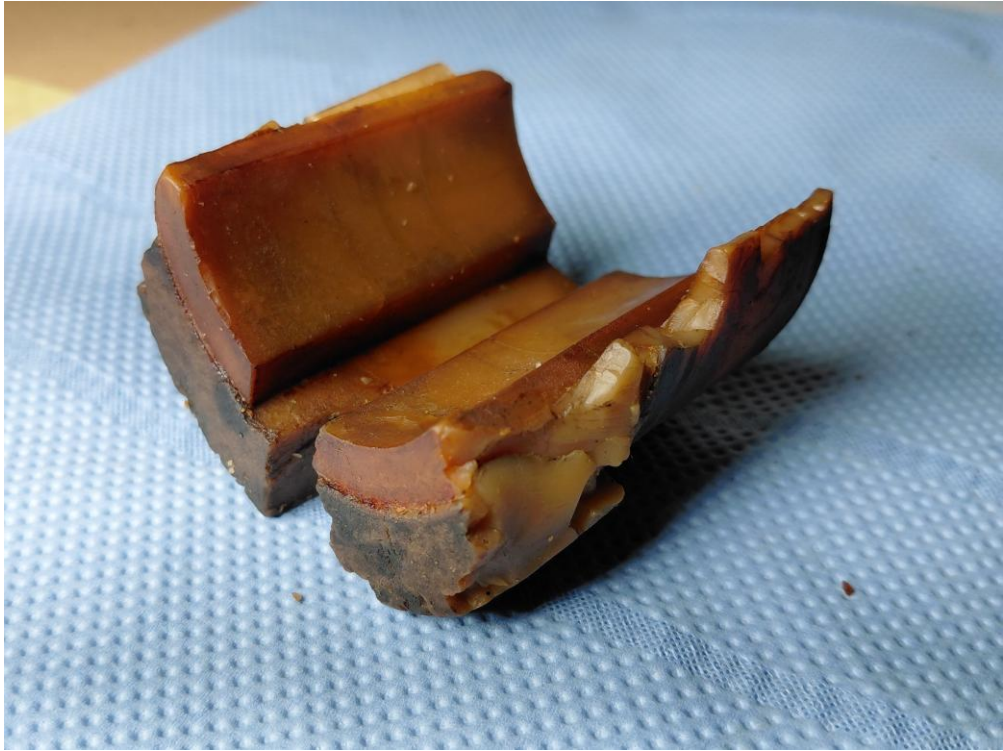
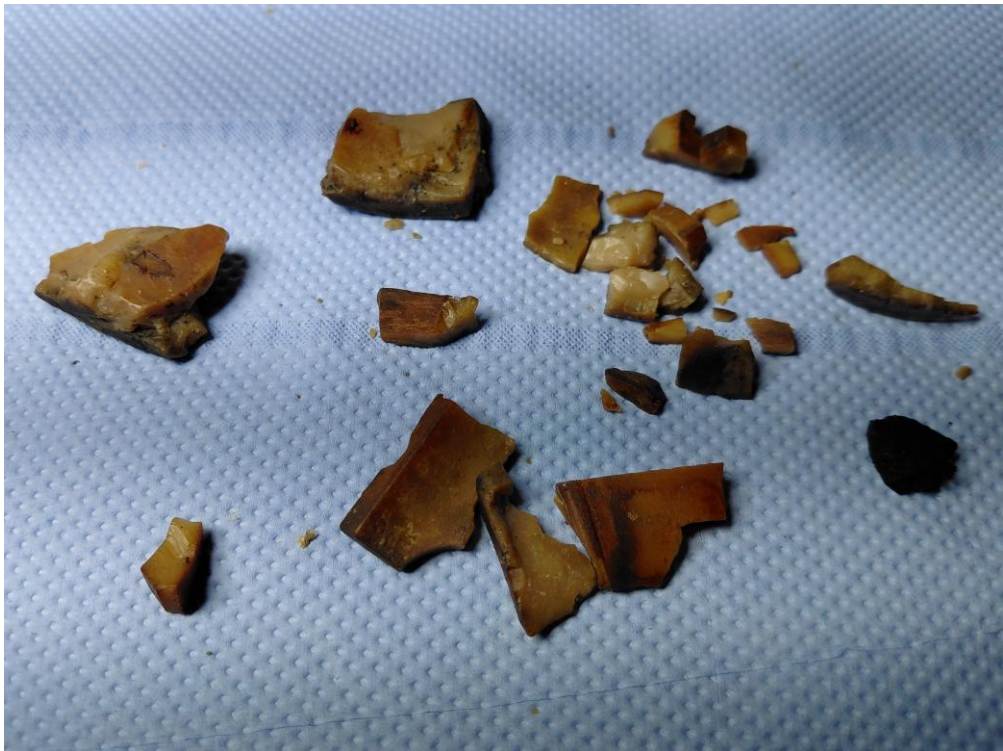
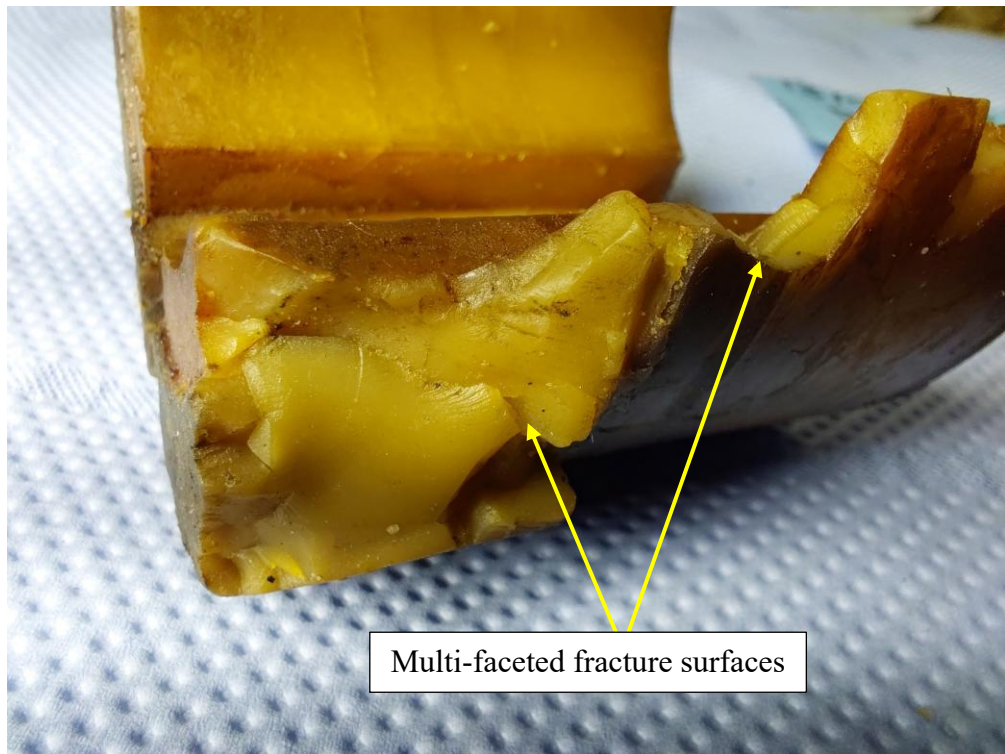
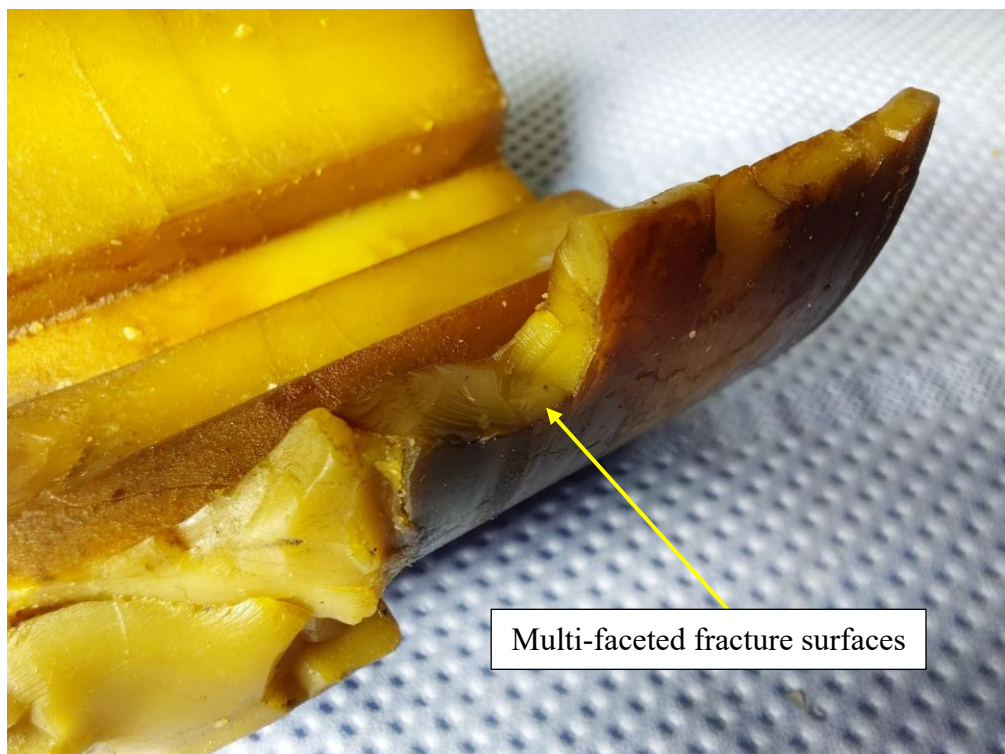
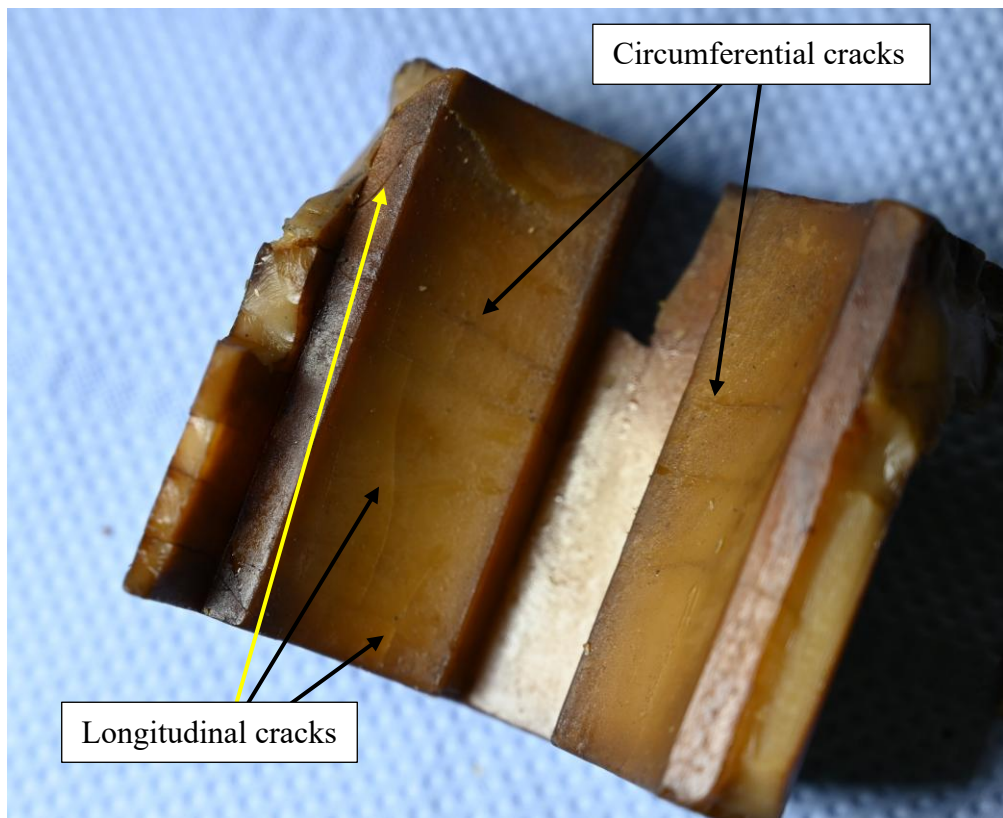
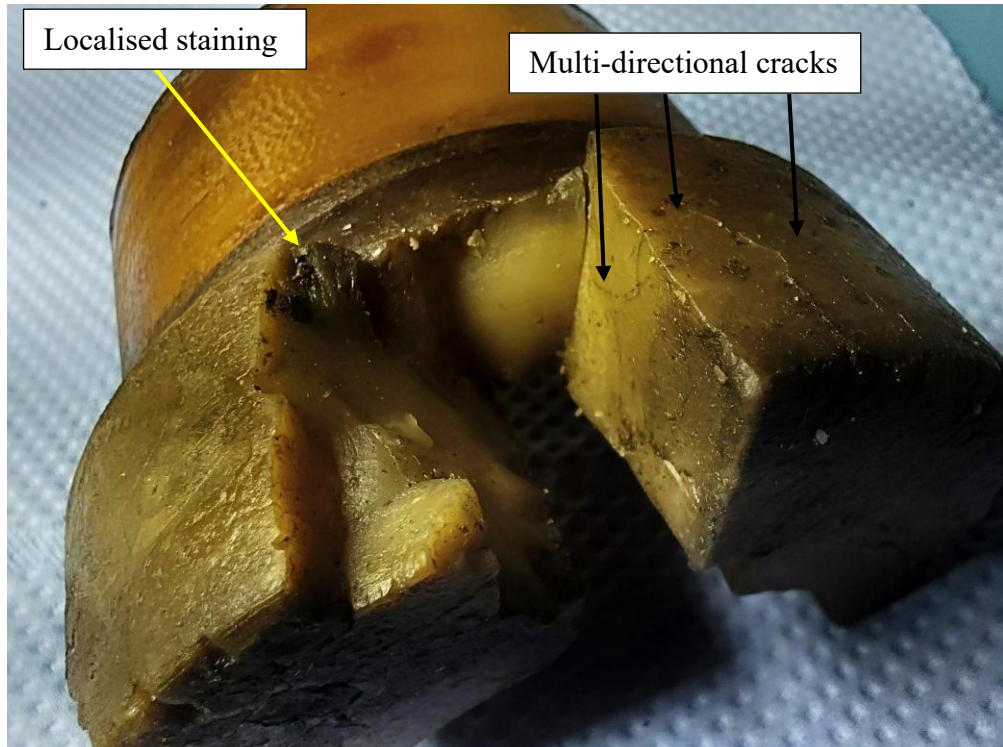
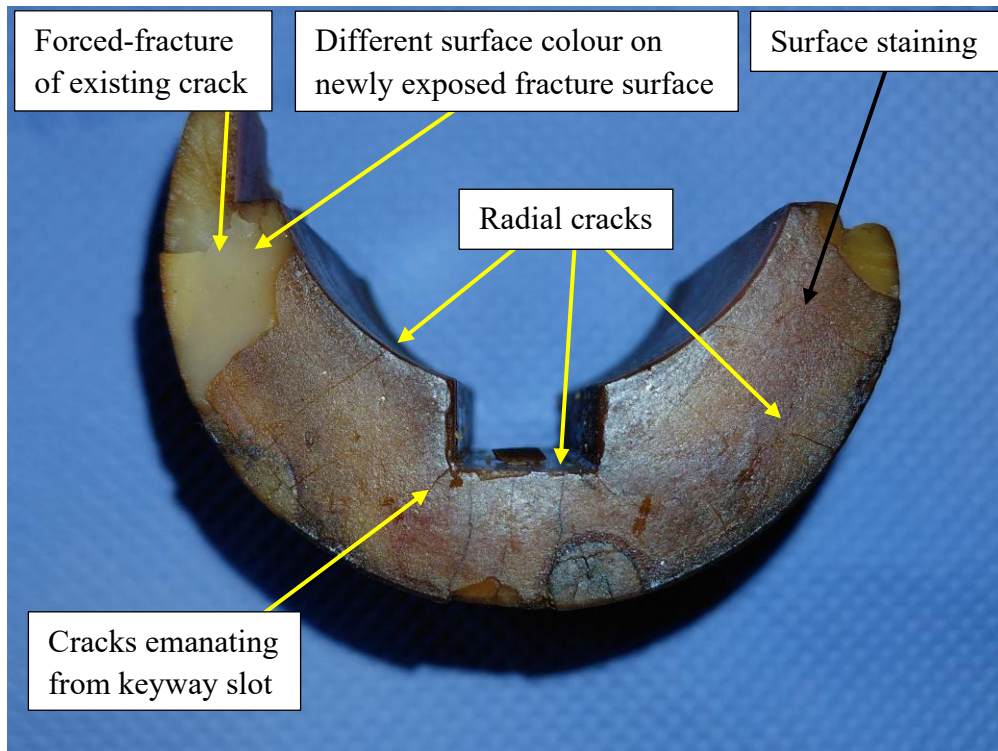
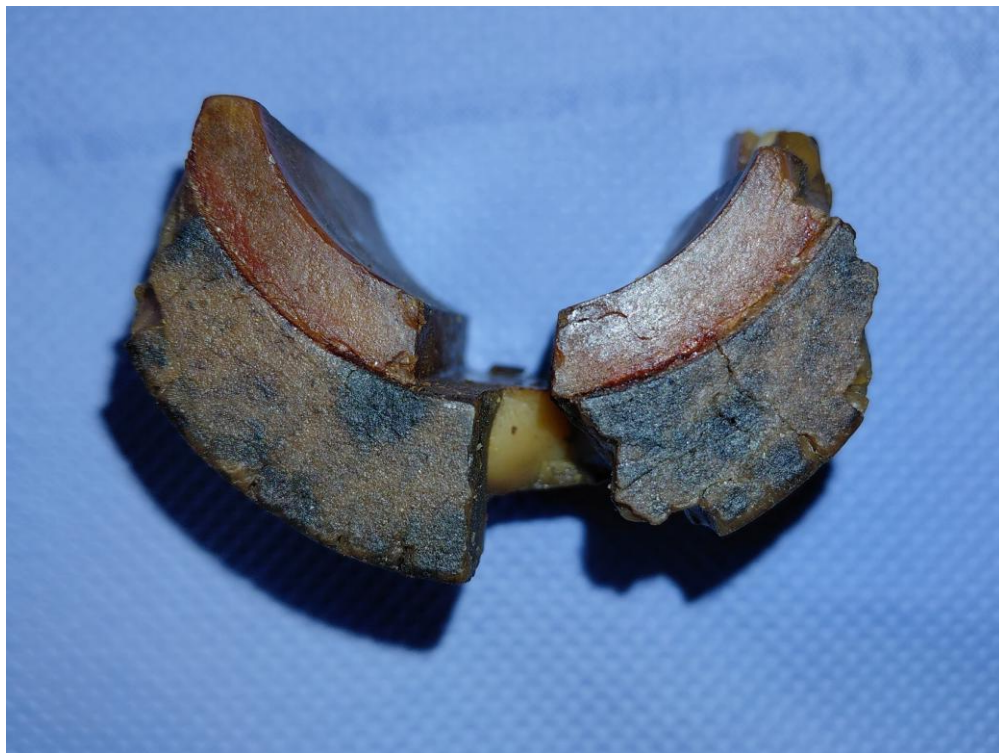
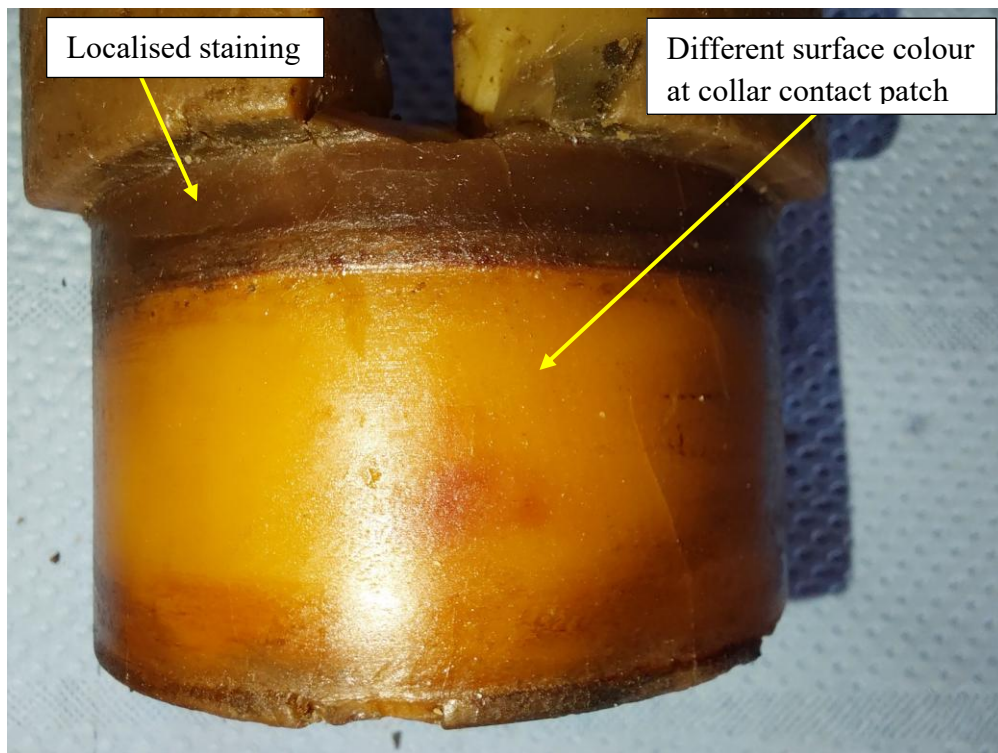
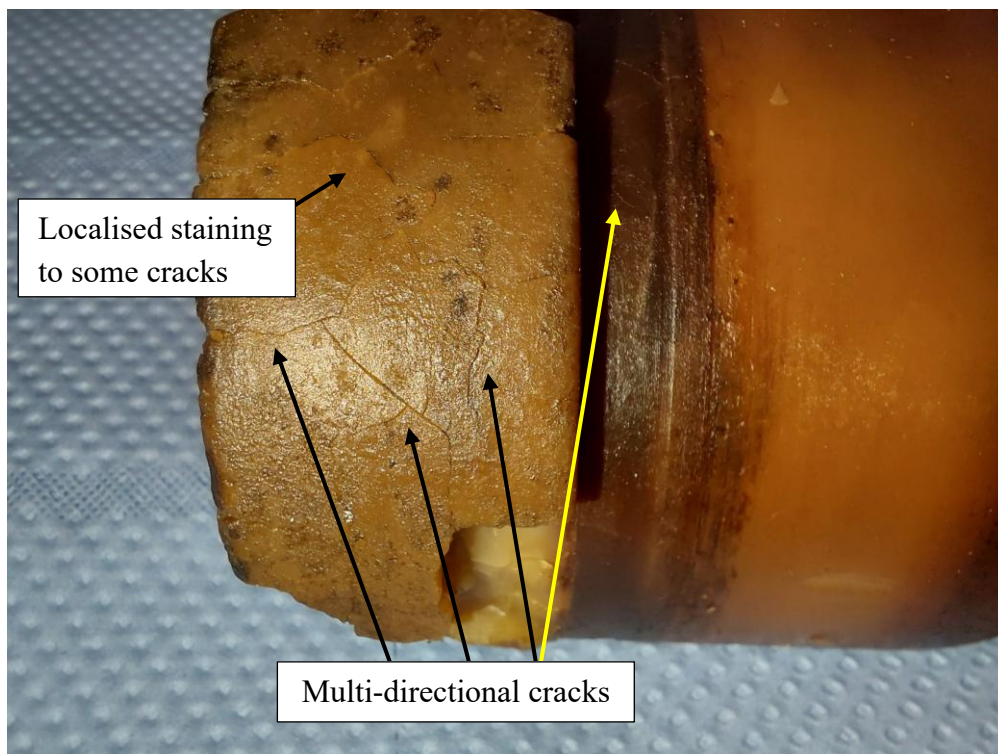
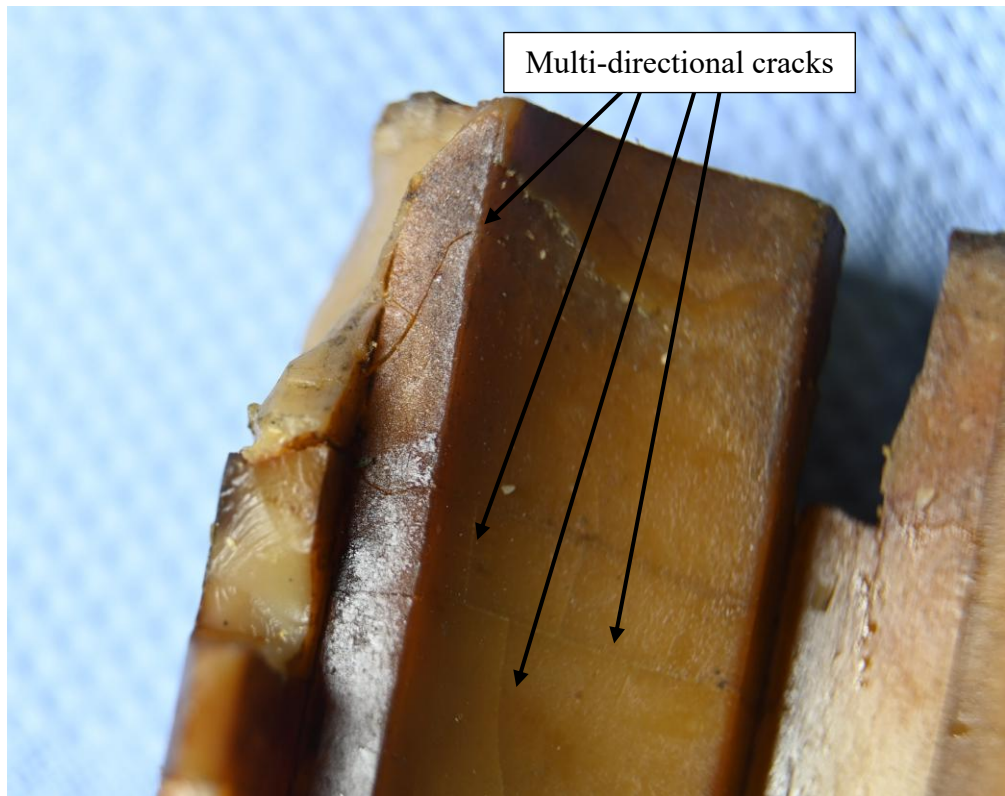
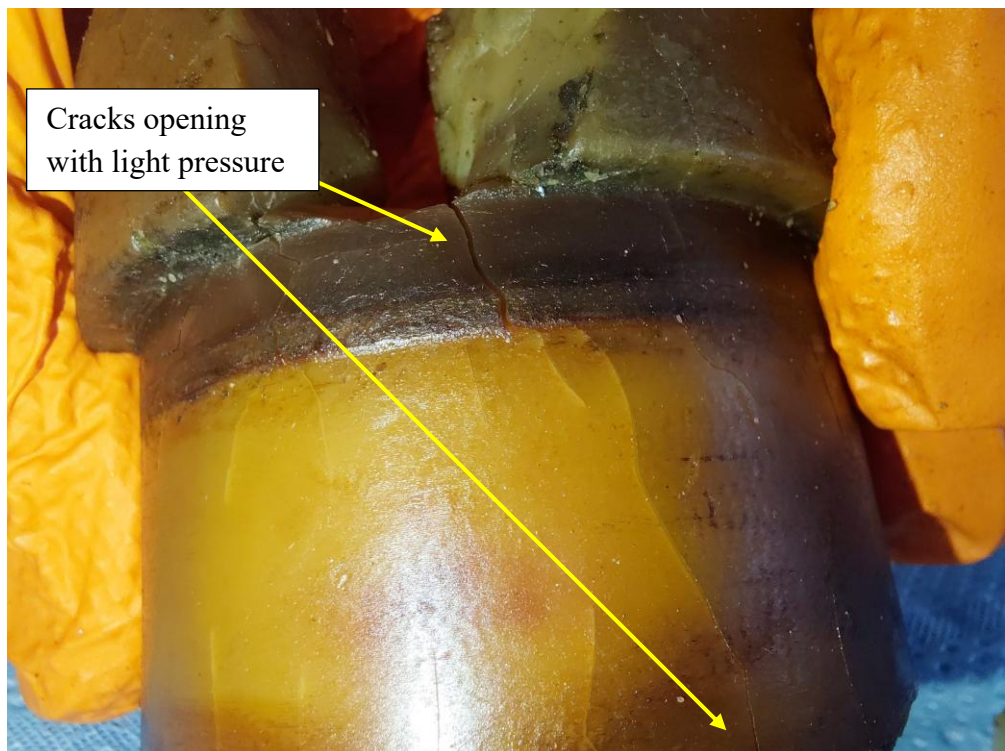
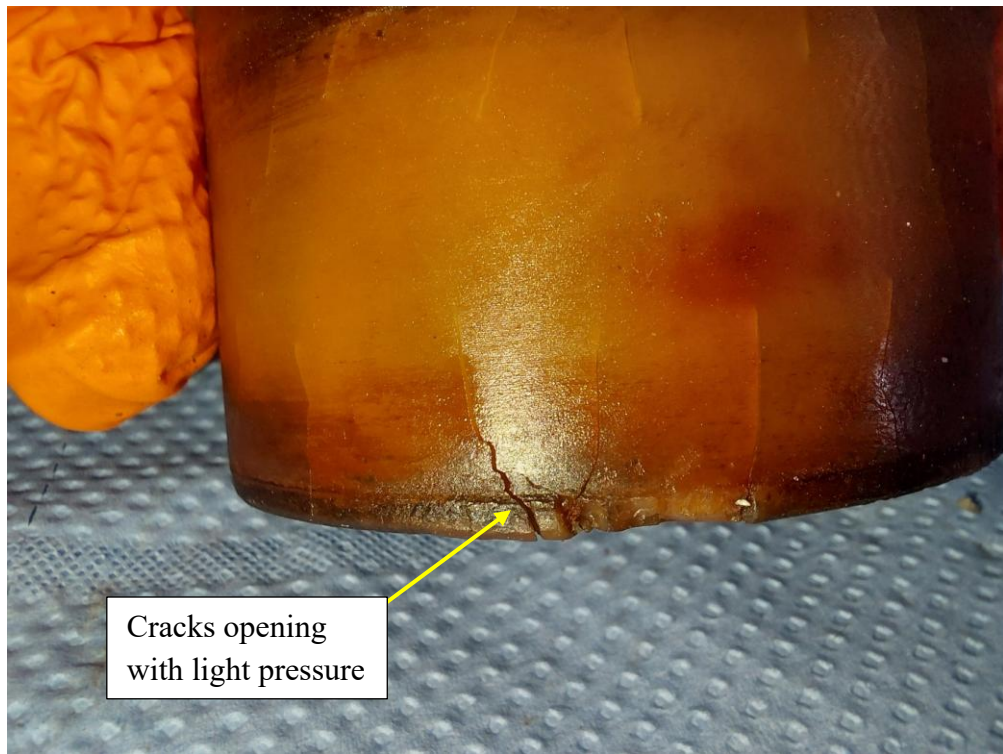
- 14.4.10. The material also felt hard and brittle to the touch, unlike the exemplar eccentric, which was comparatively soft and pliable. Light pressure on the structure also caused pre-existing cracks to open.

- 14.4.11. Photographs of the eccentric of R1 are provided in Figure 36, below, to Figure 49, on page 44.

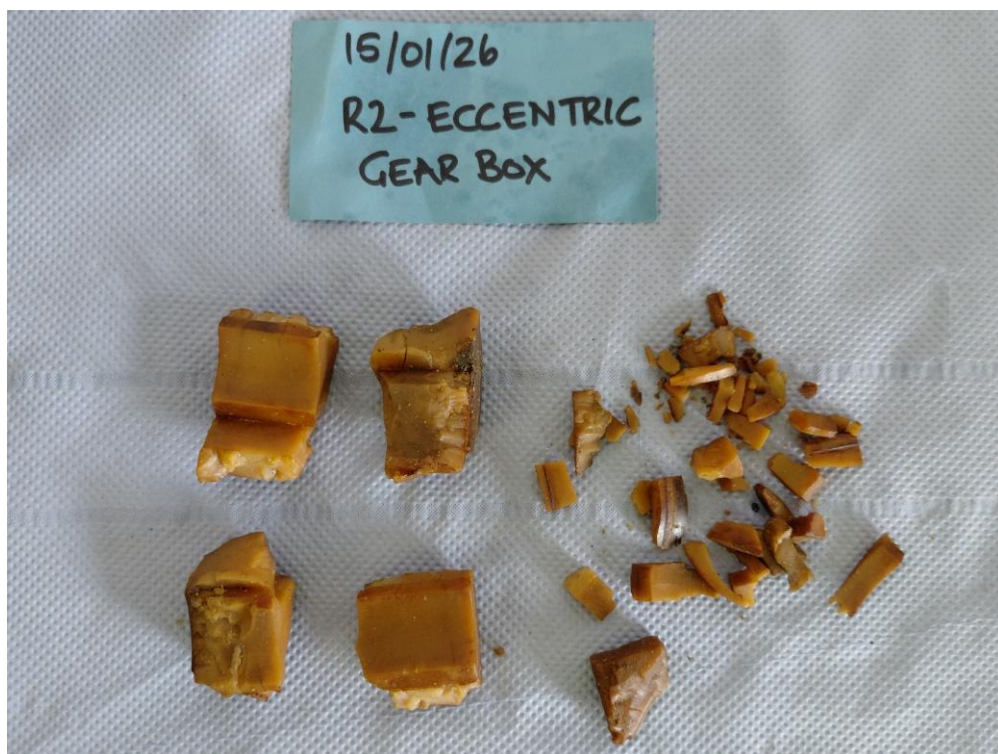
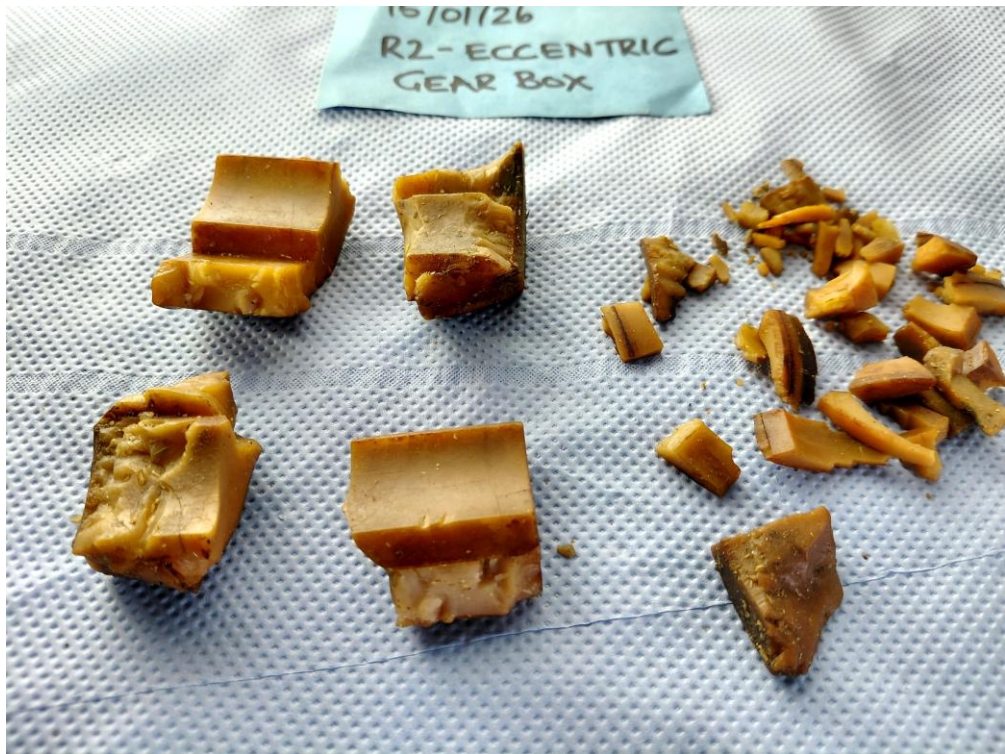
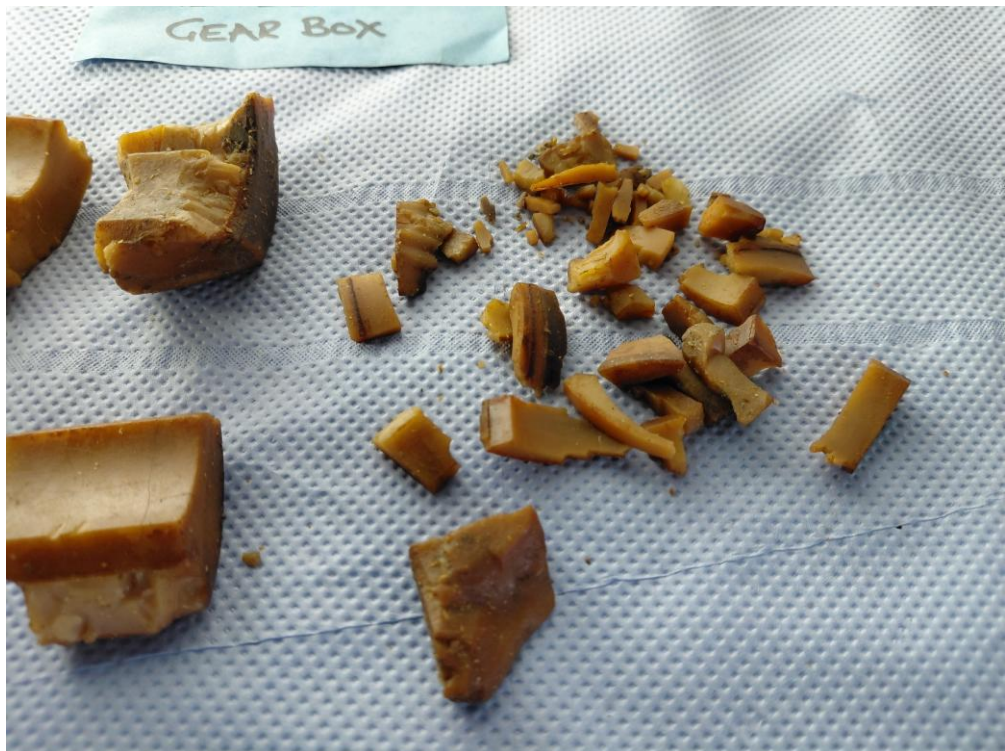
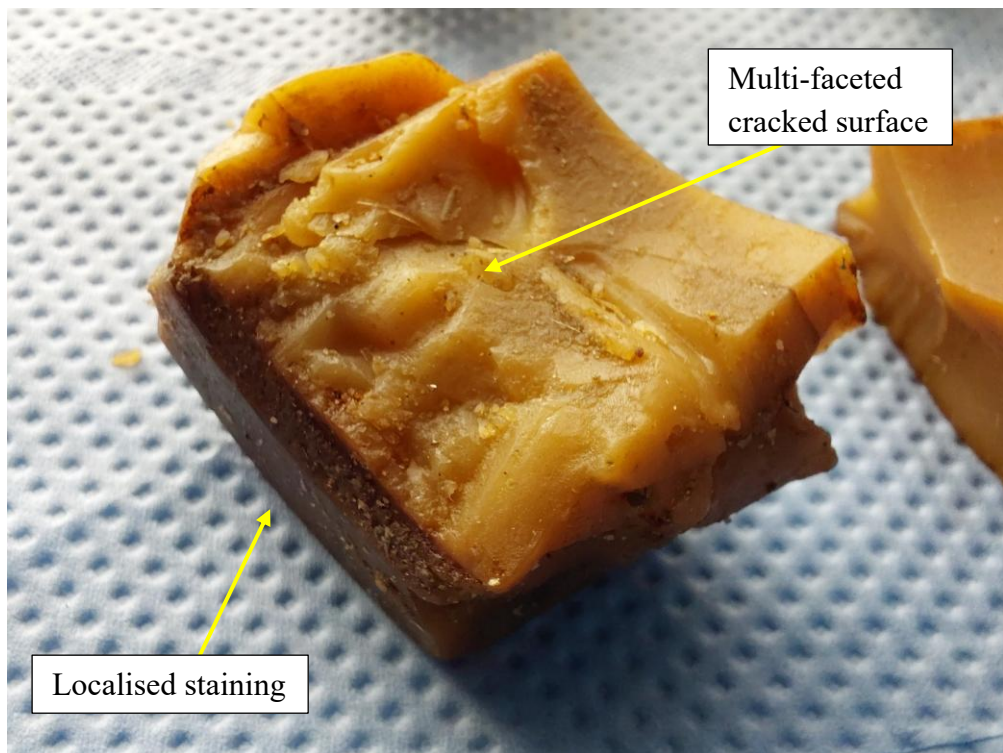
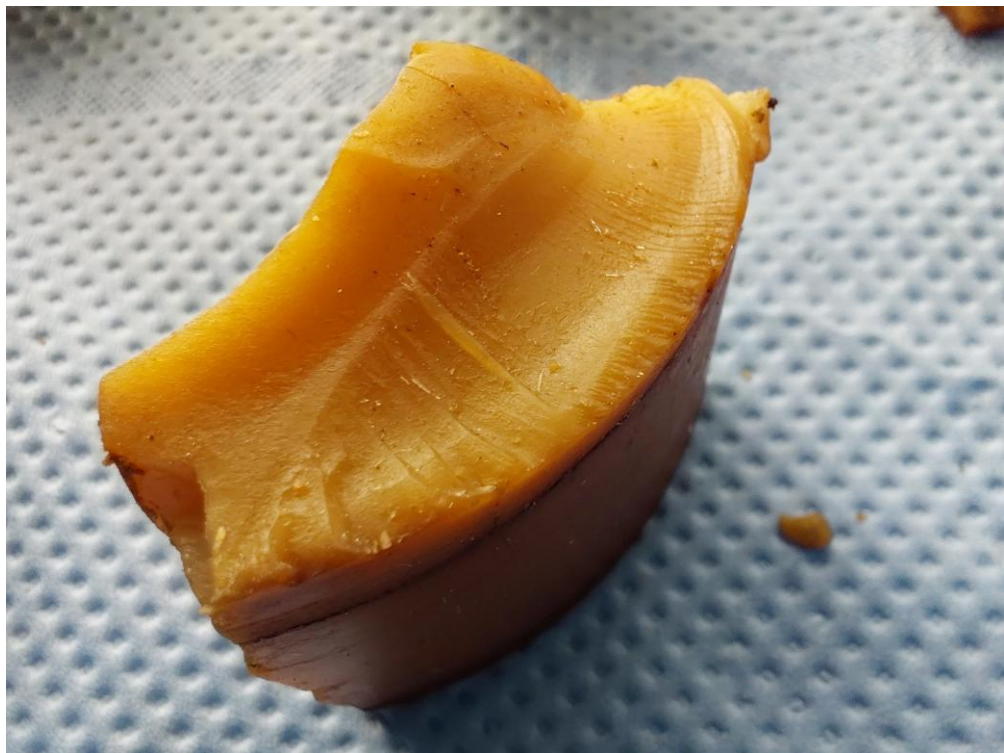
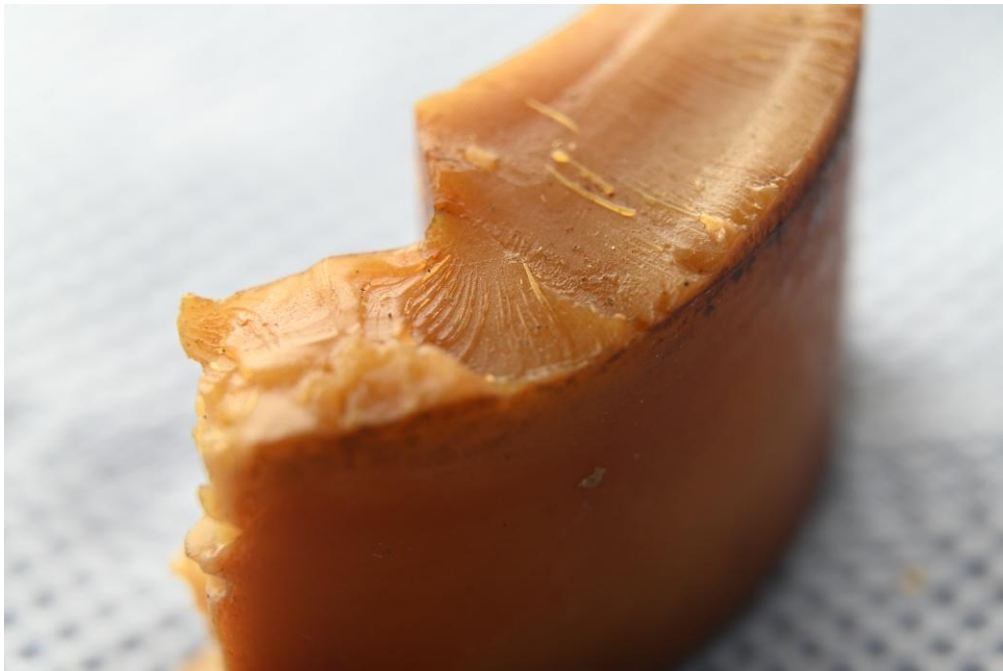
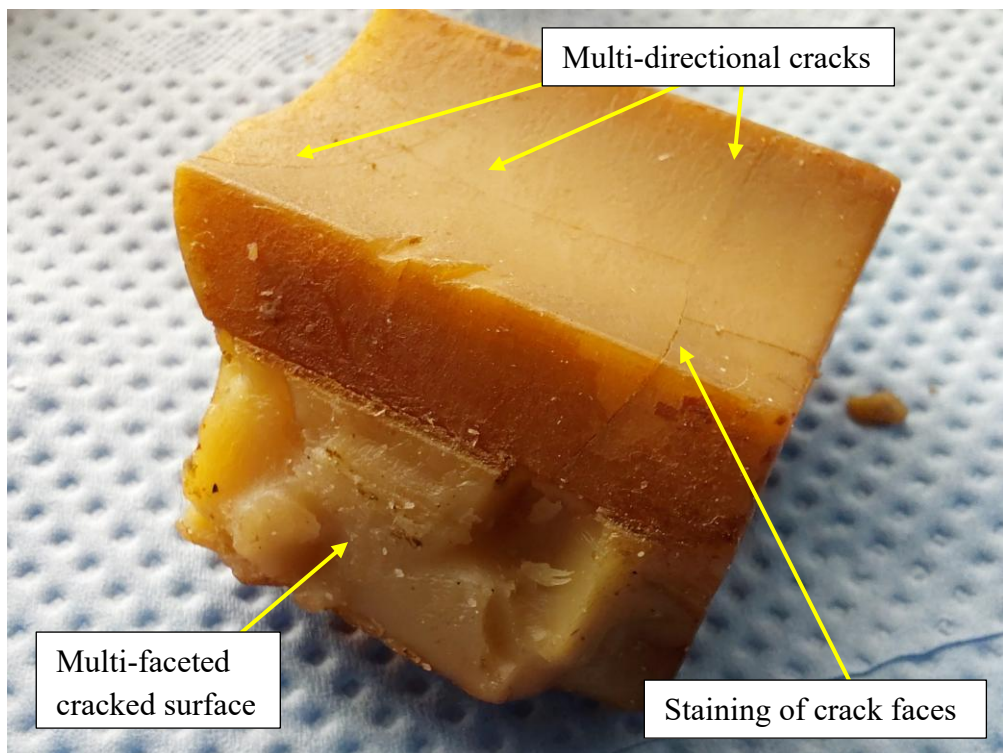
- 14.5.10. As with the R1 eccentric, the material also felt hard and brittle to the touch, unlike the exemplar eccentric, which was comparatively soft and pliable.

- 14.5.11. Photographs of the eccentric of R2 are provided in Figure 50, below, to Figure 63, on page 52.
