MECHANICAL INVESTIGATION INTO

**THE FAILURES OF WATER PUMP GEARBOXES FITTED  
TO FIRE TENDERS OPERATED BY ST HELENA AIRPORT**

St Helena Government

Dr Ross Beesley CEng MIMechE

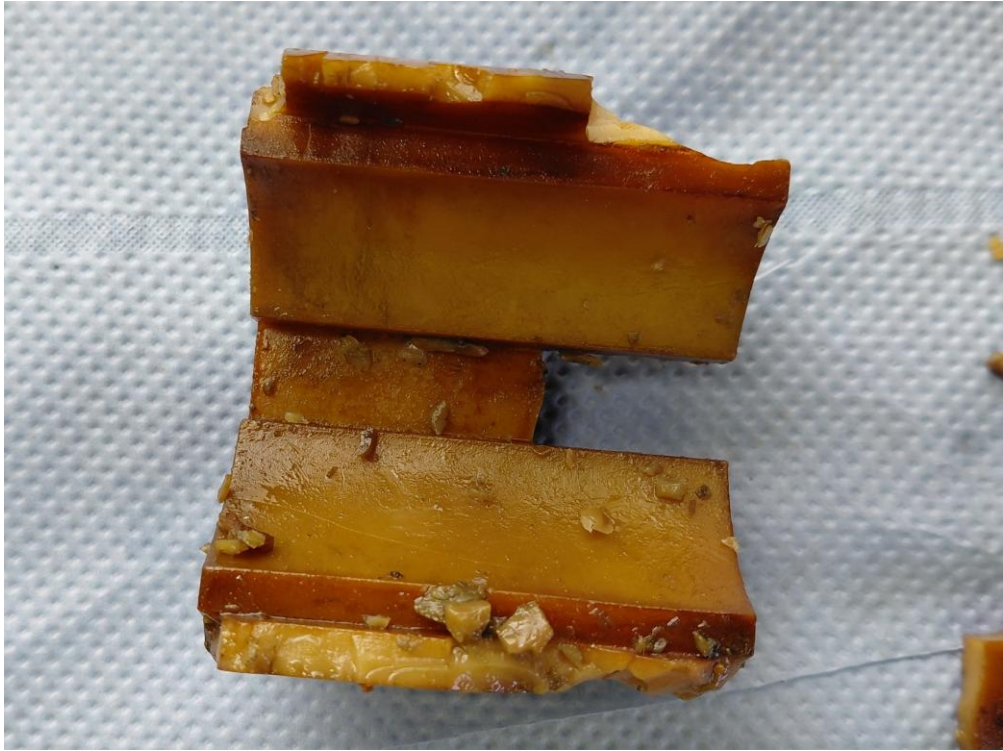
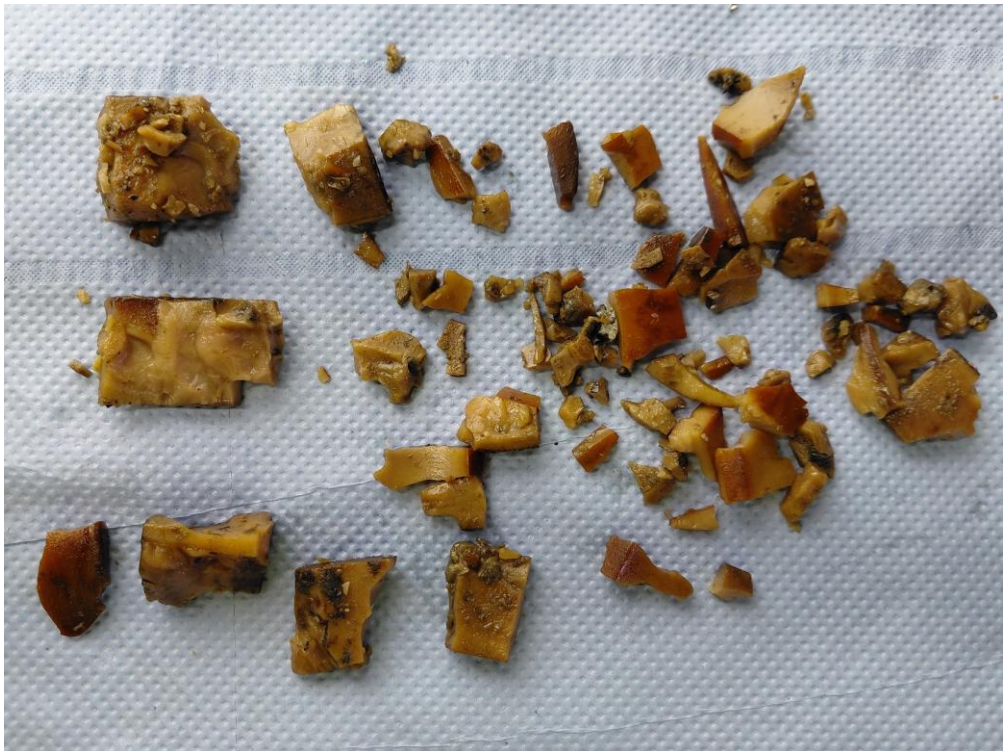
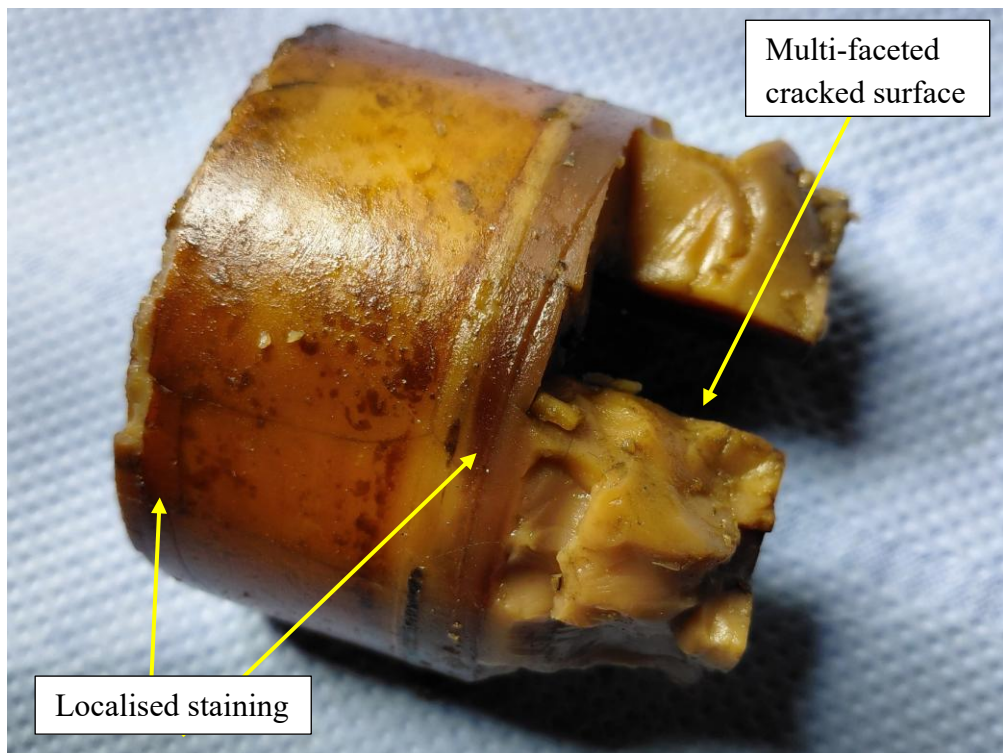
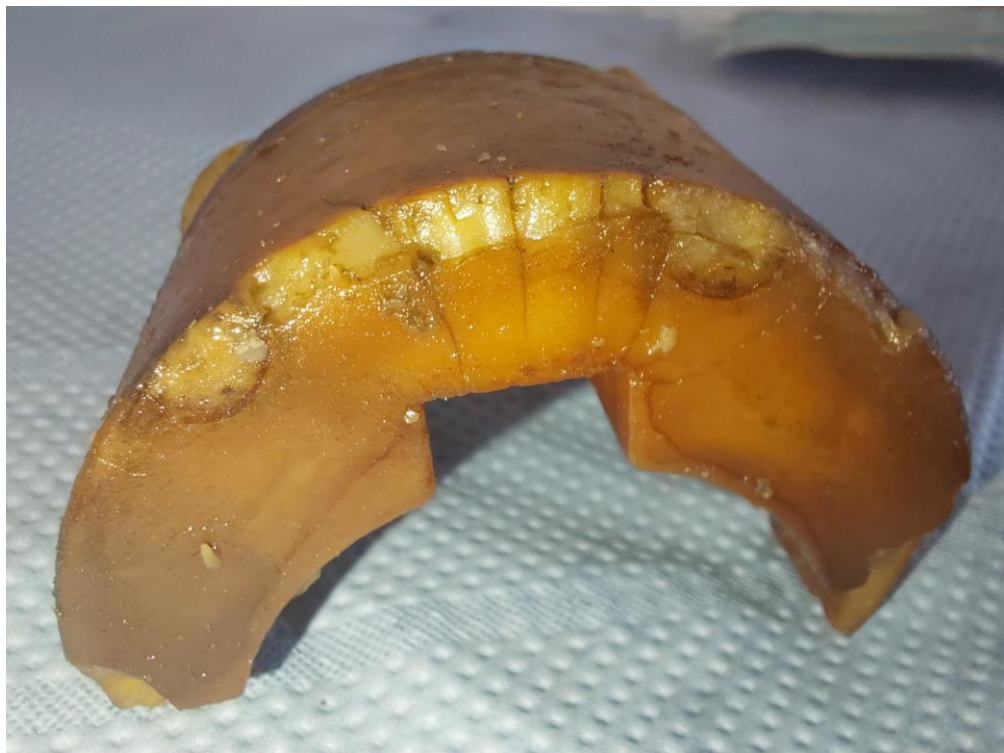
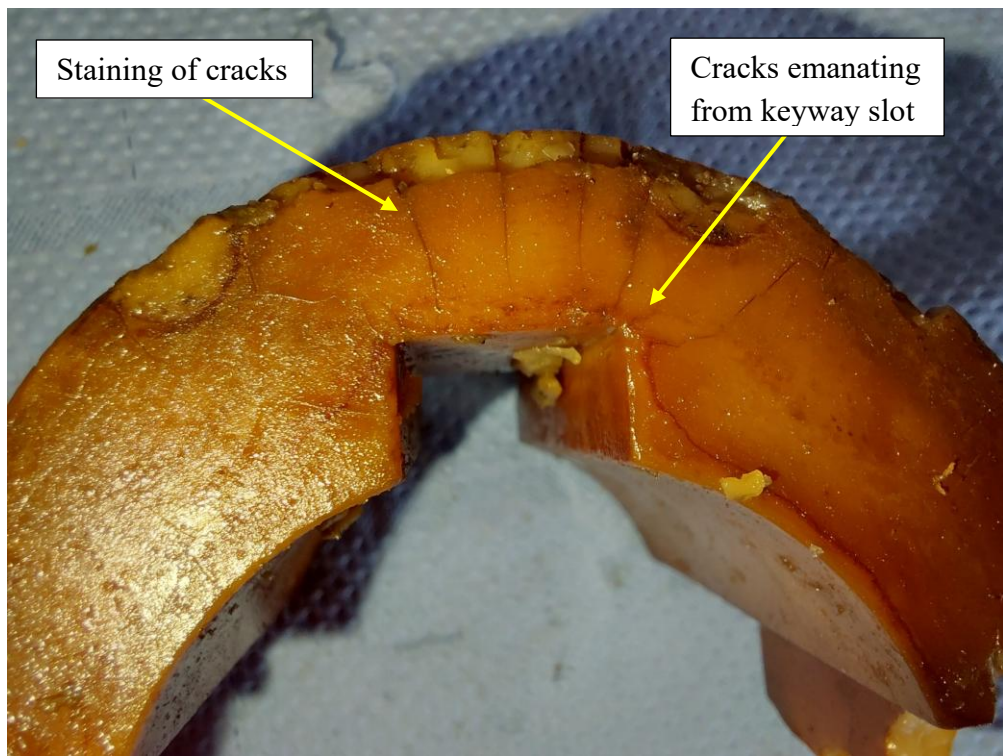
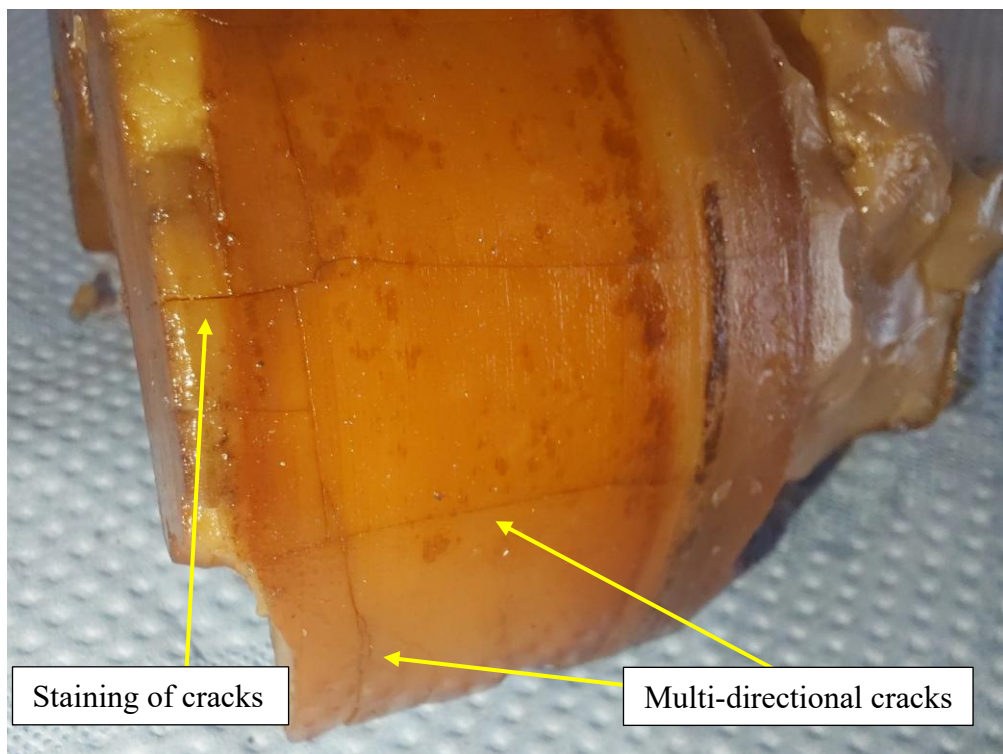
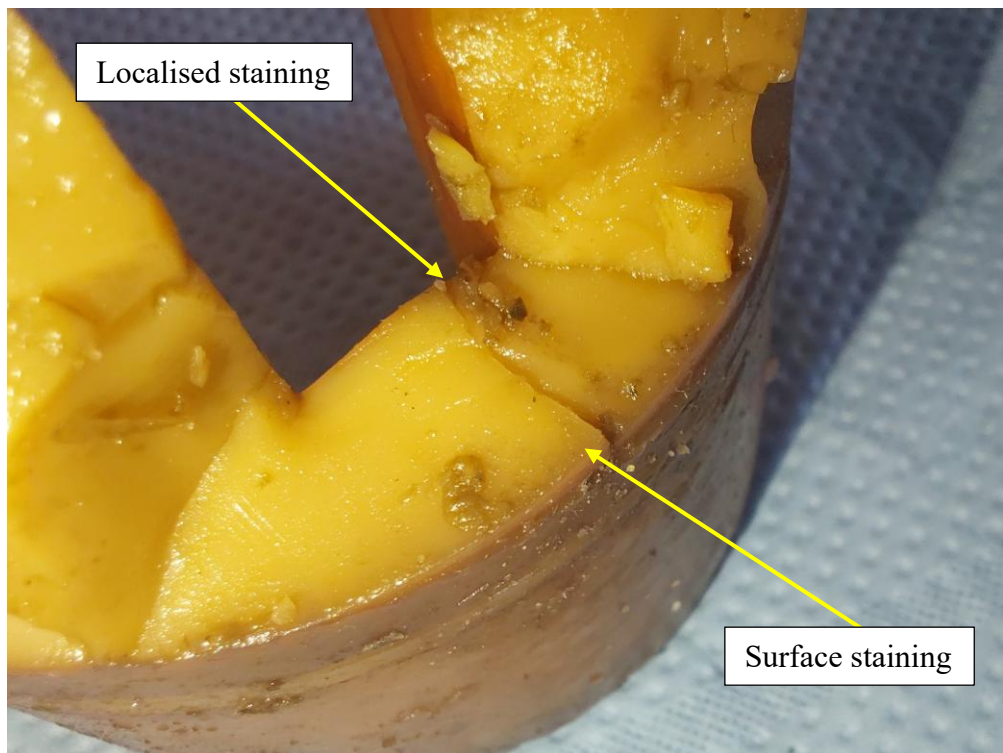
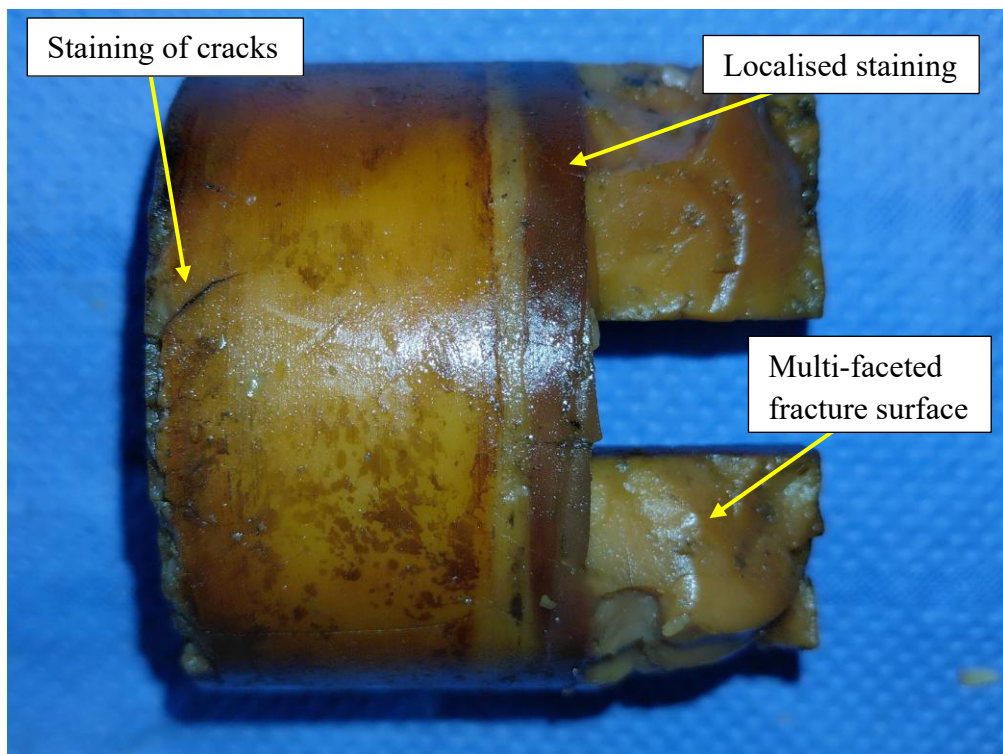
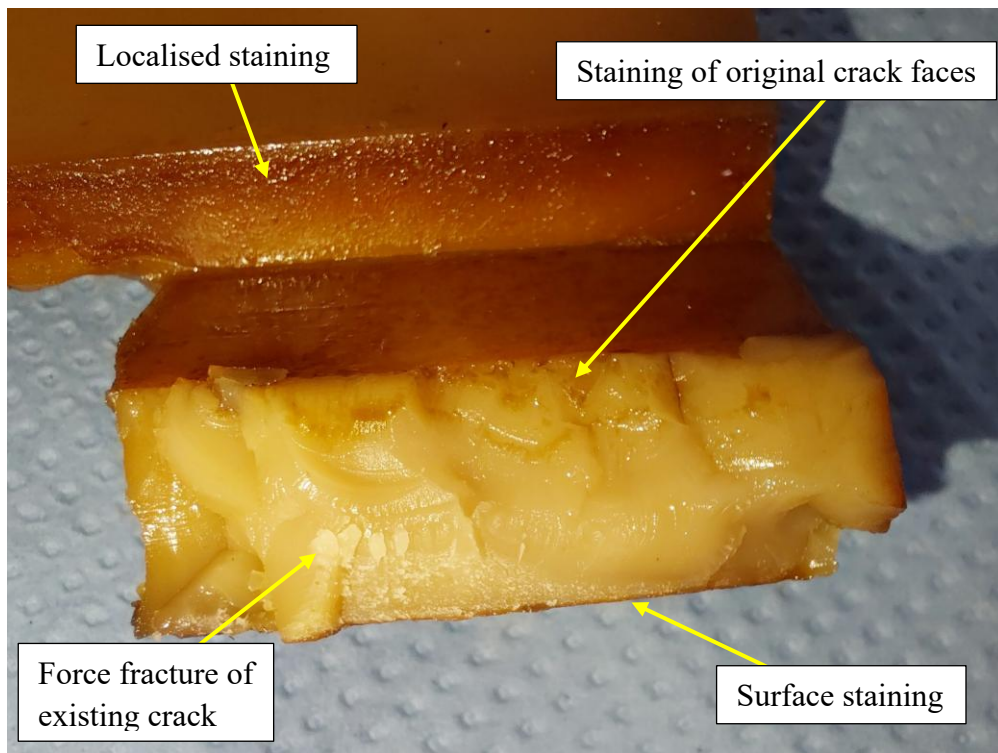
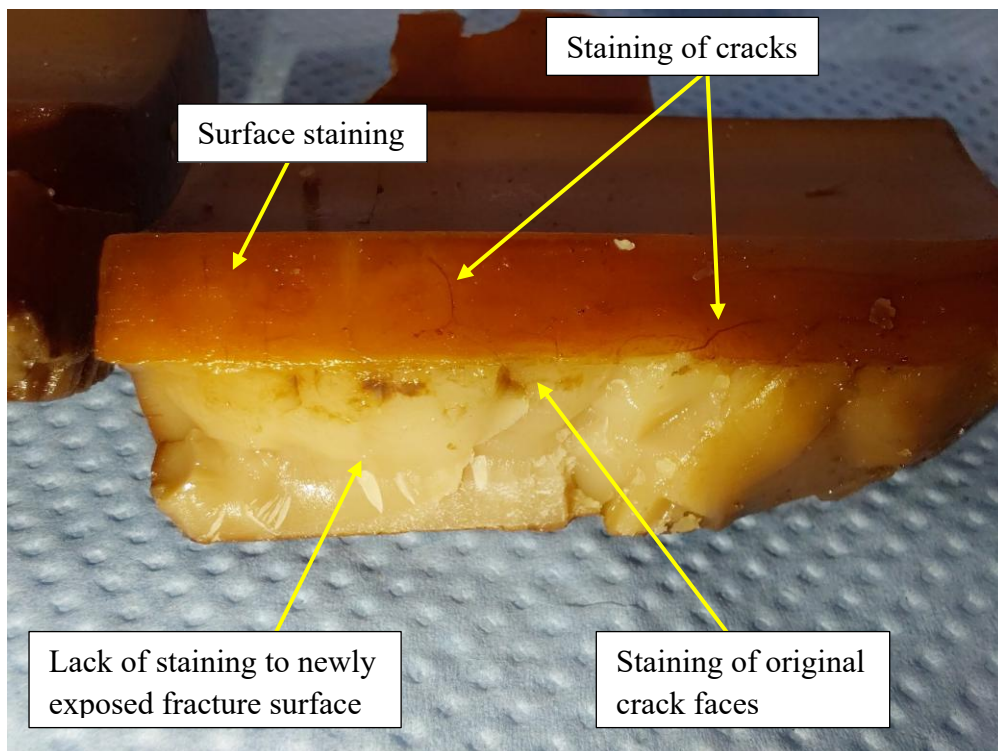
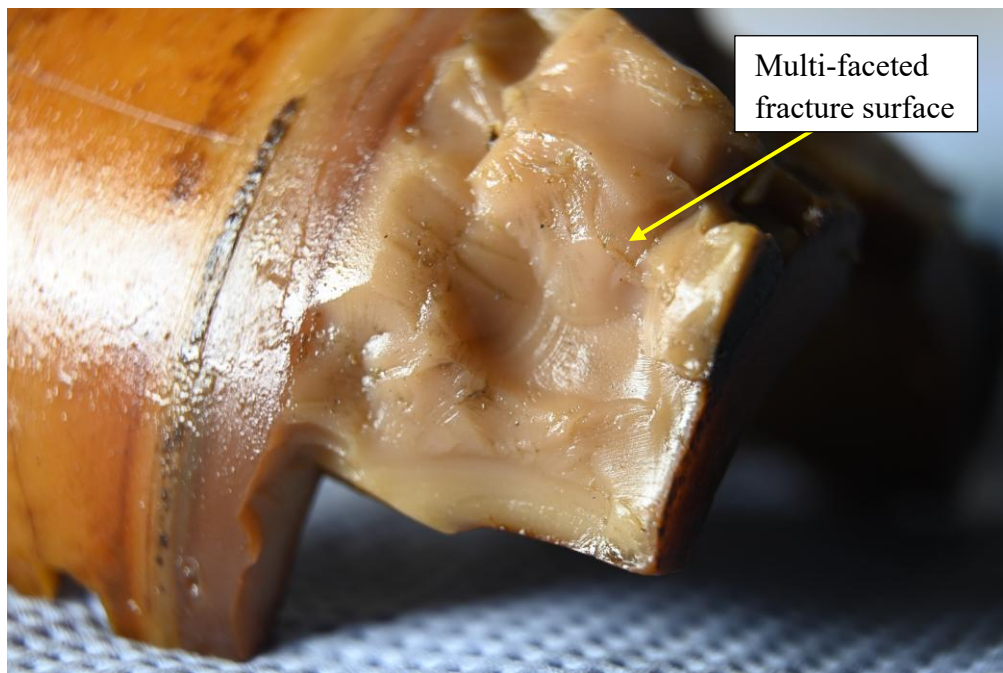
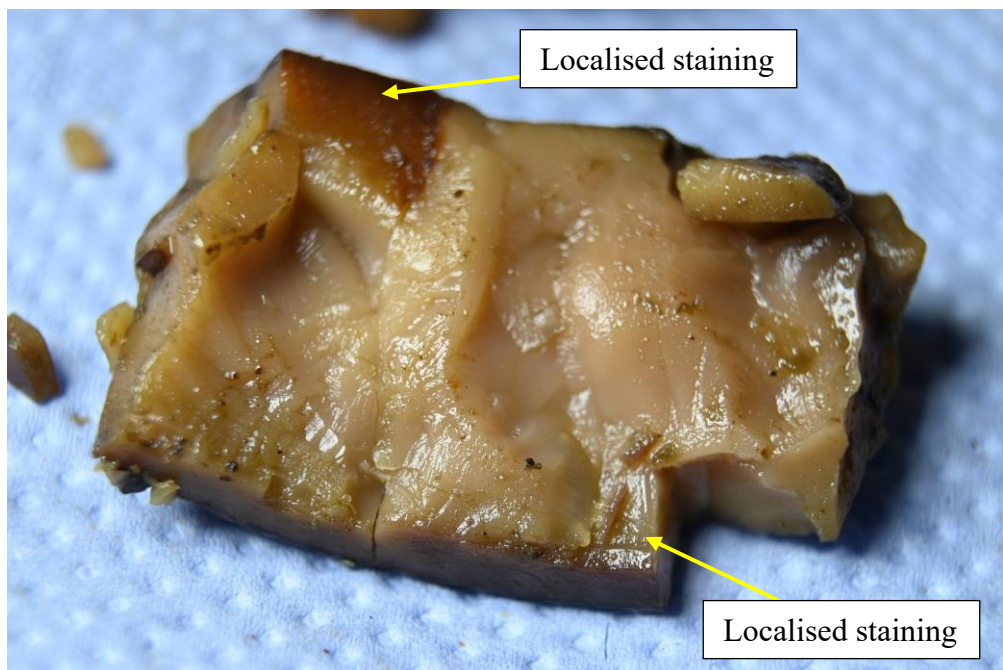
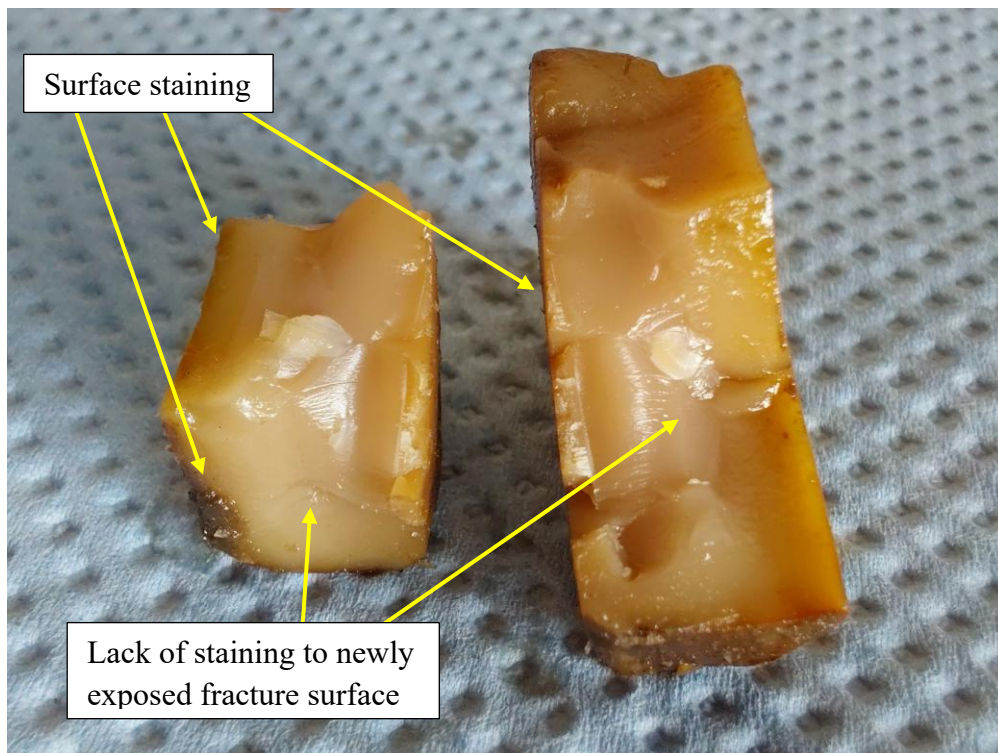
- 14.6.2. The larger fragment also had a section missing from the outer circumference of the larger diameter end of the eccentric and in the vicinity of one of the keyway slots.

- 14.6.3. The fracture surfaces of the eccentric fragments were multi-faceted in a similar manner to the R1 and R2 eccentrics.
- 14.6.4. There were a large number of cracks present across all planes of the component, including in longitudinal, radial and circumferential directions. Some of the cracks had propagated from the corners of the keyway slots.

- 14.6.5. There was significant staining of the eccentric from the oil. More specifically, in a similar manner to R2, there was localised staining from the oil that had penetrated into the cracks, increasing their contrast. The presence of staining within the cracks would suggest that the cracks had been developing for an extended period of time, and long enough for the oil to have penetrated the crack and cause the observed staining.

- 14.6.8. Finally, in a similar manner to the R1 eccentric, there was also a circumferential band of lighter colour that extended around the smaller diameter end of the eccentric. The position and size of this band suggests that this was the region to which the metal collar was previously fitted, and as such, the lighter colour would suggest that the oil was not able to stain this region of the eccentric to the same degree as the other exposed regions.

*Figure 64: Inspection of R3 eccentric (1)*

*Figure 65: Inspection of R3 eccentric (2)*

*Figure 66: Inspection of R3 eccentric (3)*

*Figure 67: Inspection of R3 eccentric (4)*

*Figure 68: Inspection of R3 eccentric (5)*

*Figure 69: Inspection of R3 eccentric (6)*

*Figure 70: Inspection of R3 eccentric (7)*

*Figure 71: Inspection of R3 eccentric (8)*

*Figure 72: Inspection of R3 eccentric (9)*

*Figure 73: Inspection of R3 eccentric (10)*

*Figure 74: Inspection of R3 eccentric (13)*

*Figure 75: Inspection of R3 eccentric (14)*

*Figure 76: Inspection of R3 eccentric (15)*

*Figure 77: Inspection of R3 eccentric (16)*

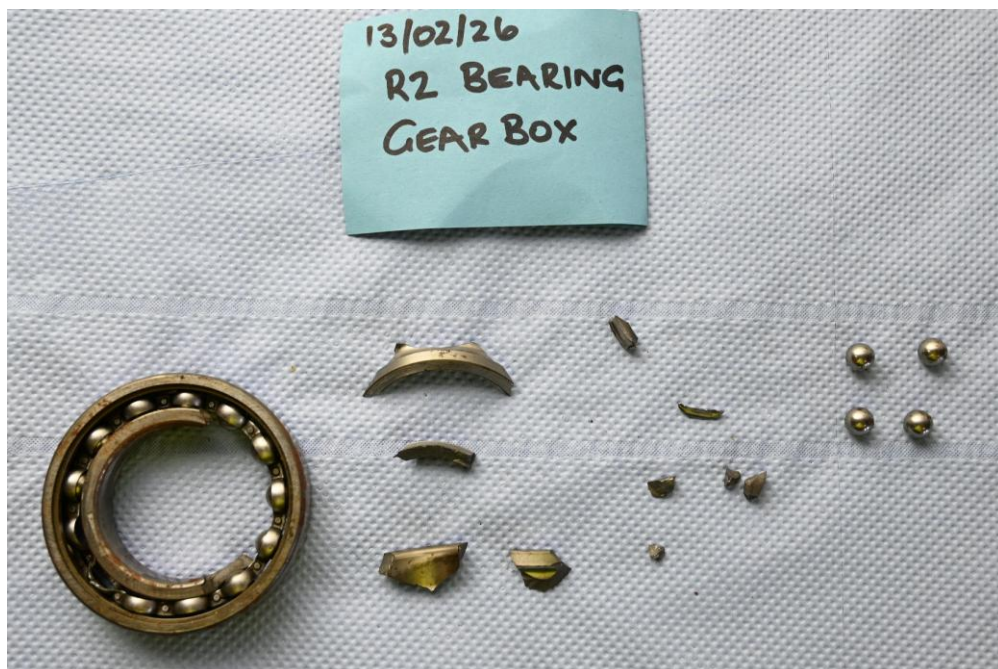
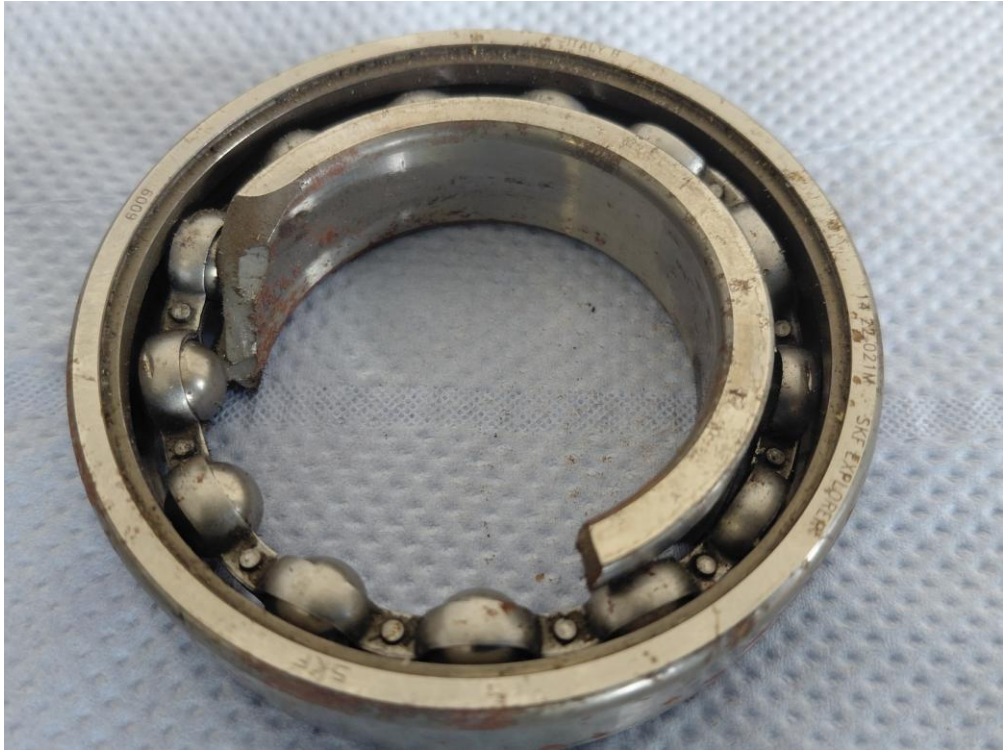
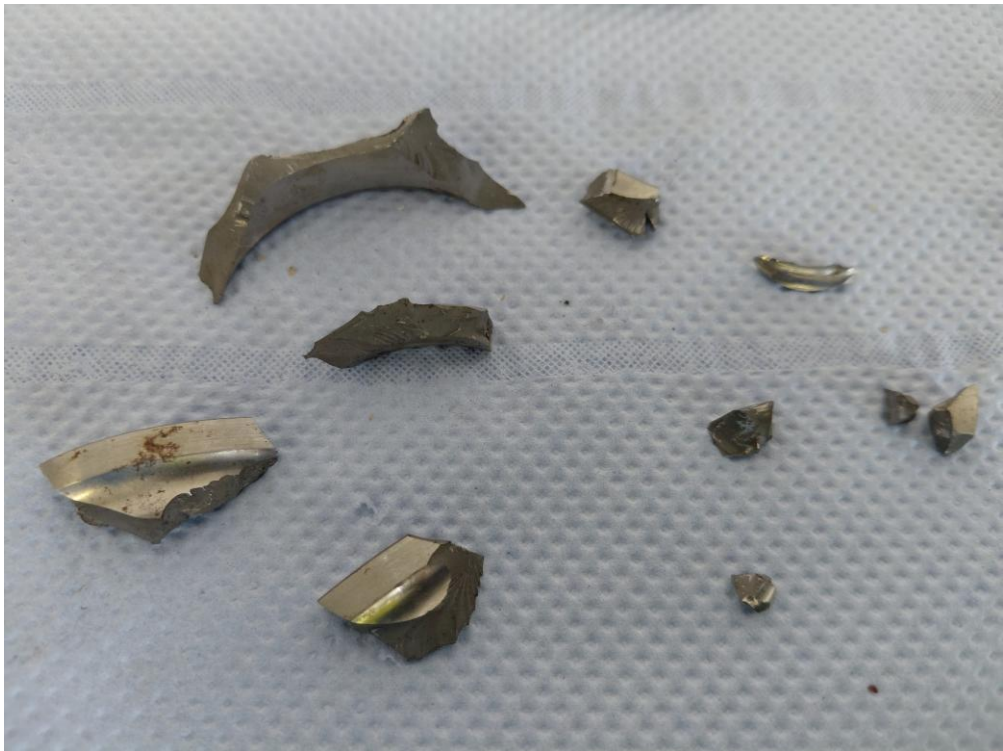
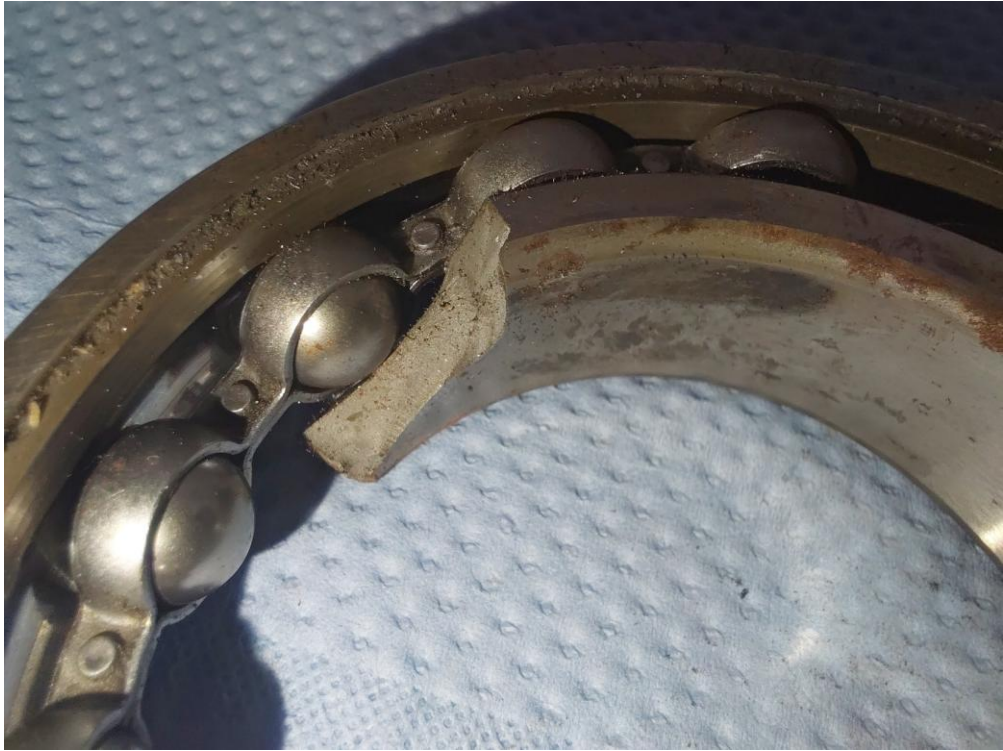
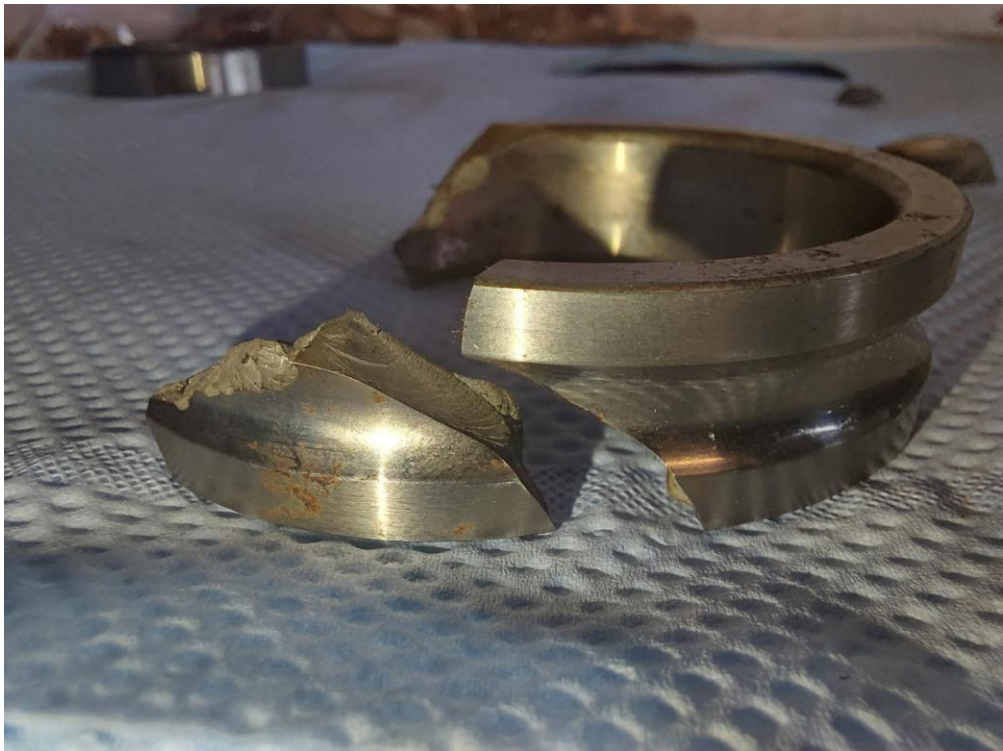
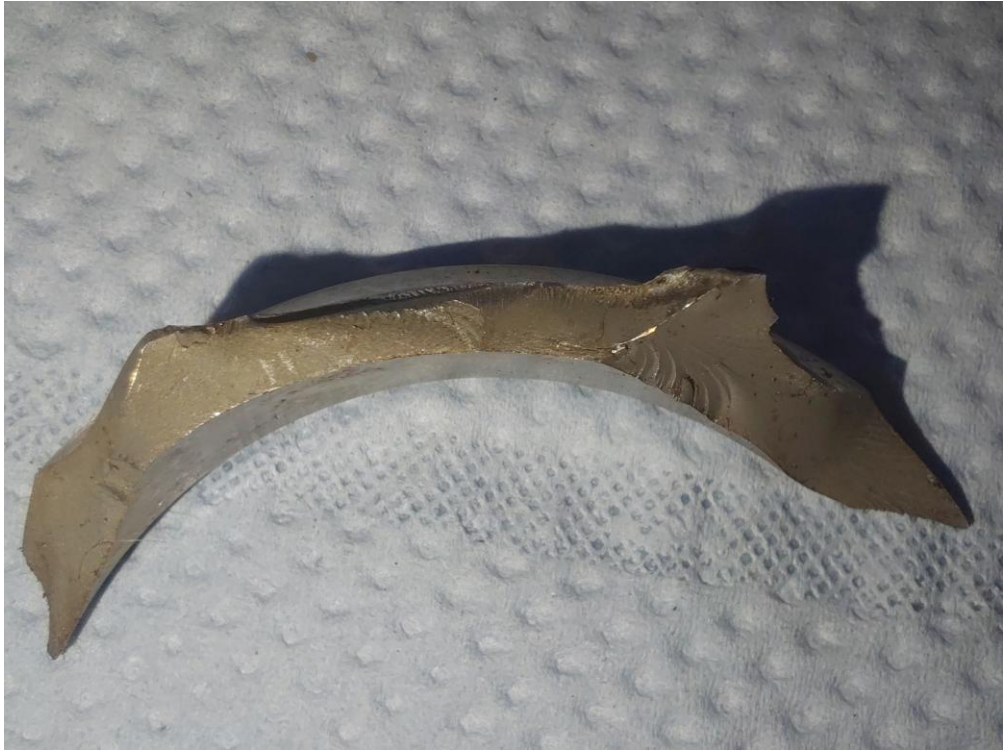
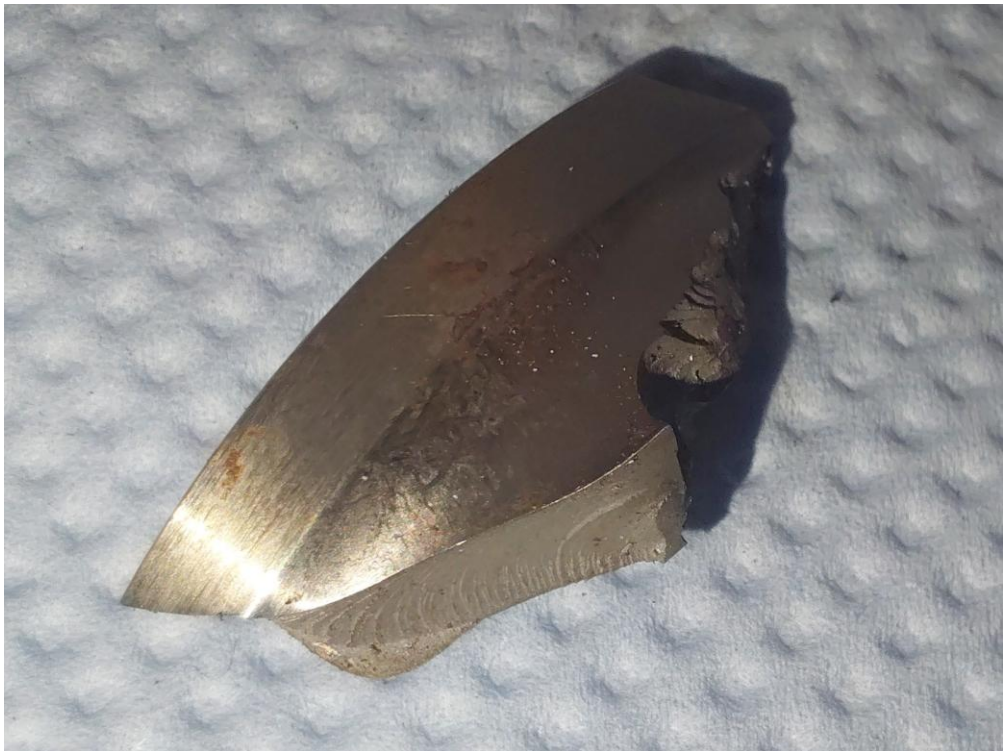
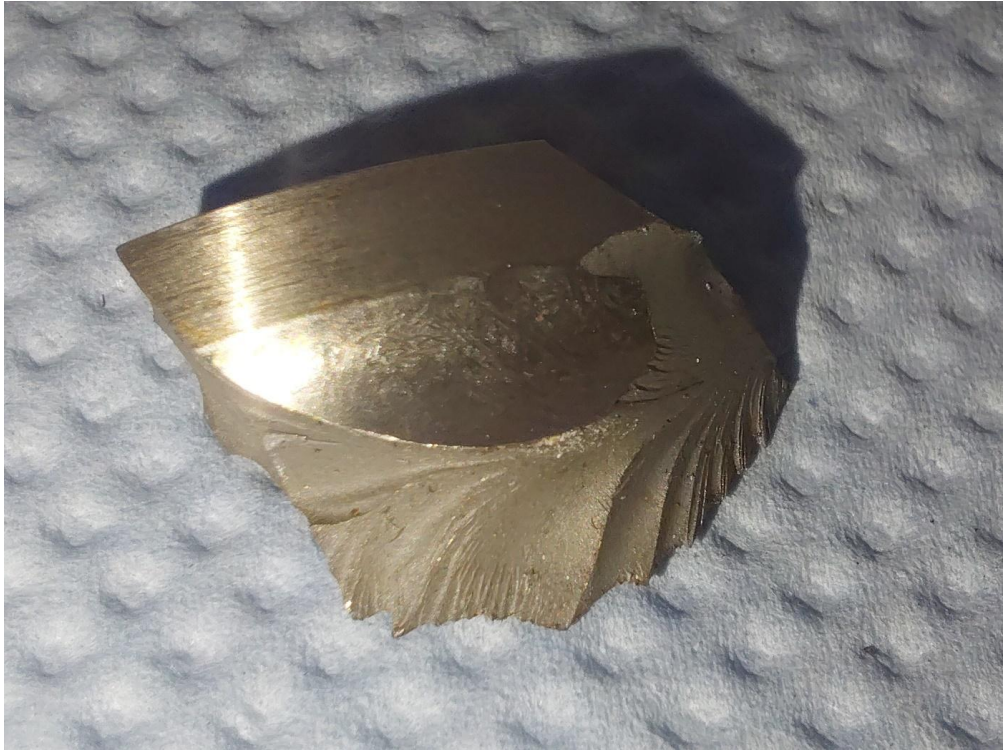
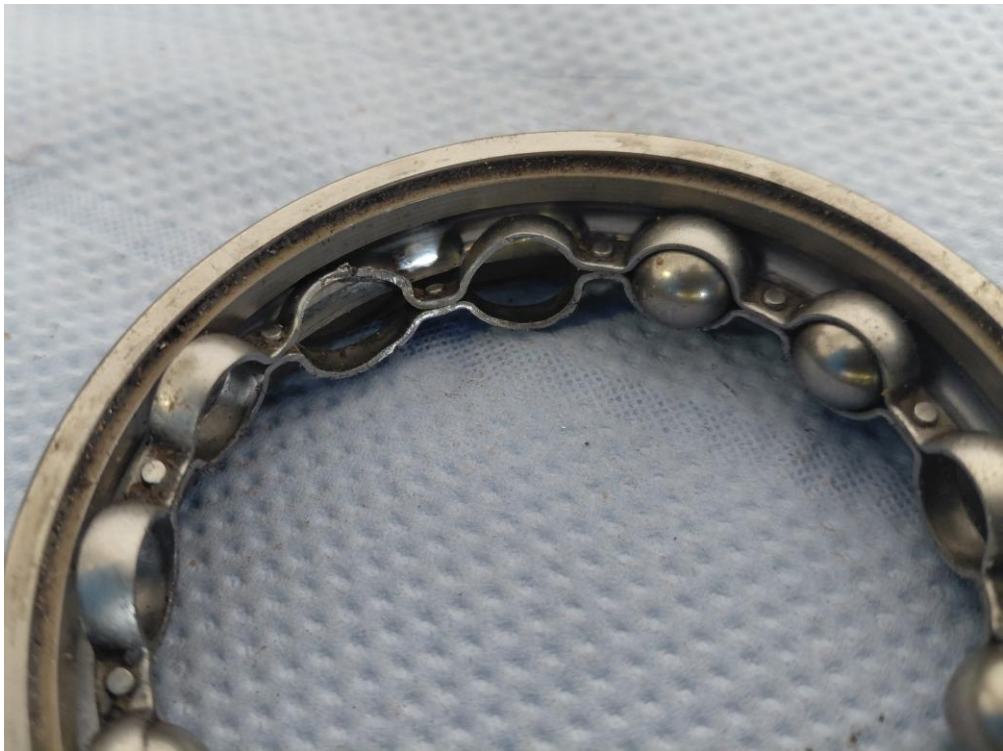
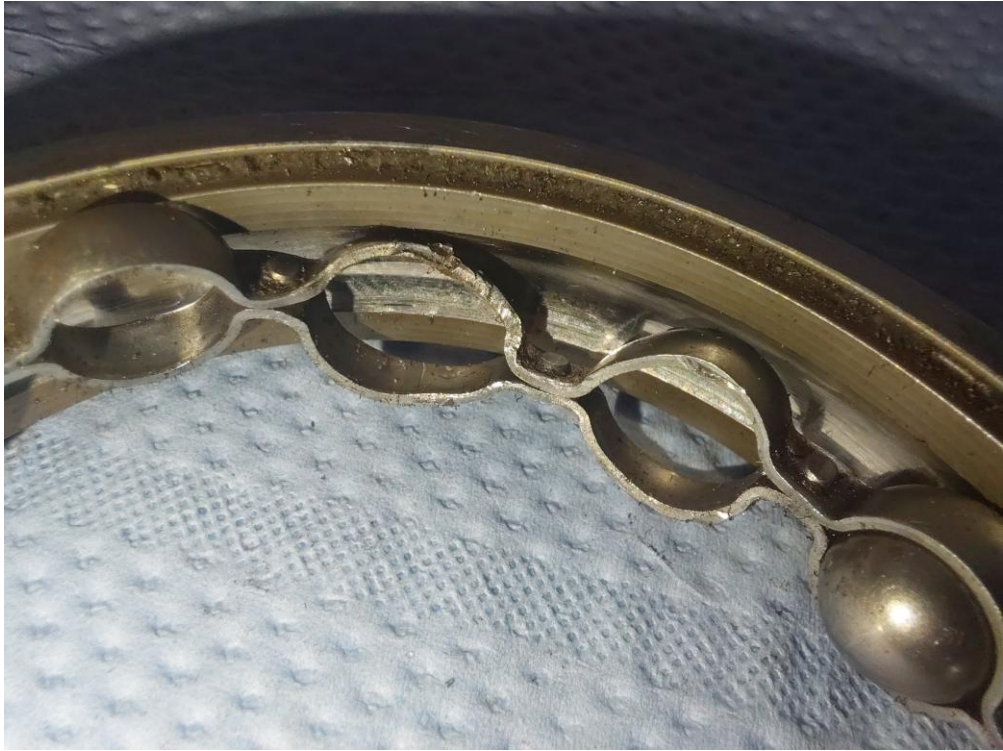
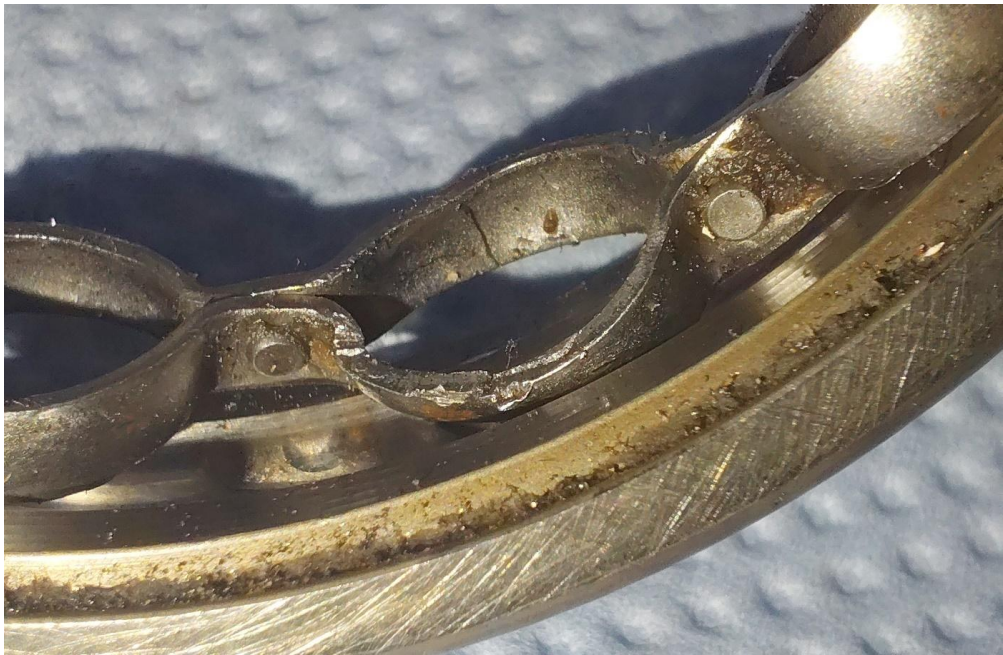
- 15.3. Nevertheless, the bearing was a ball-bearing type, comprising an inner and outer ring, and 13 ball bearings.
- 15.4. The inner ring was fractured into a number of sections.

- 15.5. The bearing cage (the component that holds the ball bearings in position) was twisted and deformed on one edge. There were also cracks to the bearing cage in places, and deformation to its outer edge.

- 15.6. To my mind, the nature of the fracture surfaces of the broken fragments of the bearing appeared consistent with brittle fracture as a result of a single, over-load type failure, and possibly a shock load. There was no evidence of any progressive degradation mechanisms such as fatigue loading and/or corrosion.

- 15.12. Furthermore, as described previously, to my mind, the nature of the deformation could suggest a twisting/bending force. This could suggest some misalignment of the bearing at the point that the force was applied. However, at this stage, I am unable to make any further comment in this regard.

*Figure 78: Inspection of R2 gearbox bearing (1)*

*Figure 79: Inspection of R2 gearbox bearing (2)*

*Figure 80: Inspection of R2 gearbox bearing (3)*

*Figure 81: Inspection of R2 gearbox bearing (4)*

*Figure 82: Inspection of R2 gearbox bearing (5)*

*Figure 83: Inspection of R2 gearbox bearing (6)*

*Figure 84: Inspection of R2 gearbox bearing (7)*

*Figure 85: Inspection of R2 gearbox bearing (8)*

*Figure 86: Inspection of R2 gearbox bearing (9)*

*Figure 87: Inspection of R2 gearbox bearing (10)*

*Figure 88: Inspection of R2 gearbox bearing (11)*

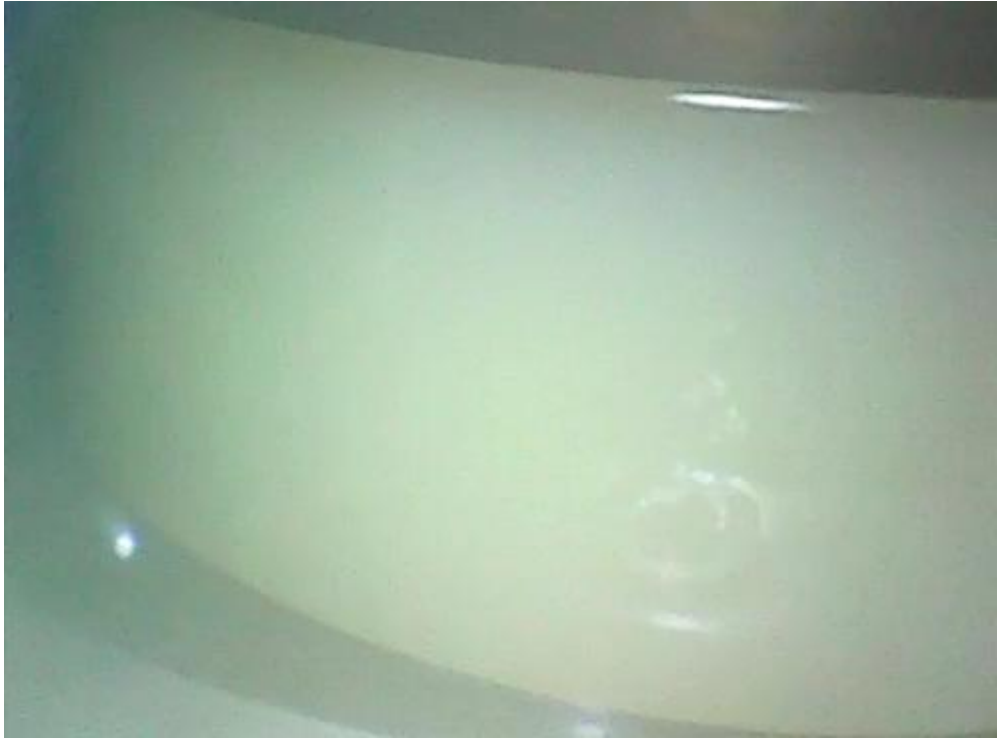
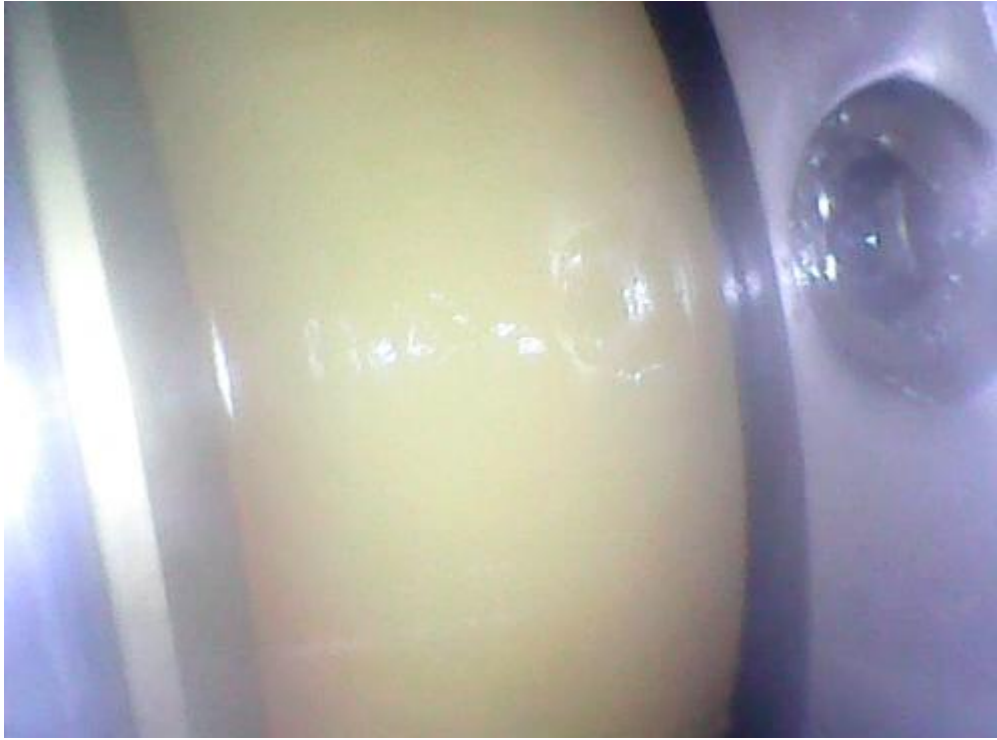
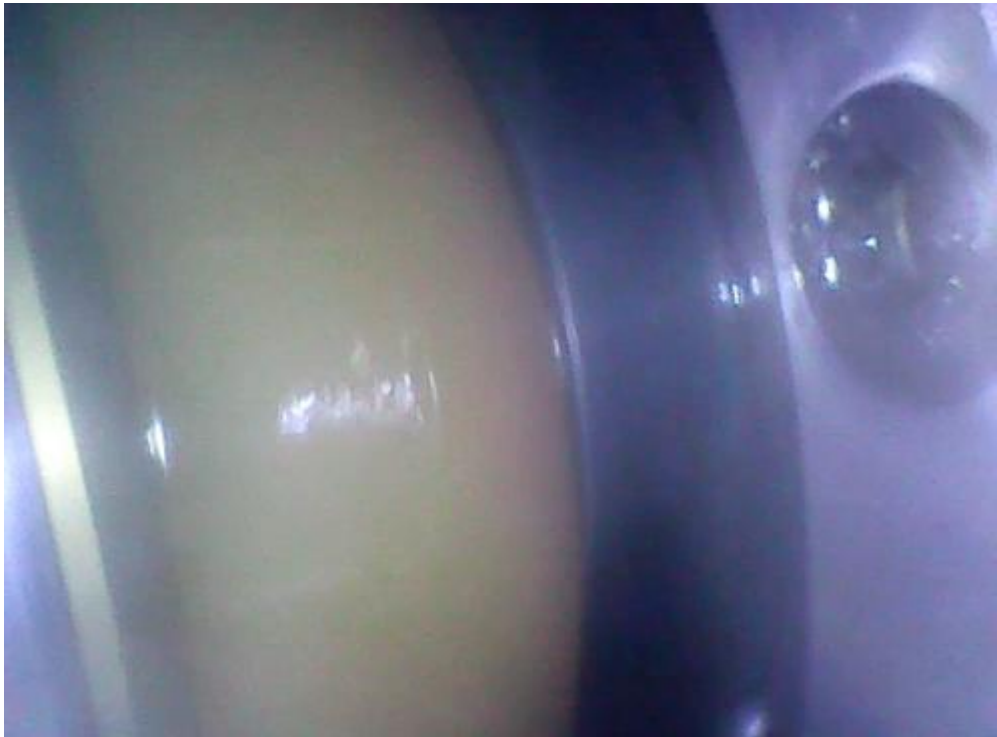
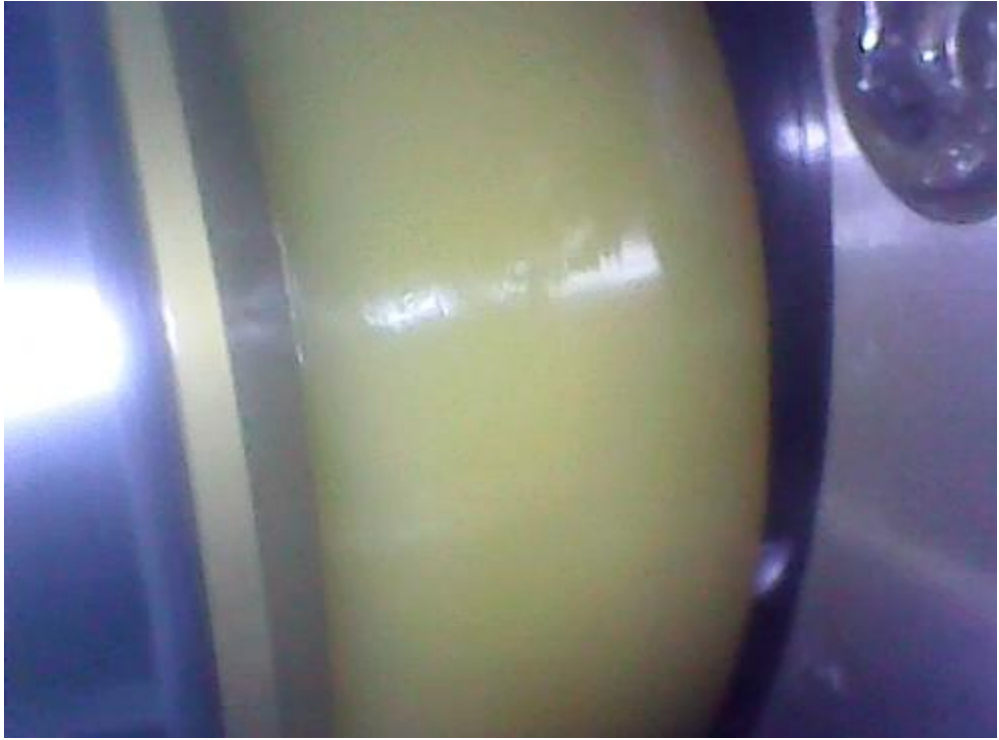
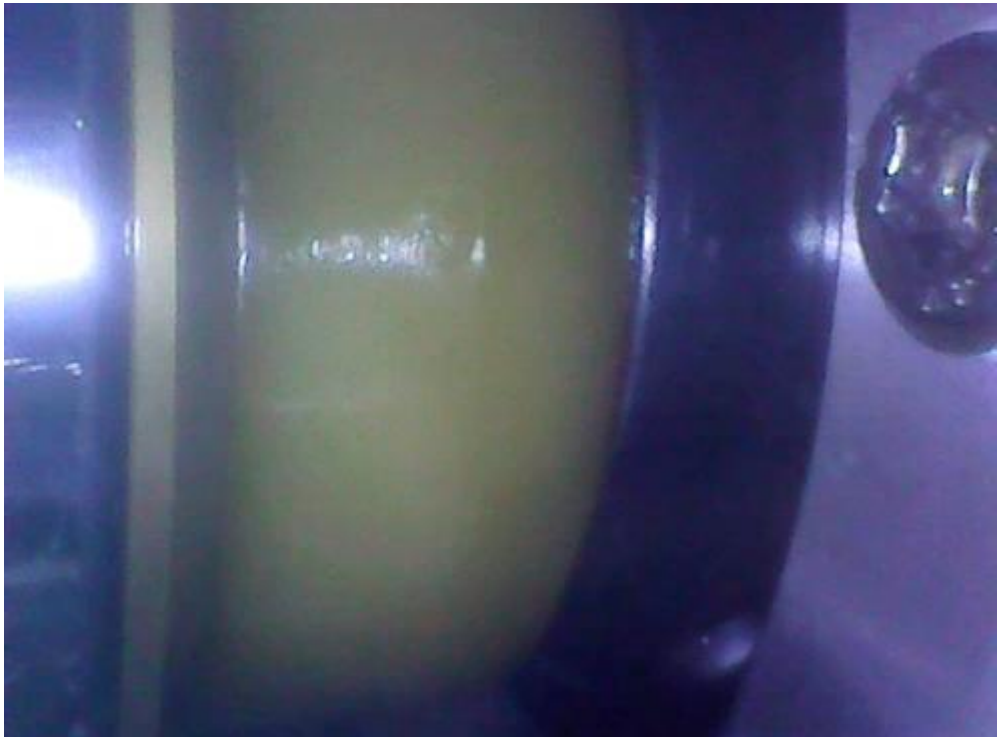
- 17.6. On this basis, this cursory in-service inspection provided an up-to-date assessment of the condition of each of the eccentrics.
- 17.7. Inspection of the full circumference of the larger diameter end of the eccentric from each ARFF vehicle showed that the eccentrics appeared to be intact, with no visible damage, defect, abrasion, cracking or the like.

*Figure 96: Eccentric of R1 (in situ) (1)*

*Figure 97: Eccentric of R1 (in situ) (2)*

*Figure 98: Eccentric of R2 (in situ) (1)*

*Figure 99: Eccentric of R2 (in situ) (2)*

*Figure 100: Eccentric of R3 (in situ) (1)*

*Figure 101: Eccentric of R3 (in situ) (2)*
