MECHANICAL INVESTIGATION INTO

**THE FAILURES OF WATER PUMP GEARBOXES FITTED  
TO FIRE TENDERS OPERATED BY ST HELENA AIRPORT**

St Helena Government

Dr Ross Beesley CEng MIMechE

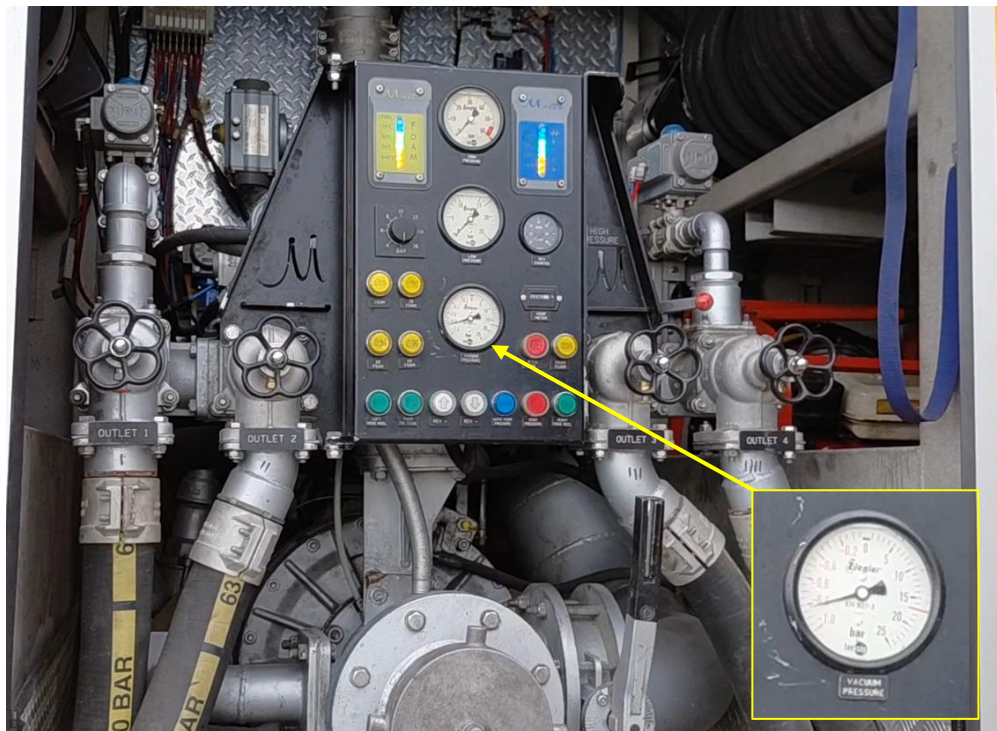
- 20.3.5. During the test that I witnessed, a negative pressure was first detected after the pump had been running for approximately 15 seconds, and a reading of -0.8 bar was achieved after approximately 30 seconds. The negative pressure of -0.8 bar was then sustained for in excess of 1 minute, at which point the test was stopped as it was deemed satisfactory. Images from the dry-vacuum test are provided in Figure 103, below, and Figure 104, overleaf. Instructions for this test are also outlined in the pump operating manual, and this is shown in Figure 105, also overleaf.

Figure 104: Dry vacuum test: negative pressure of -0.8bar achieved after ~30s

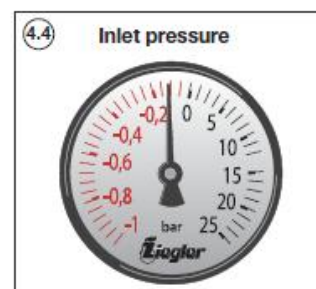
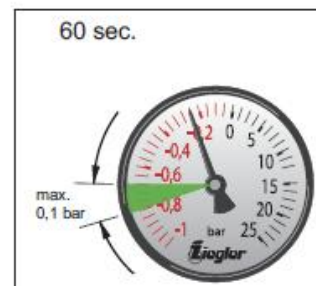
Figure 105: Instructions for dry-vacuum test of pump

The pointer on the pressure gauge/vacuum gauge (4.4) must be in the red area at the latest after 20 s.

- Switch off pump when a partial vacuum of approx. 0.8 bar is reached.
- Observe indication of the pressure gauge/vacuum gauge (4.4):  
The partial vacuum is allowed to drop by a maximum of 0.1 bar within 1 minute!

If the partial vacuum drops more, the pump is leaking. This means that air is entering the pump and the pump can no longer draw correctly!

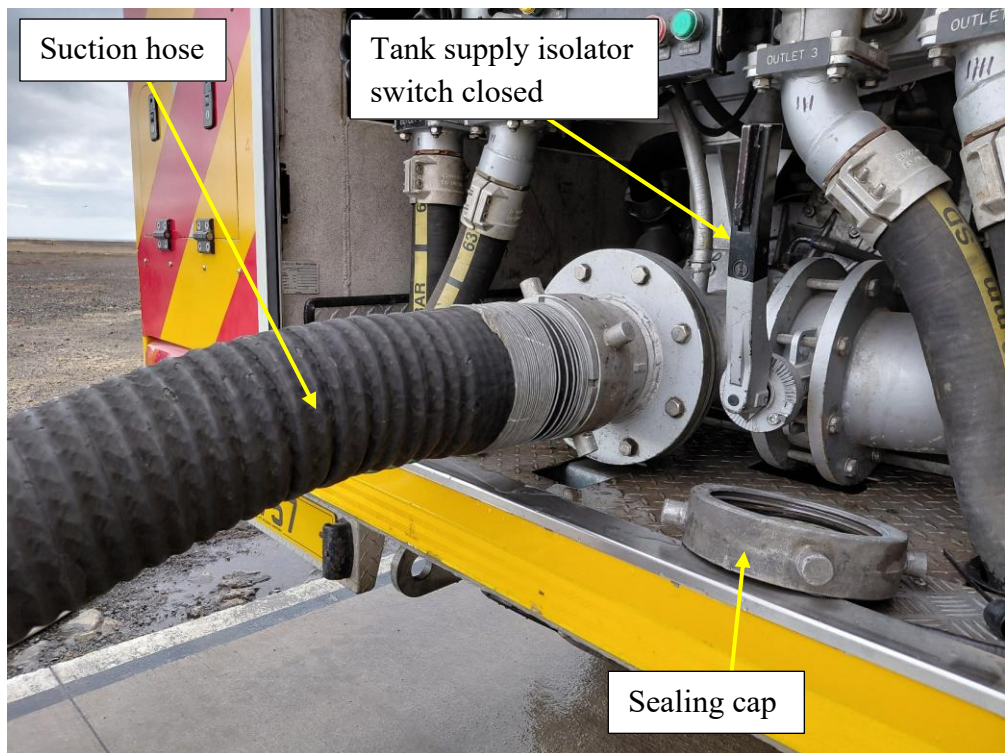
- 20.4.6. However, when drafting water from an external source in this way, the water level is below the level of the pump. This means that the pump will not be gravity-fed, and as such is reliant on the Trokomat primer to remove any air from the system. If any air remains within the pump, an air-lock would be generated, in turn preventing the flow of water. Consequently, testing the drafting function in this manner also tests the operation of the Trokomat primer.

*Figure 106: Suction hose connected to drafting inlet*

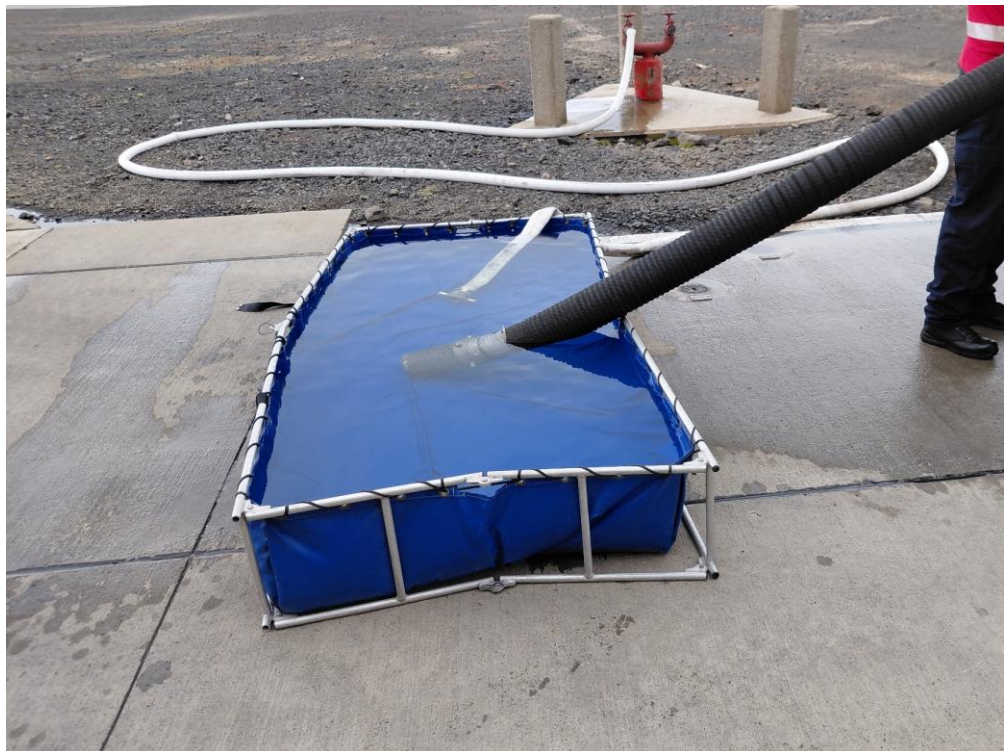
*Figure 107: Opposing end of suction hose inserted into external water supply*

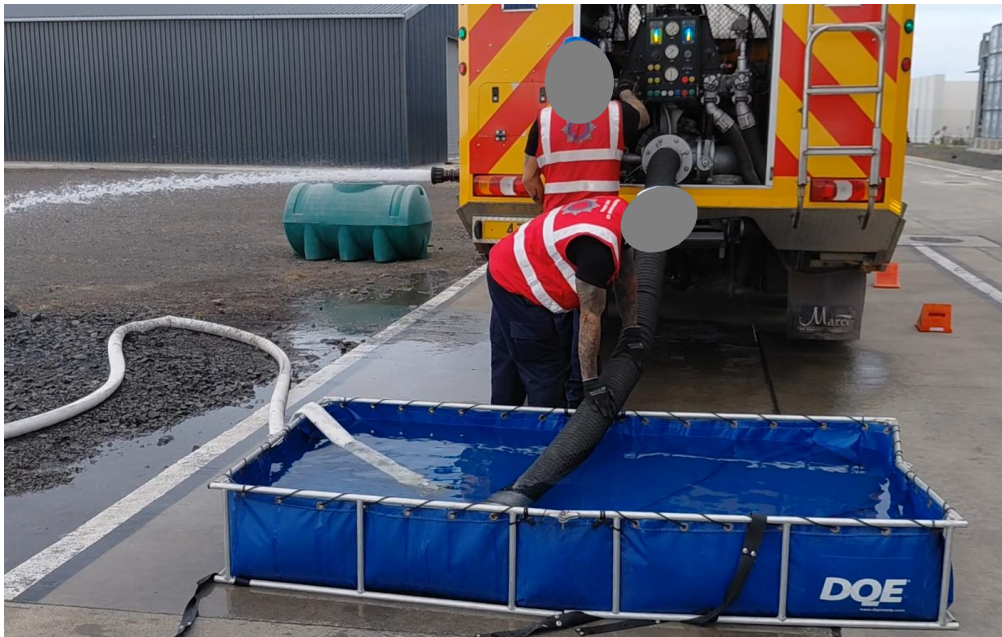
*Figure 108: Water pumped from external supply*

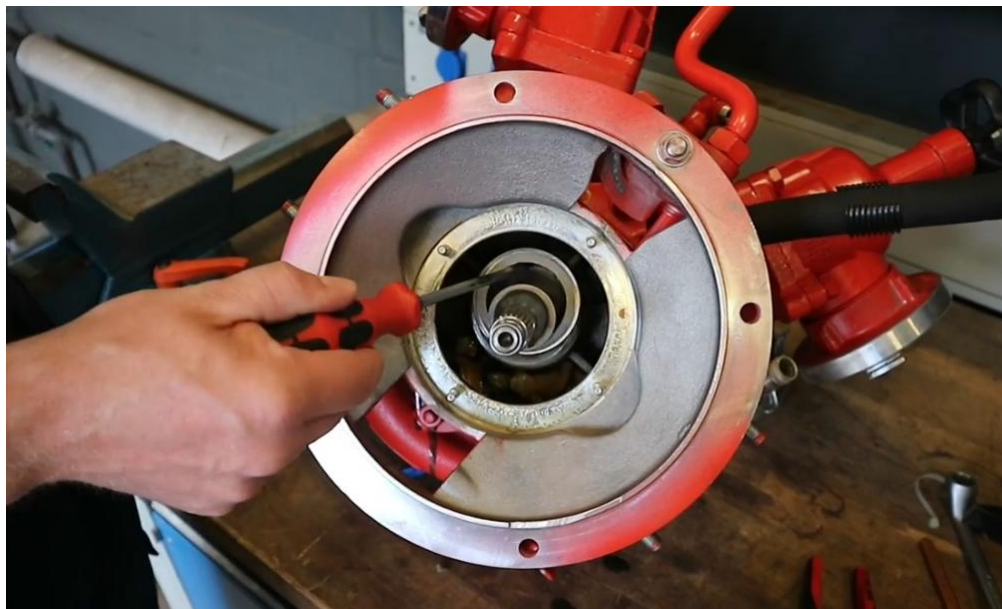
*Figure 117: Online video tutorial showing disintegrated eccentric (1) © ‘Scotty’s Maschinisten Channel’ (<https://www.youtube.com/watch?v=XECFggaW3FA>) [accessed August 2026]*

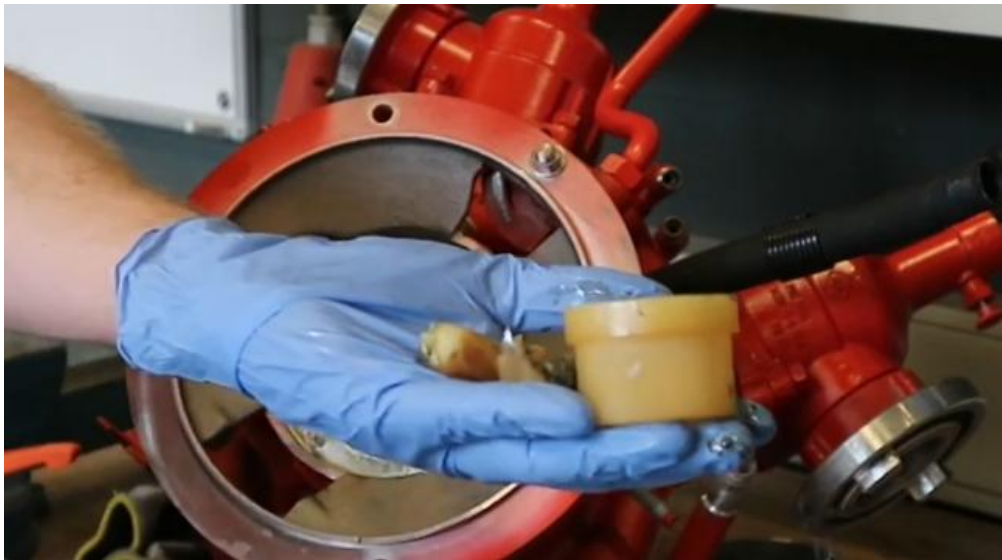
*Figure 118: Online video tutorial showing disintegrated eccentric (2) © 'Scotty's Maschinisten Channel' (<https://www.youtube.com/watch?v=XECFggaW3FA>) [accessed August 2026]*

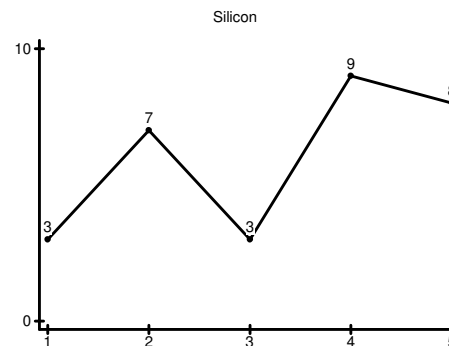
5.) Sample Number H116432 on 08.07.2026 smr 298 HRS  
Wear rates are normal. Debris analysis normal. 1.6% Water present in the oil - check for point of entry.  
Water contamination made the oil unfit for further use. Oil already changed do not drain again. Please return feedback.

- 3.) Sample Number DH14977 on 27.05.2026 smr 296 HRS  
Viscosity measurement carried out in duplicate. Viscosity is low for this grade of oil. Wear rates are normal. Debris analysis normal. 1.2% Water present in the oil - check for point of entry. The oil was not fit for further use due to contamination. Oil already changed do not drain again. Please return feedback.
