## Planning Officer's Report - LDCA JULY 2022

<b>APPLICATION</b>	<b>2021/47</b> – Annual Tree Maintenance at the Duke of Edinburgh Playground
<b>PERMISSION SOUGHT</b>	Permission in Full
<b>REGISTERED</b>	17 <sup>th</sup> June 2021
<b>APPLICANT</b>	Property Division, TI & SD Portfolio
<b>PARCEL</b>	JT080061 & JT080062
<b>ZONE</b>	Intermediate Zone
<b>CONSERVATION AREA</b>	Jamestown Conservation Area
<b>PUBLICITY</b>	The application was advertised as follows: <ul style="list-style-type: none"><li>▪ Independent Newspaper on 18<sup>th</sup> June 2021</li><li>▪ A site notice displayed in accordance with Regulations.</li></ul>
<b>EXPIRY</b>	2 <sup>nd</sup> July 2021
<b>REPRESENTATIONS</b>	None Received
<b>DECISION ROUTE</b>	<del>Delegated</del> / <b>LDCA</b> / <del>EXCO</del>

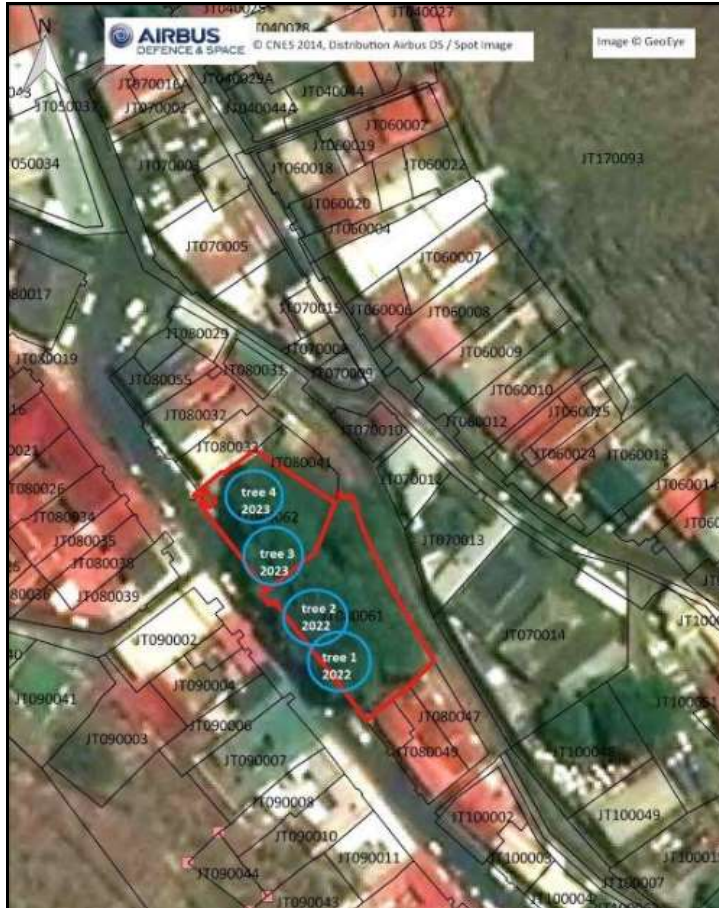
**Diagram 1: Location of Trees**

The limbs of trees in the upper play area are far reaching, extending almost to the buildings on the opposite of Main Street. The tree within the lower play area has a full even canopy but again extends outwards to the existing residential properties and street. The trees bordering the Run are those recently reduced in height and spread through the ENRP Annual Tree Maintenance Programme and are now without any visible defects or wide spread canopy. All of the trees with the exception of the latter are approximately 60 feet plus in height and below them are public car parks, amenity and recreation areas, residential and business properties and the main highway in Jamestown, all of which could be impacted by the trees.

The canopies of the trees in the upper playground are transparent giving good visuals of the extent of their spread and condition. Overall an estimated 40% of the canopies are made up of dry material of small girth. It is worth noting that very little regeneration from previous cuts can be seen, especially of the nature seen on the trees of the Castle Gardens. The regeneration seen in the Duke of Edinburgh Playground is young, leafy growth, not developed as yet into limb materials at heights of 20 plus feet, interestingly on sections of the trees that were pruned approximately 10 plus years ago.

- **2022 Annual Tree Maintenance Schedule** – Removal of all dry limbs within the tree canopies, and removal of all low hanging limbs that may cause an obstruction to all users of the area.
- **2022-2023 Annual Tree Maintenance Schedule** – Topping of trees 1 and 2 only to a management height for future tree maintenance.
- **Year 2023-2024** – Topping to a manageable height for future tree management – trees 3 and 4.
